# UPPER BIG COVE CREEK WATERSHED IMPLEMENTATION PLAN

June 2024

Prepared by Center for Watershed Protection, Inc. (CWP)  
&  
Ecosystem Planning & Restoration (EPR)

Prepared for the Fulton County Conservation District

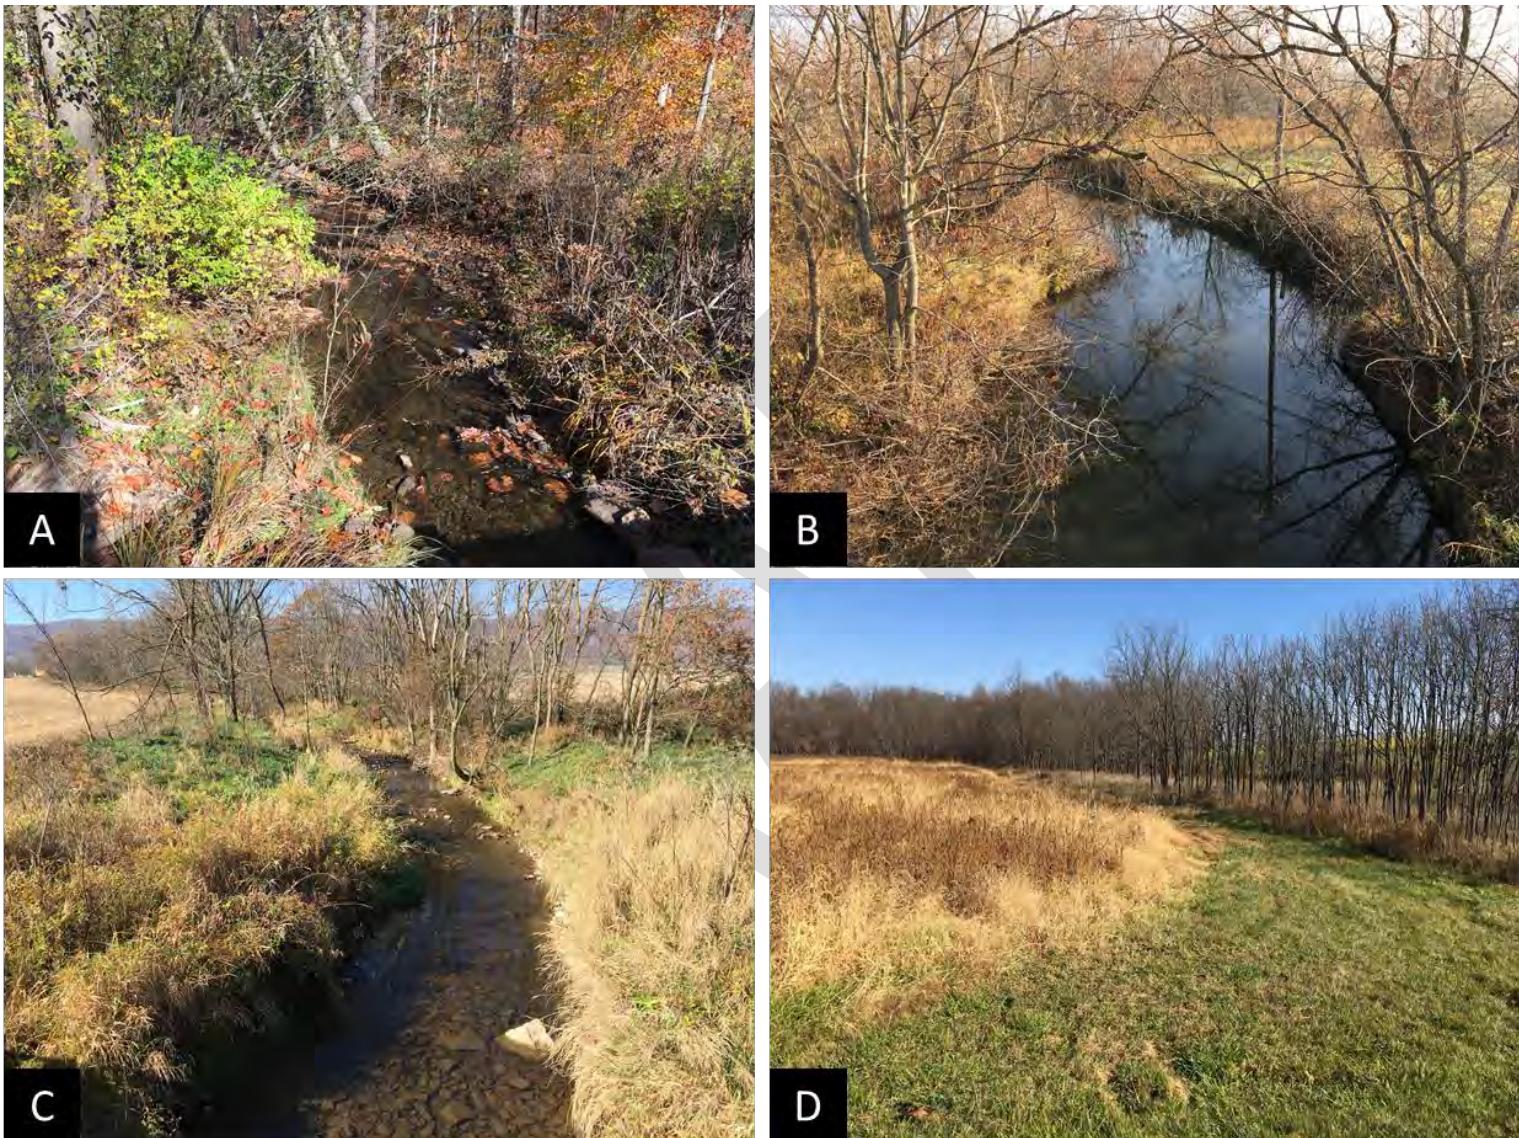
**Figure 23.** Forested riparian buffers within the Cove Creek subwatershed. The watershed began in a forested mountain area (Photograph A). Forested riparian buffers were common in valley areas further downstream, though they were often narrow.

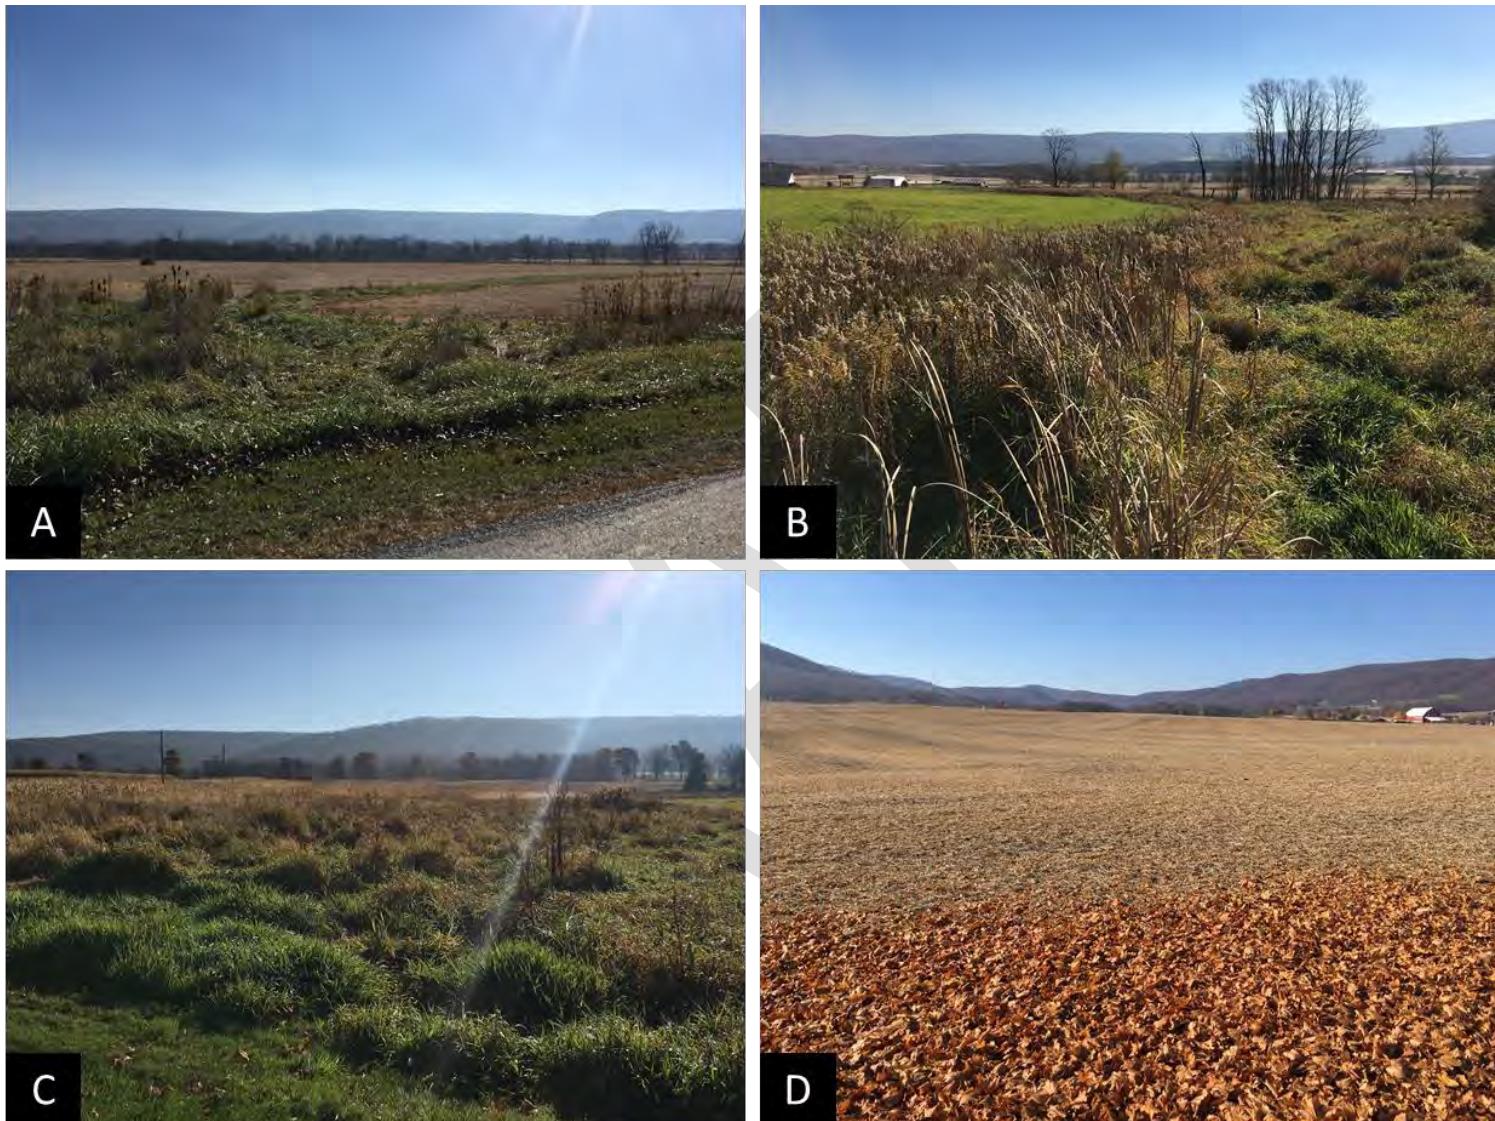
**Figure 24.** Other factors contributing to water quality protection in the Cove Creek subwatershed. Drainageways/small streams were protected by herbaceous wetland buffers in some cases. Also note the crop residues protecting agricultural soils following harvest in A and D.

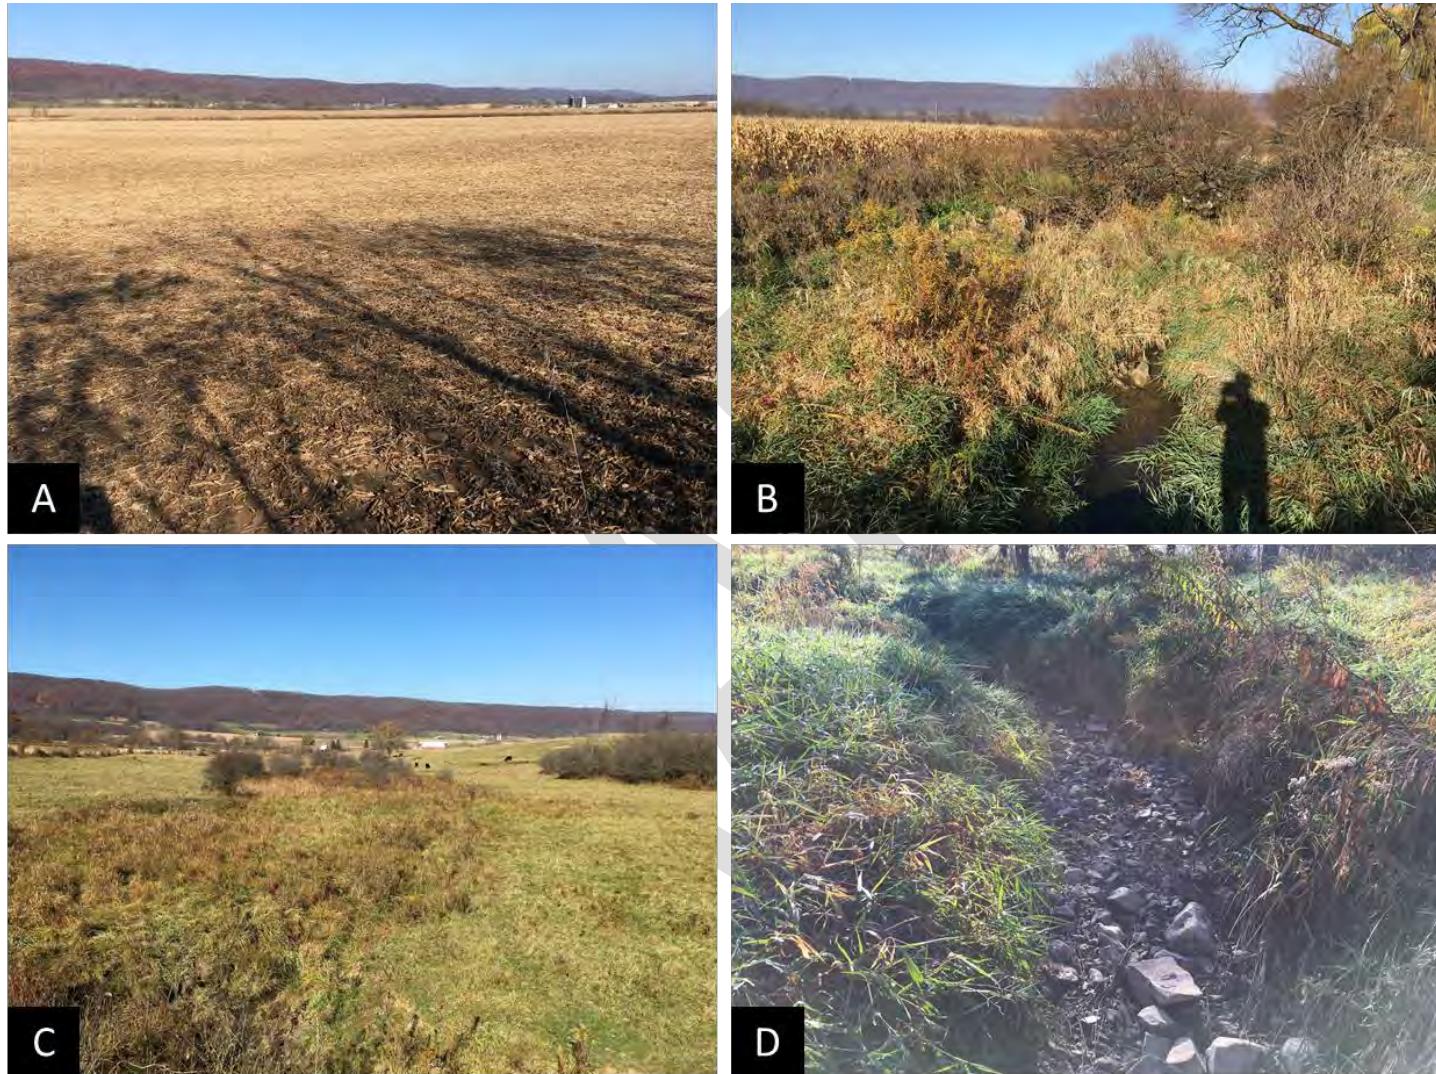
**Figure 25.** Factors contributing to water quality degradation within the Cove Creek subwatershed. Vast areas of croplands, such as those shown in A, occurred in some areas. While buffers were common, they were often very narrow as in B. Photograph C shows a small stream segment where it appears that livestock had direct access to the stream, though grazing appeared to be light. Photograph D shows an area with obvious bank erosion.

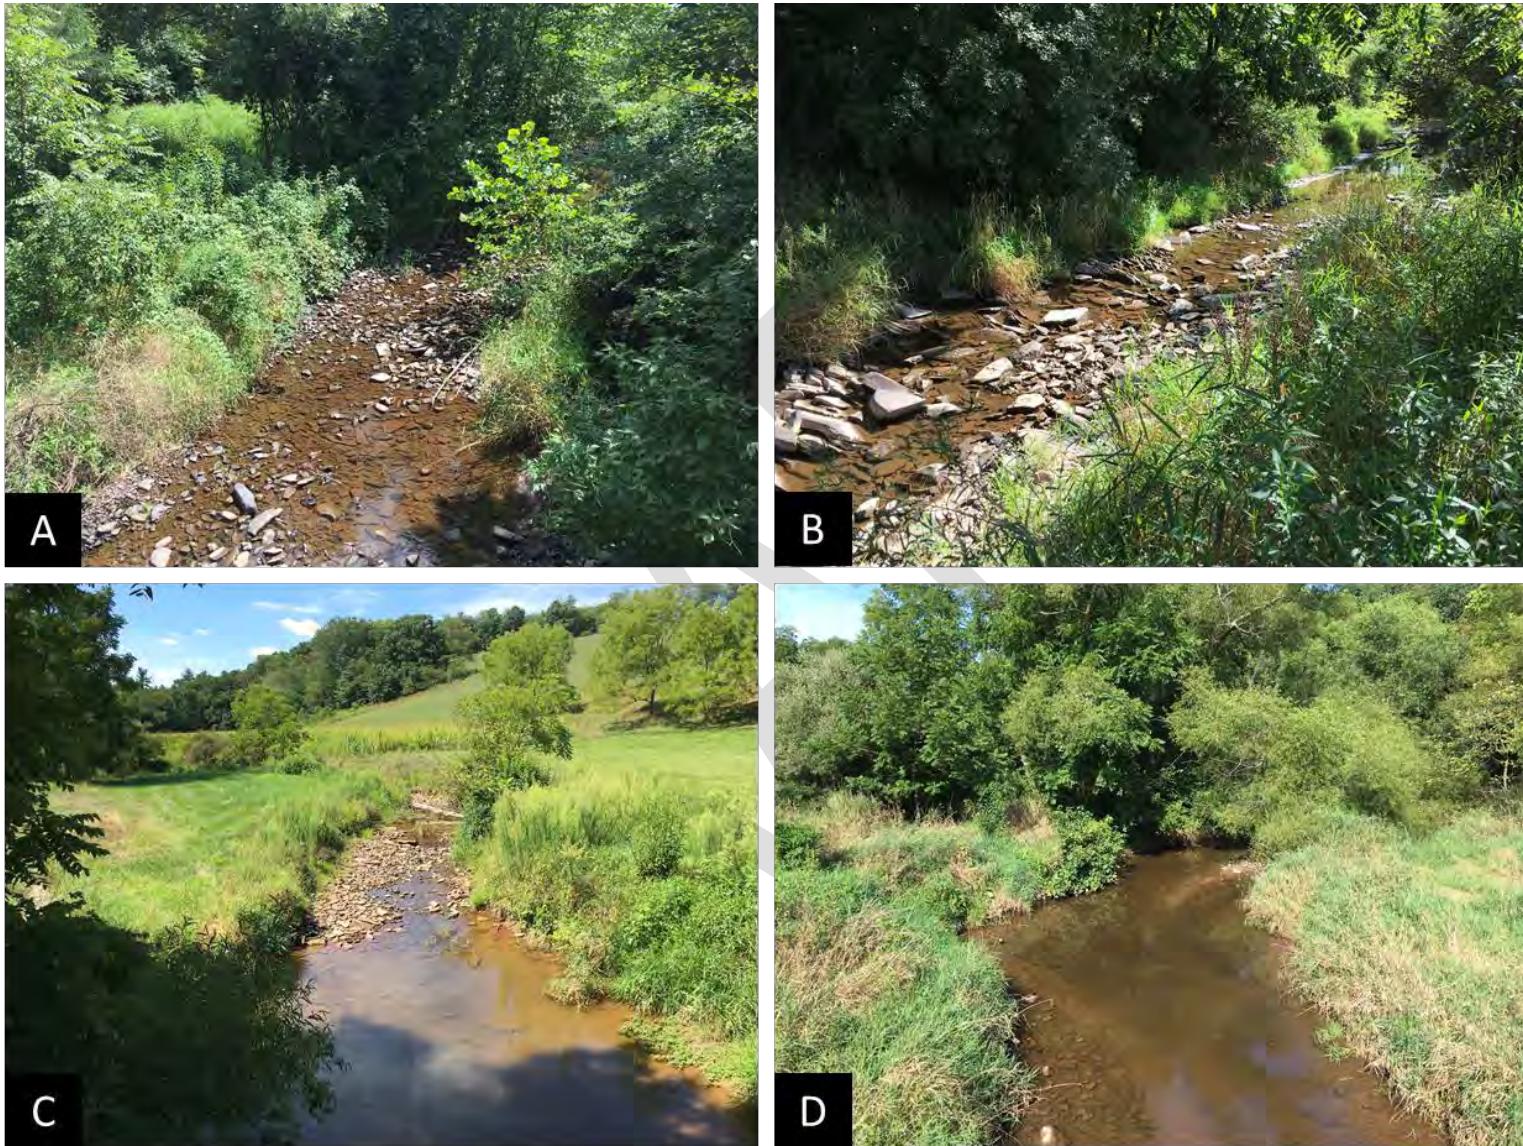
**Figure 26.** Stream conditions within the lower mainstem of the Wooden Bridge Creek subwatershed during summer low flows. Higher gradient riffle areas appeared to be rocky, while significant sediment deposition was observed in some pools.

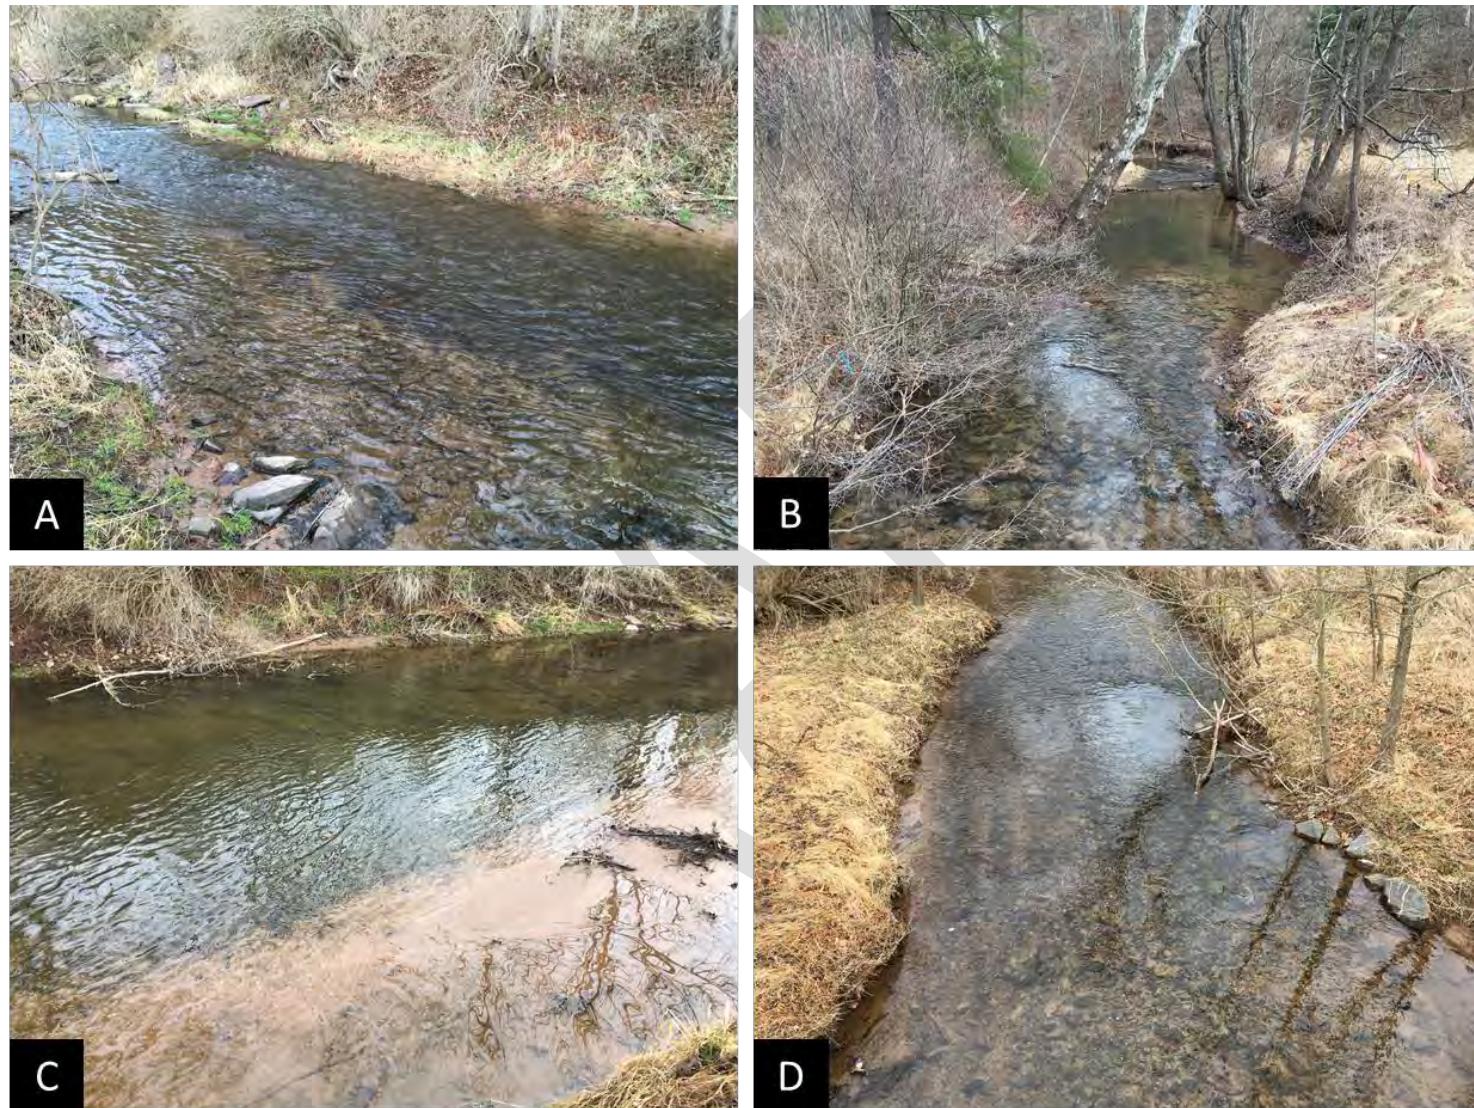
**Figure 27.** Stream conditions within the lower mainstem of the Wooden Bridge Creek subwatershed during higher spring flows. The substrate tended to be primarily rocky in flowing reaches. However, a bar of fine sediments can be observed in photograph C, and some embeddedness was apparent in D.

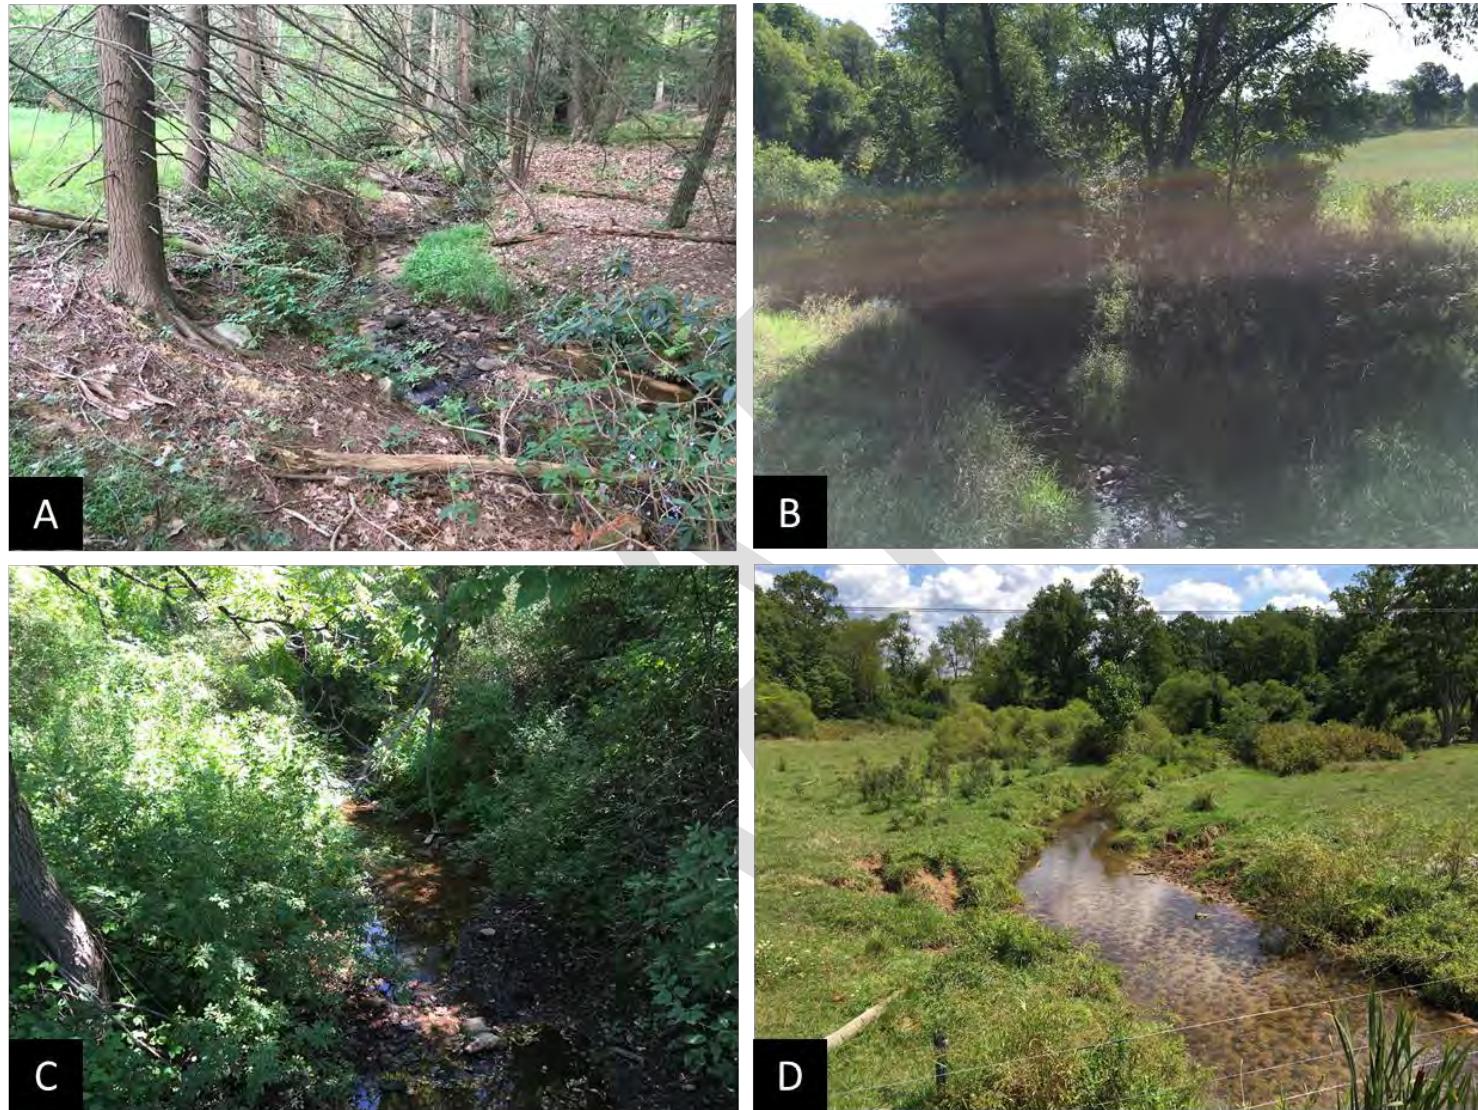
**Figure 28.** Example small tributaries of the Wooden Bridge Creek subwatershed during low summer flows. In many cases stream segments appeared to be healthy and have rocky substrate. However, some apparently localized areas exhibited substantial fine sediment deposition (D).

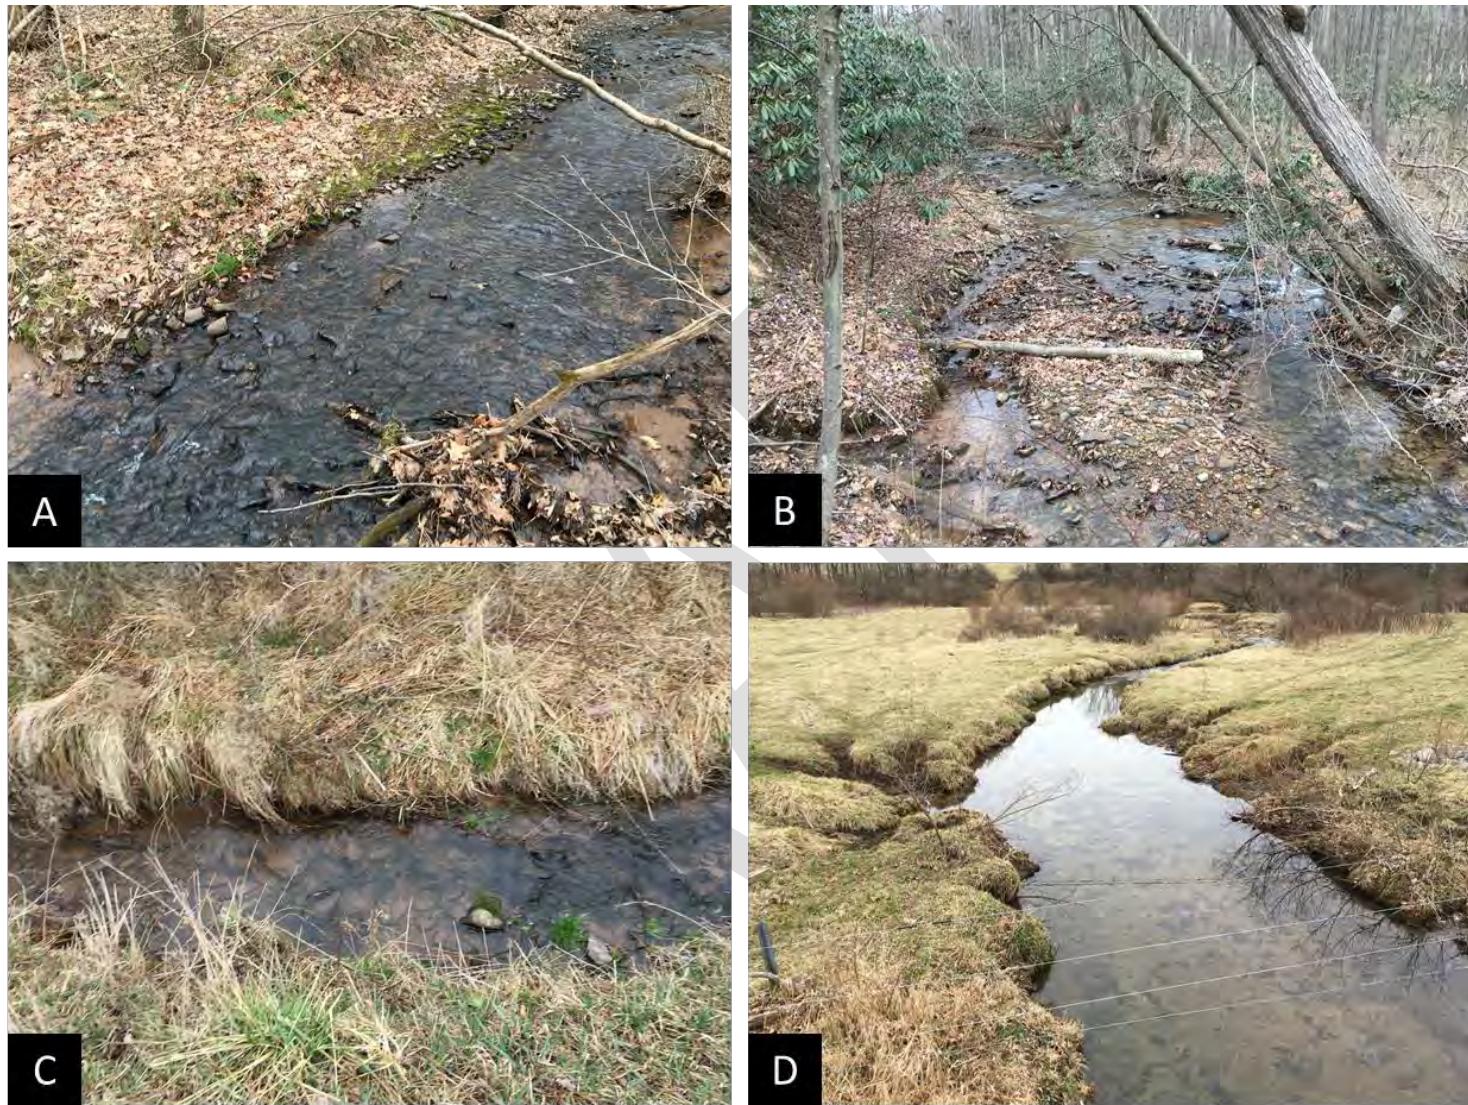
**Figure 29.** Example small tributaries of the Wooden Bridge Creek subwatershed during higher spring flows. Again, many stream segments appeared to be healthy and with rocky substrate, though, some apparently localized heavy fine sediment deposits were observed (D).

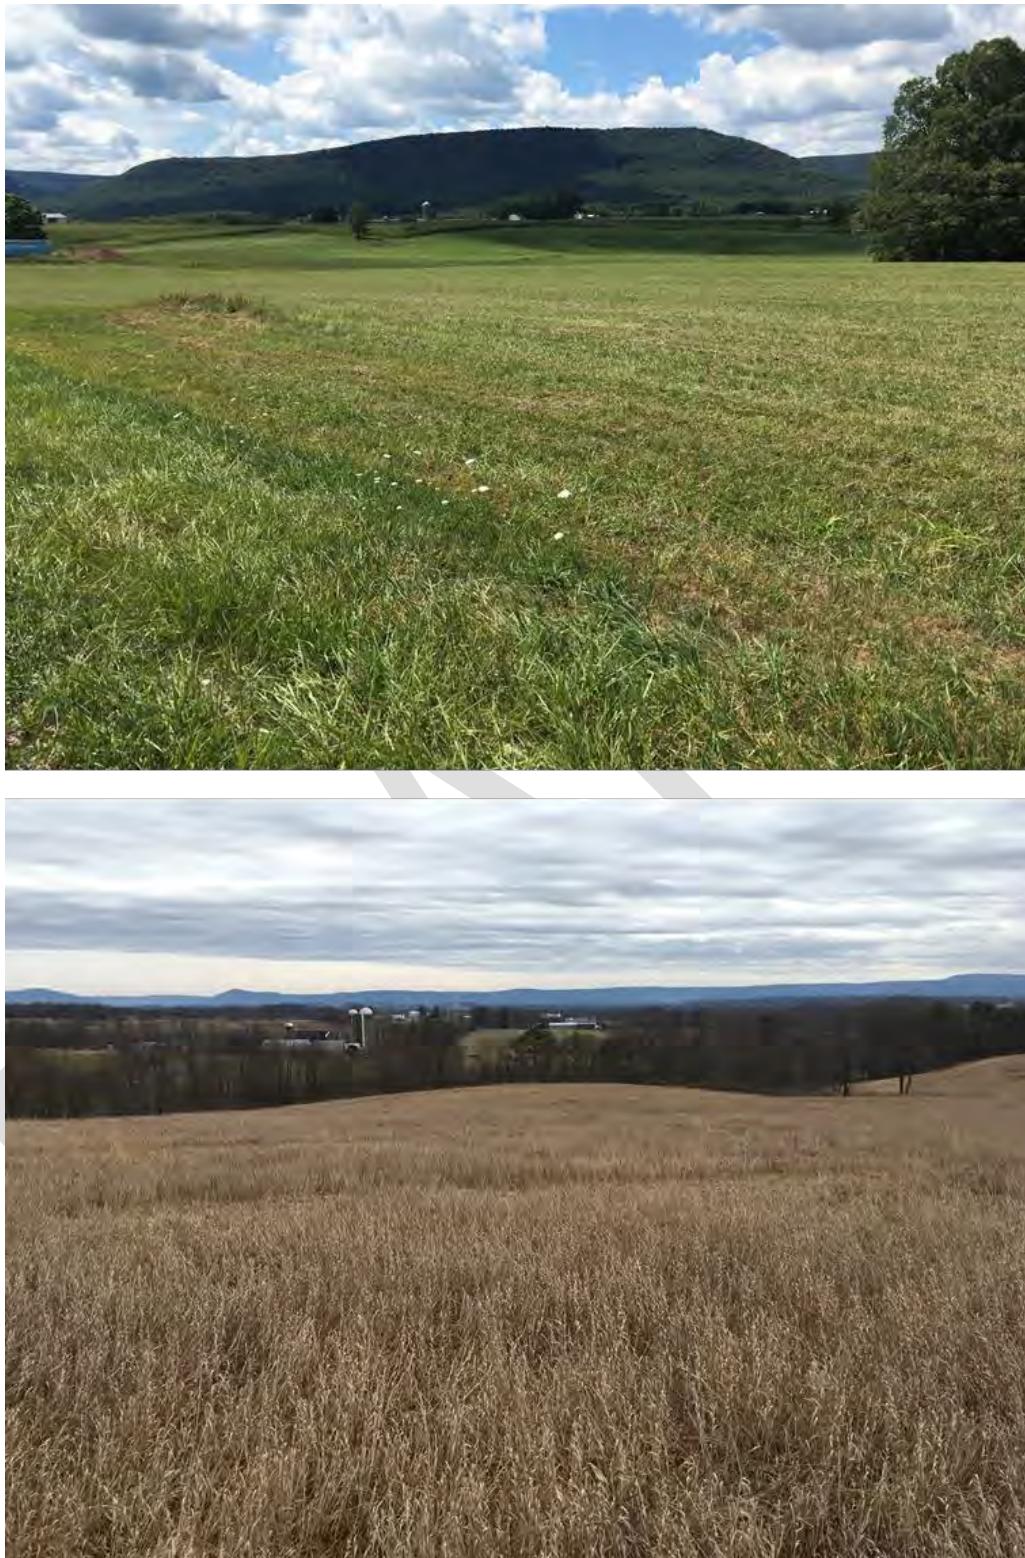
**Figure 30.** Example landscapes within the Wooden Bridge Creek subwatershed. The uppermost area of the watershed descended from a forested mountainous area (above). There was significant agricultural lands in the valley area of the lower watershed, though streamside areas were often forested (below).

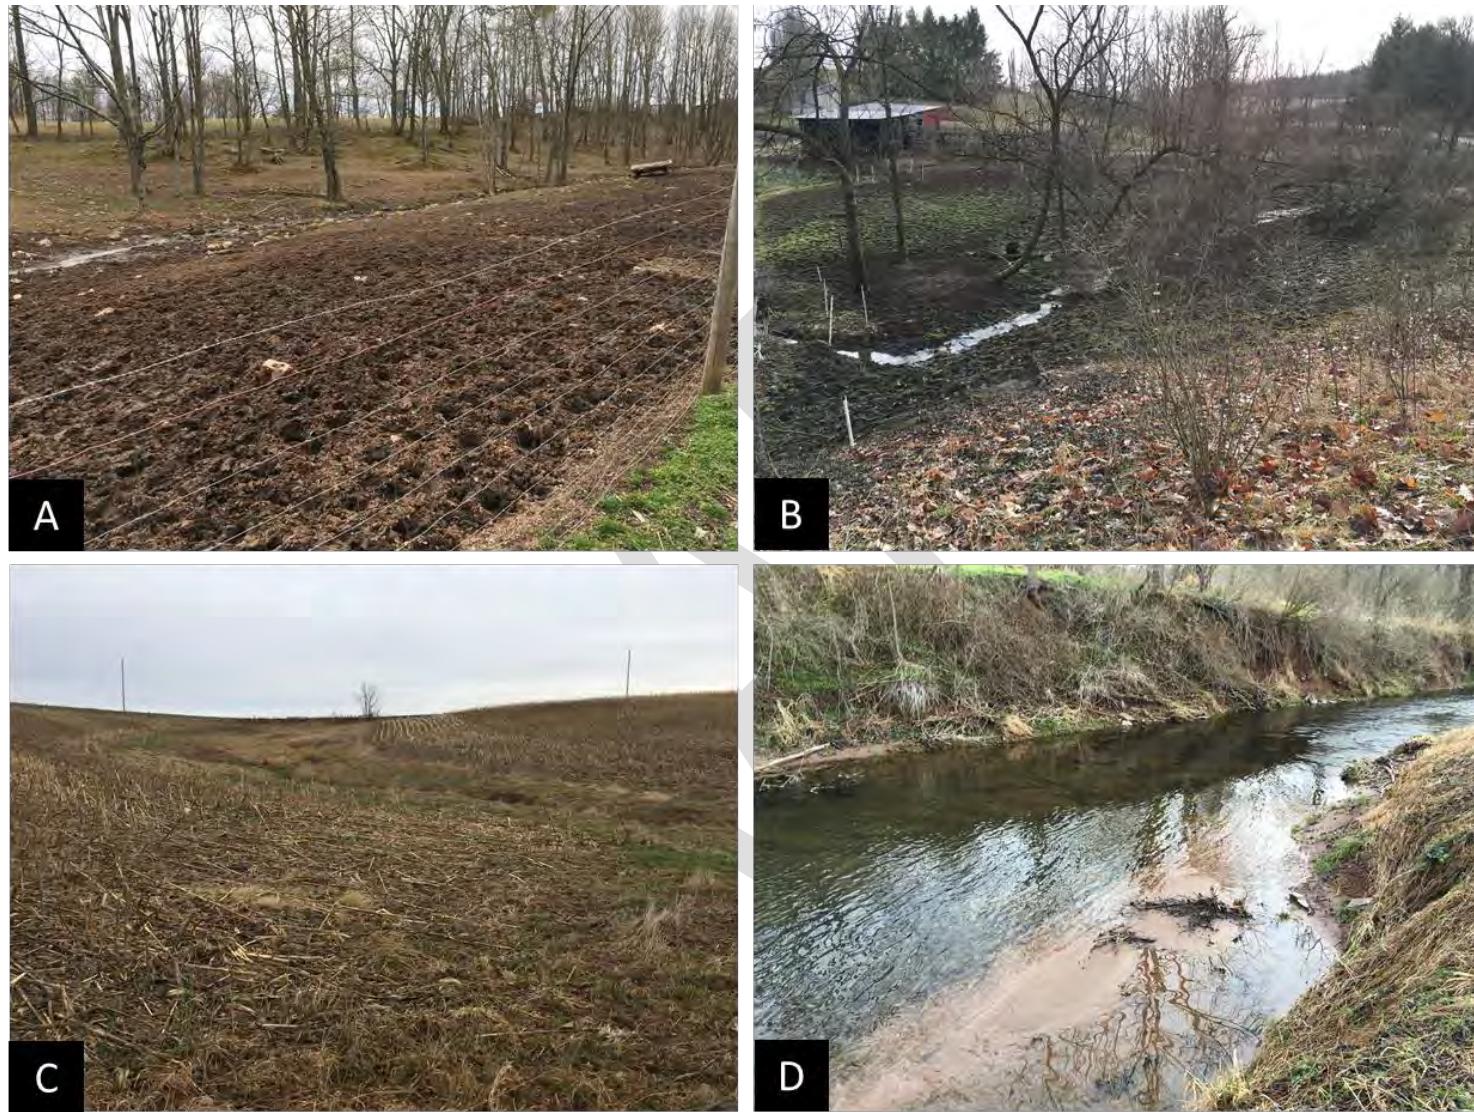
**Figure 32.** Factors that may promote sediment pollution in the Wooden Bridge Creek subwatershed. The stream segments shown in A and B appear to flow through highly degraded pasture areas. Photograph C shows what appears to be a largely unbuffered drainageway flowing through croplands. Photograph D show a stream area with erosive banks.
