TECHNICAL REPORT/1994

INVESTIGATION OF DAMAGE TO STRUCTURES IN THE McCUTCHANVILLE-DAYLIGHT AREA OF SOUTHWESTERN INDIANA

Part VII: Experimental and Analytical Studies of the Vibration Response of Residential Structures Due to Surface Mine Blasting.

Experimental and Analytical Studies of the Vibration Response of Residential Structures Due to Surface Mine Blasting.

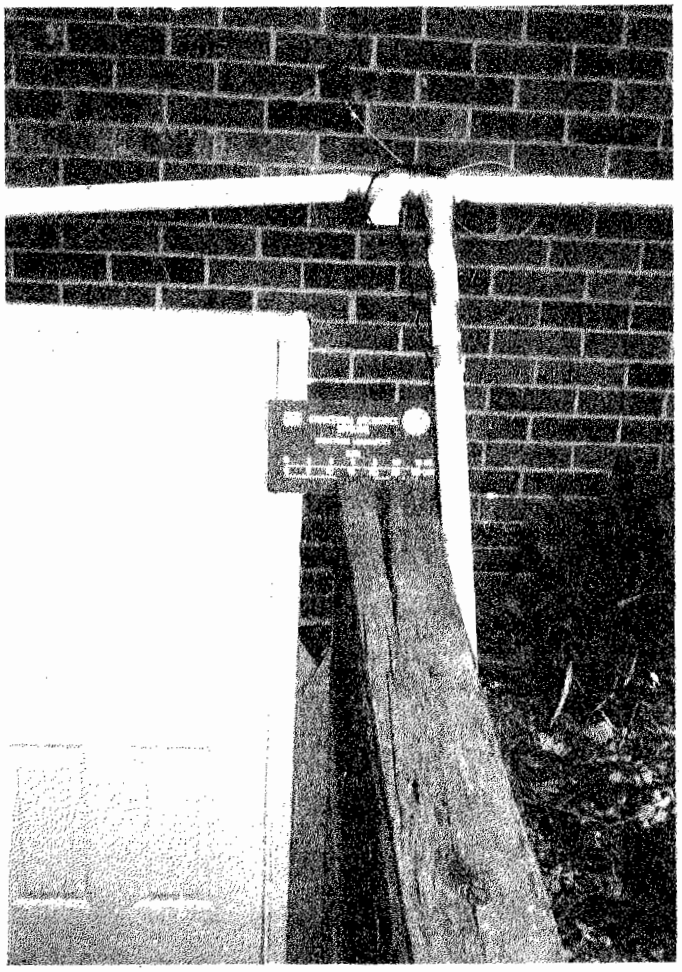
Figure 2.9 View of horizontal exterior accelerometer locations on the east wall above and below the first floor level (top accelerometer is on the exterior face of the brick veneer; bottom accelerometer is on the exterior face of the block of the basement wall)

34. The measured acceleration shown in Figure 2.20 is for the gages shown in Figure 2.9 which were located above and below the first floor, where cracks were observed in other houses in the study area. This figure shows the phase relationship between the two accelerometers. The data indicate an in-phase relationship although there is amplification up the wall. Because there is no significant out-of-phase relative motion there is no discernable relative movement across the potential crack area.

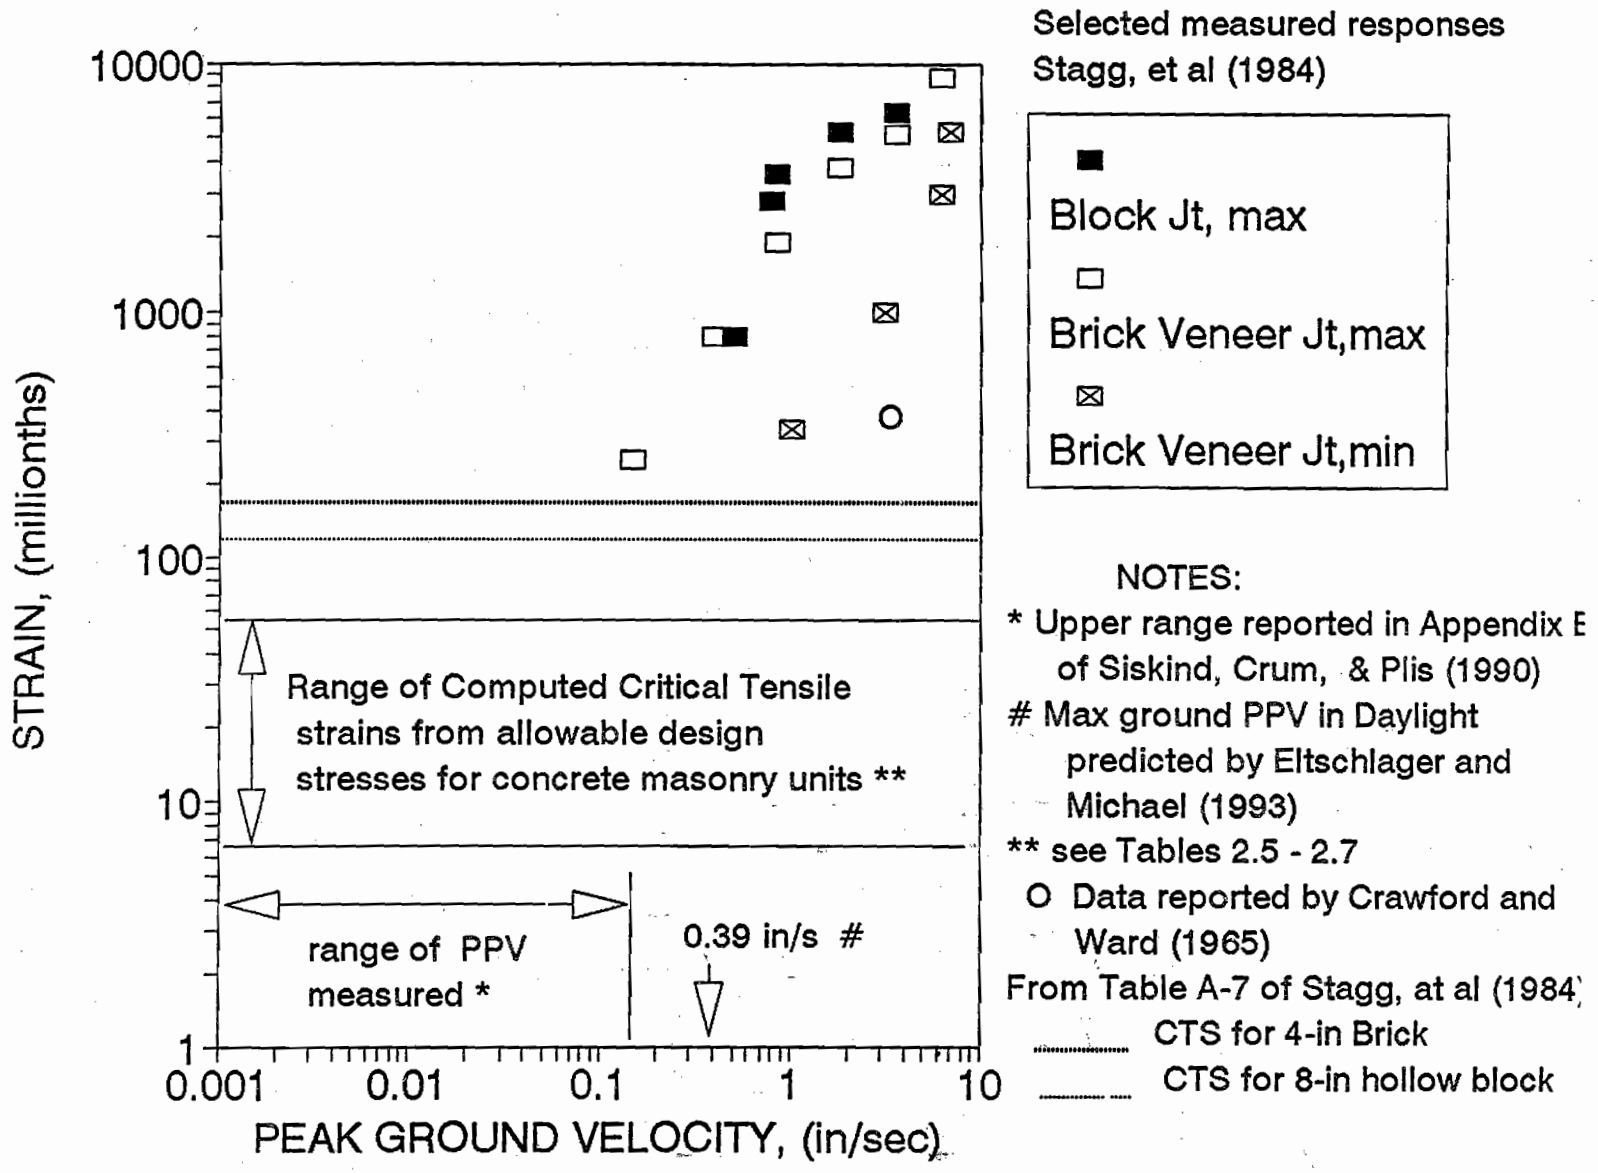
Figure 2.22 Strain versus peak ground velocity for block joint and brick veneer joint

38. Figure 2.22 shows maximum values of strain versus peak ground velocity for block joint and brick veneer joint for the test house reported in Stagg et al. (1984). The solid and open box symbols are selected maximum values of strain response for the block and brick veneer joint, respectively. These maximum values were selected from Figures 35 and 36 found in the report by Stagg et al. (1984). The description of these data does not indicate levels of damage, but simply presents maximum response strains versus maximum ground velocities. Stagg et al. (1984) reported that in brick or block walls visible cracking occurred after measuring displacements from 0.01 mm to 0.1 mm, which corresponds to strains of 770 μin./in. to 7,700 μin./in. across joint widths of 13 mm. Cracks generally occur in the mortar joints and, therefore, decrease strains and increase damping resulting in the bricks and block not cracking. In the notes footnoted by "*" the range marked indicates the upper range of ground motions reported by Siskind, Crum, and Plis (1990).

41. During communications with Siskind and Stagg (1994) it was revealed that some data in Figures 33-37 from Stagg et al (1984) - aka RI 8896 - were measured strains across prexisting cracks. Thus, the strain measurements reported include material

strains combined with displacements of the crack openings. Since the minimum critical tensile strains reported in Figure 2.22 are for the material only, Siskind and Stagg think that their data should not be used in these comparisons. If Siskind's and Stagg's experiment had been conducted on a completely uncracked wall, their strain measurements would only contain material strains and would directly compare to strains based on elastic material properties. The fact that cracks existed in Siskind's and Stagg's experiments is consistent with Figure 2.22 which indicates all their reported peak data are above the critical tensile strain limits. The data reported by Stagg et al. (1984), from which the maximum values were selected, contain much scatter. The lower bounds for peak ground velocity less than 1 in. per second is almost zero. It is important to note that the maximum values reported in Figure 2.22 display a consistent relationship between strains and peak ground velocity. This consistent relationship would allow an engineer to make meaningful interpretation of brick or block wall response for peak ground velocities between about .3 to 8 in./sec. which includes peak ground motions important for this study.

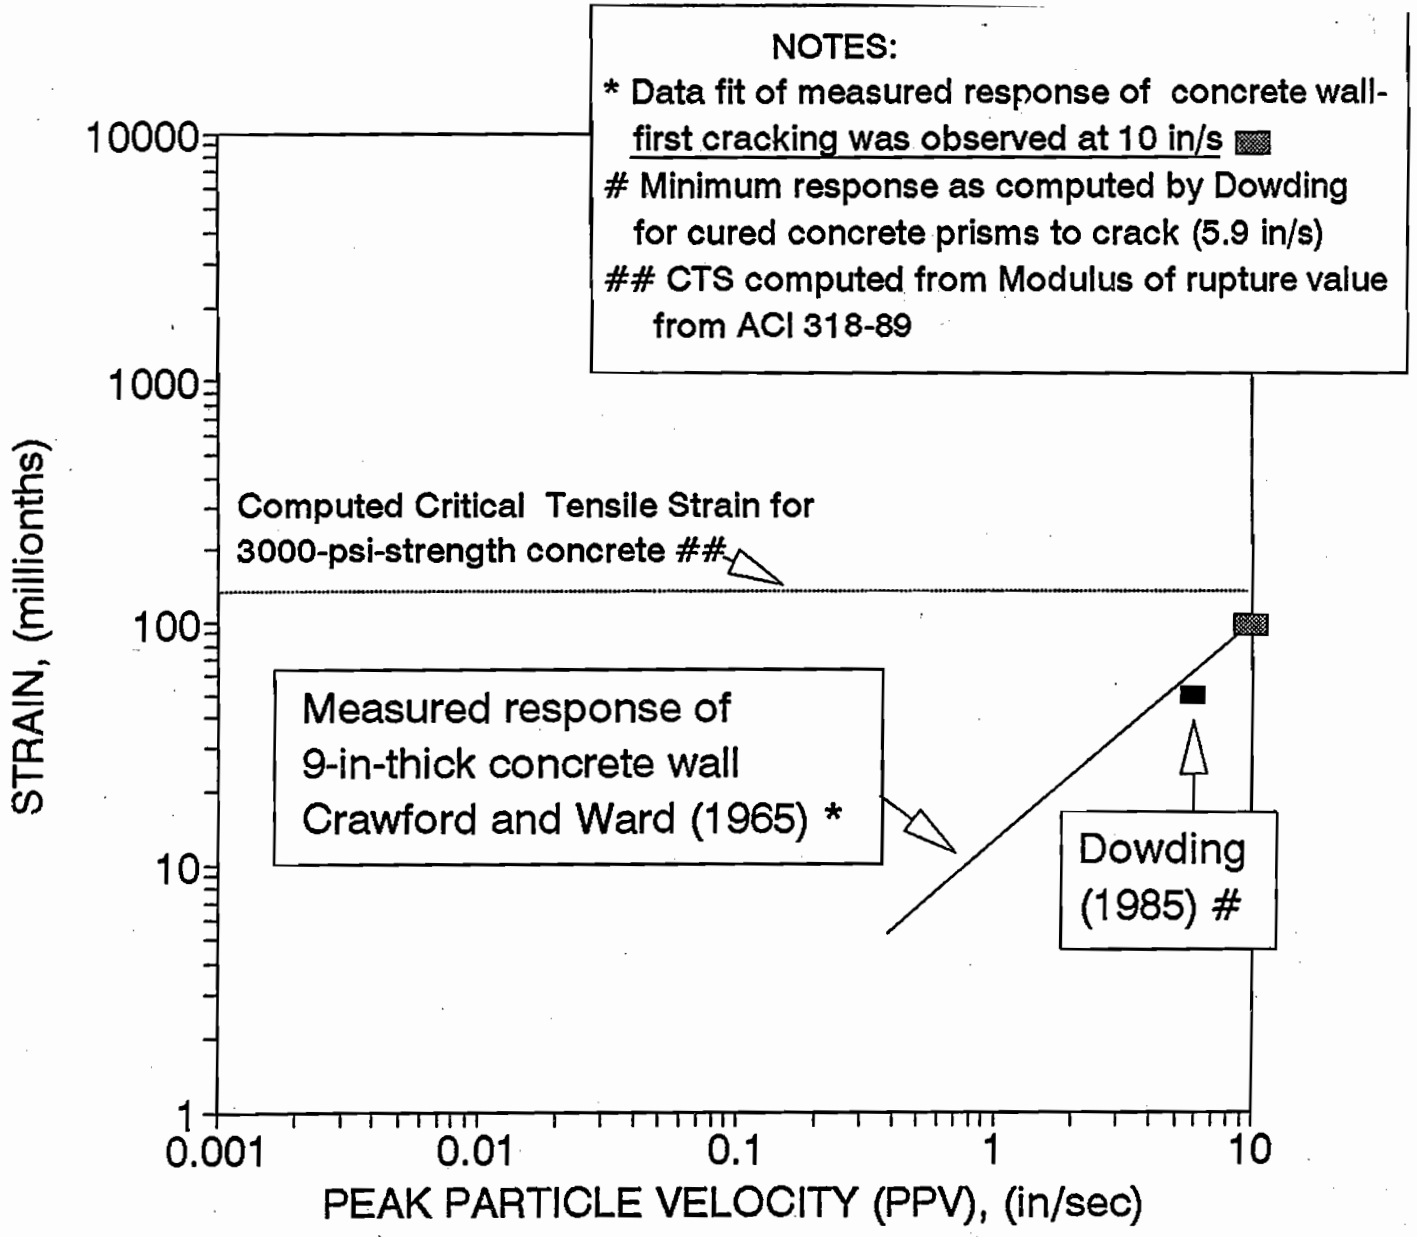
Figure 2.23 Strain versus peak particle velocity for unreinforced concrete

42. Figure 2.23 shows the fitted line of measured PPV versus strain of a 9-in.-thick concrete wall (the PPV and strains were measured at the center of the wall (Crawford and Ward 1965)). In Figure 2.23 this is compared to a critical response point computed by Dowding (1985) and the static critical tensile strain computed from the modulus of rupture and the initial elastic modulus for 3000-psi strength concrete.

43. According to Dowding (1985) at least 5.9 in./sec of material response (through wave propagation) is required for cracking to occur of plain concrete beams subjected to hammer impacts in the tests he discusses. This would correspond to threshold damage. The line fitted by Crawford and Ward indicates no threshold damage observed until the velocity of the concrete wall reached 10 in./sec. The static CTS level is reasonably close to the strains required to cause threshold damage in

concrete. Thus, one would not expect any evidence of threshold damage in concrete unless the material response exceeded 5.9 in./sec.

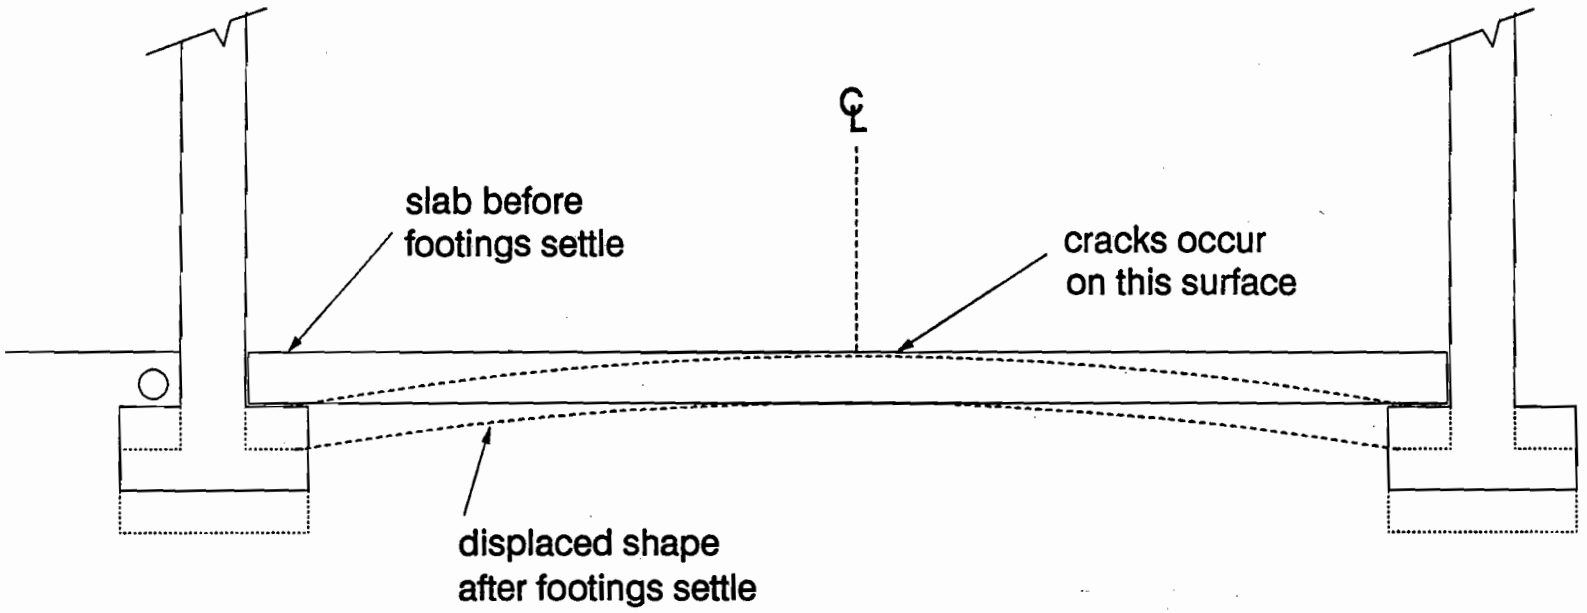
Figure 3.3 Idealized displaced shape of concrete slab after footings settle. Tension occurs on top surface. Amplitude of displaced shape is exaggerated to illustrate

9. Differential foundation settlements required to cause cracking in basement floor slabs were predicted from static analyses. Also, total earth pressures and vertical house loads were applied to basement walls to determine resulting stresses and the potential for cracking. Finally, the potential for fatigue damage was investigated based on comparing the cyclic characteristics and duration of measured structural motions and relevant historical case histories of fatigue studies. Specific tasks accomplished in this study in order of presentation in this report are:

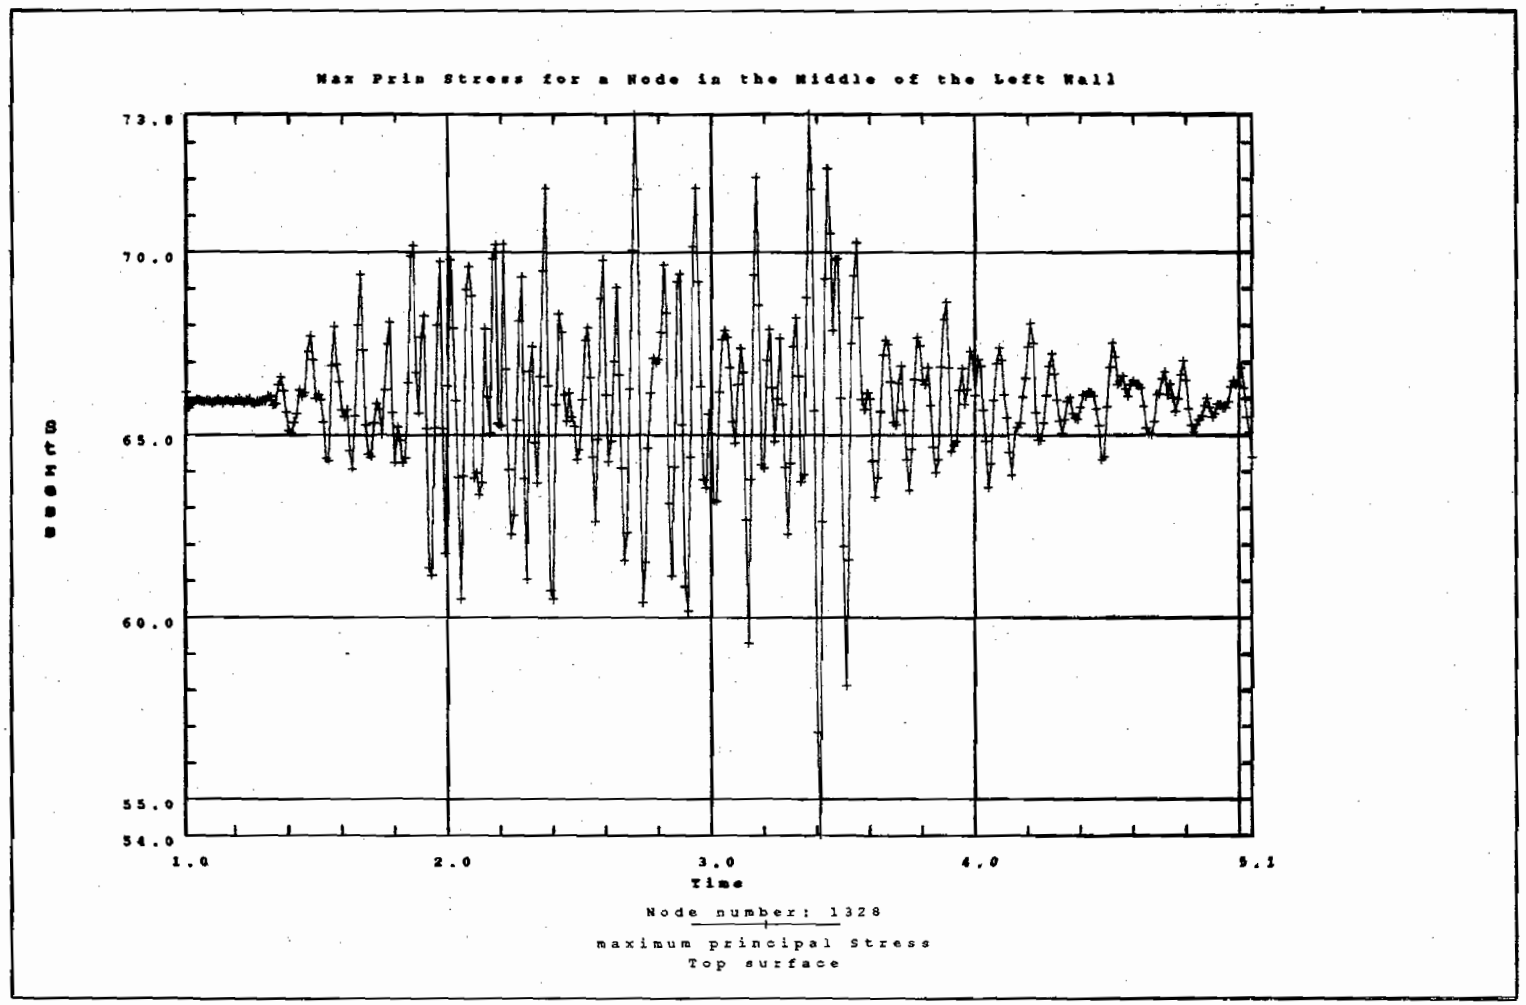
Figure 4.10 Principal stress time-history for middle of exterior wall of single-story house (FE results in psf)

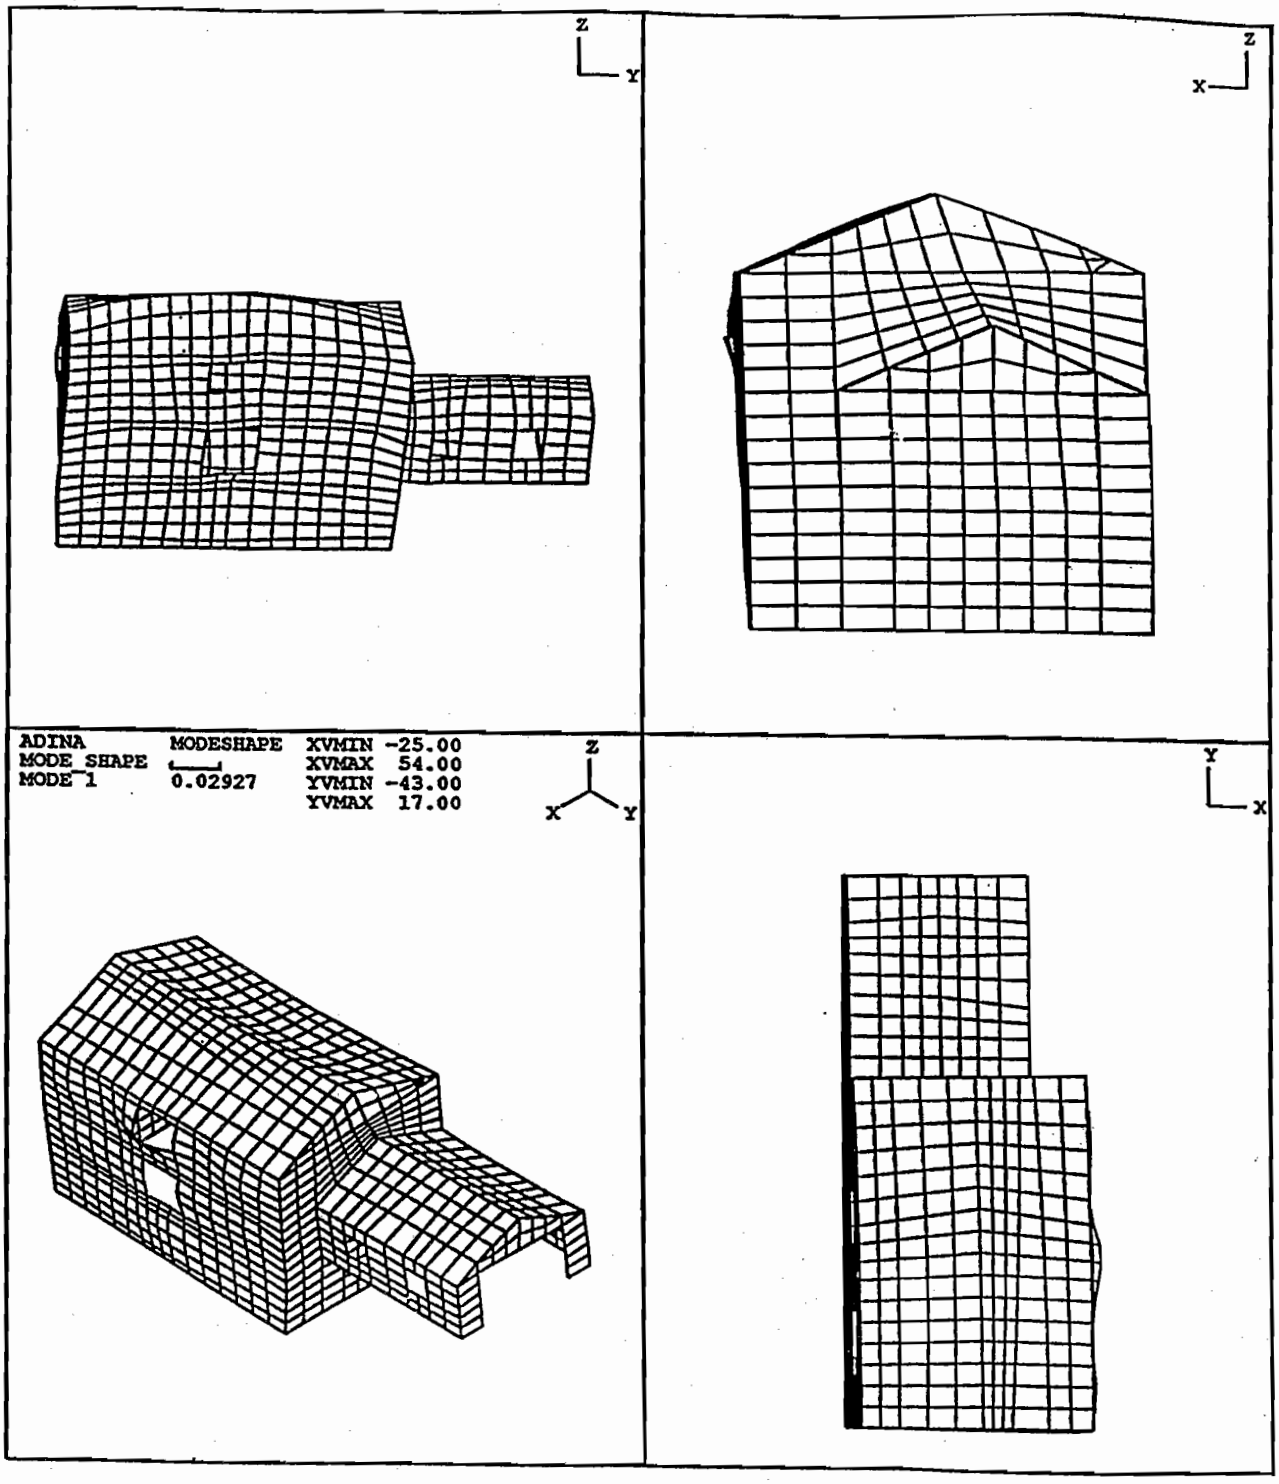
73. As with the one-story house, the first step of the dynamic analysis of the two-story house was to determine the natural modes and frequencies of the model. The first mode is shown in Figure 4.12 and has a corresponding frequency of 23.7 Hz. The first mode generally found for typical two-story houses is a side-sway motion about the long axes with a frequency of 5 to 10 Hz. The addition of the garage adds considerable stiffness to the dynamic response which results in a more complex first mode of the house responding at a higher frequency.

Figure 4.12 First mode shape of the two-story house

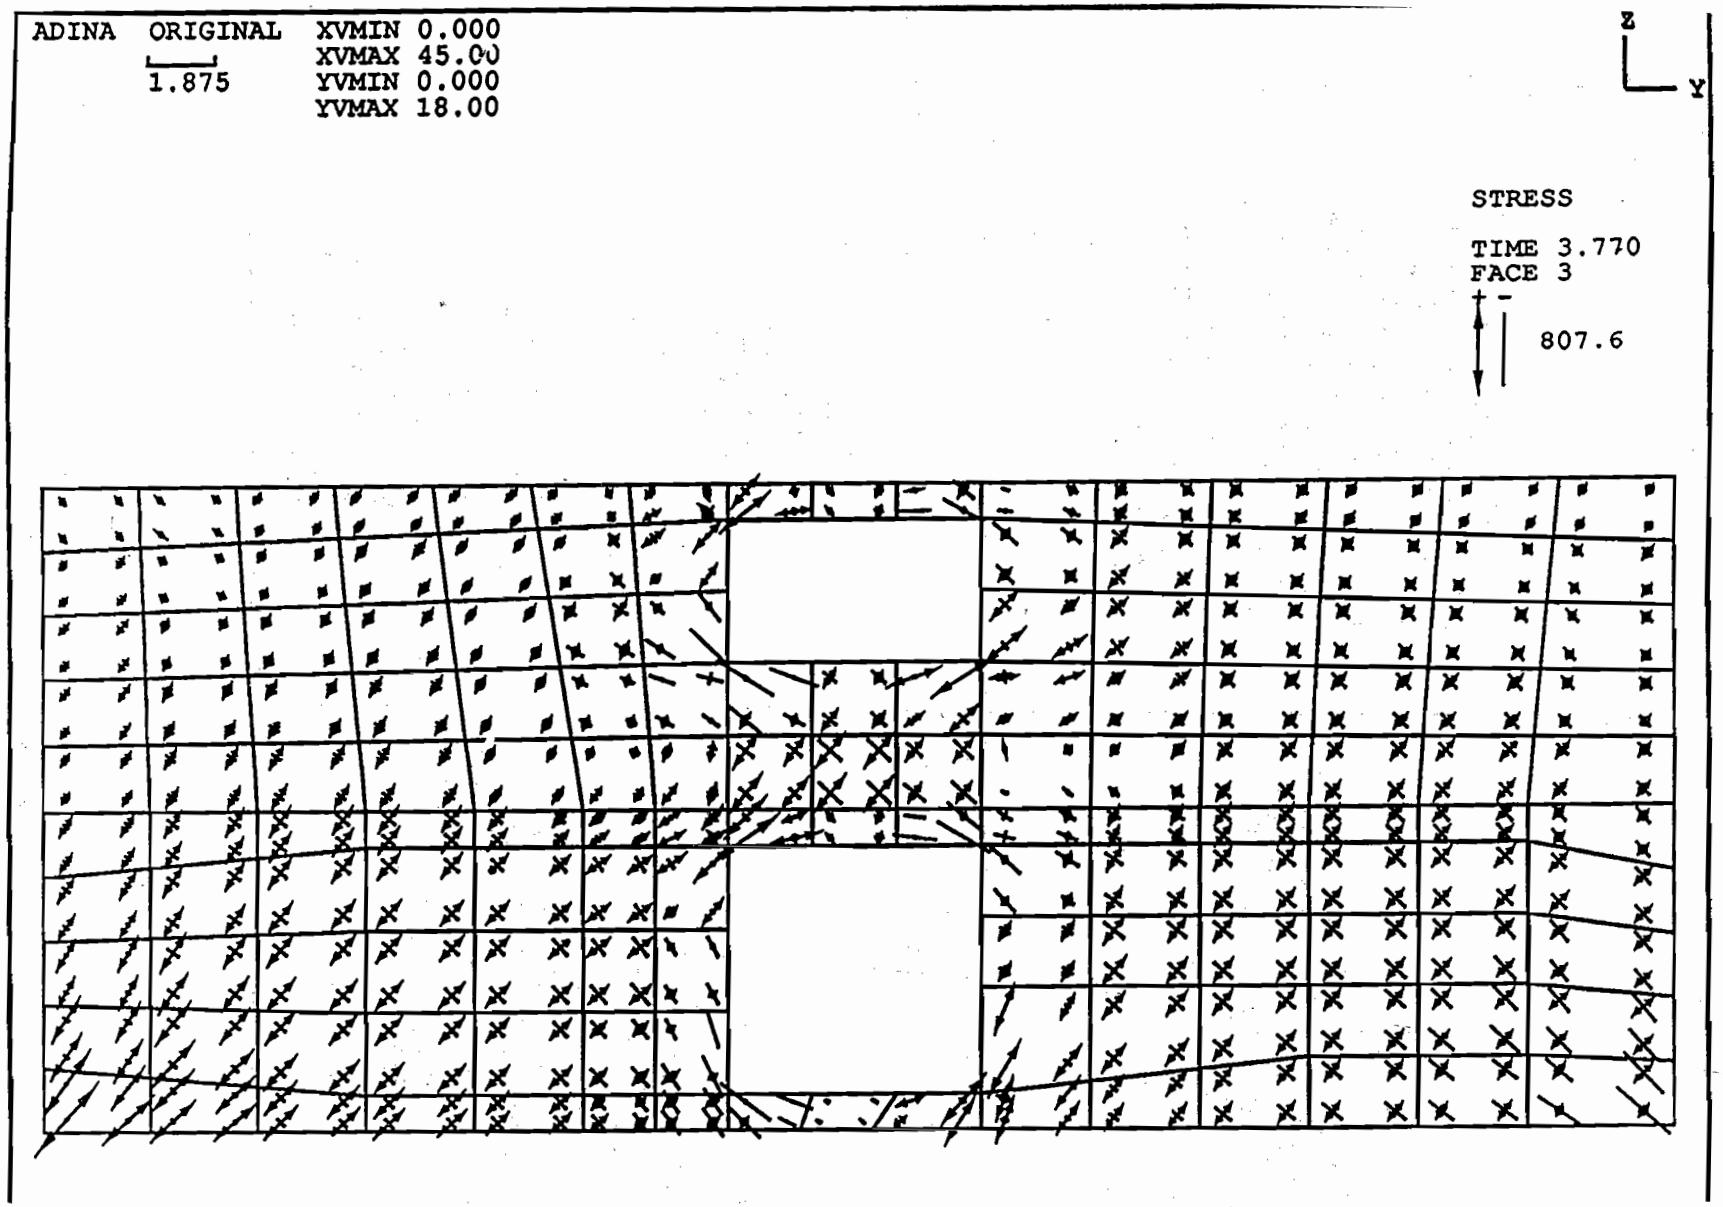
74. Figures 4.13 and 4.14 display stress vector plots during the time of peak response. These Figures indicate highest stresses at the corners of the windows. These stresses at the corners are commonly encountered in FE analyses due to numerical singularities in dealing with sharp corners resulting from the hole in the grid, such as windows. Due to these problems these stresses are usually considered artifacts of the model and are ignored.

75. However, Figures 4.13 and 4.14 do provide important information pertinent to this study. These figures indicate the magnitude of stresses and stress patterns caused by blast-induced ground motions. These stress patterns also indicate a potential crack pattern (if stresses exceed the material strengths) on the exterior wall surface as shown in Figure 4.15.

Figure 4.13 Principal stress-vector plot on exterior wall of the two-story house (FE results)

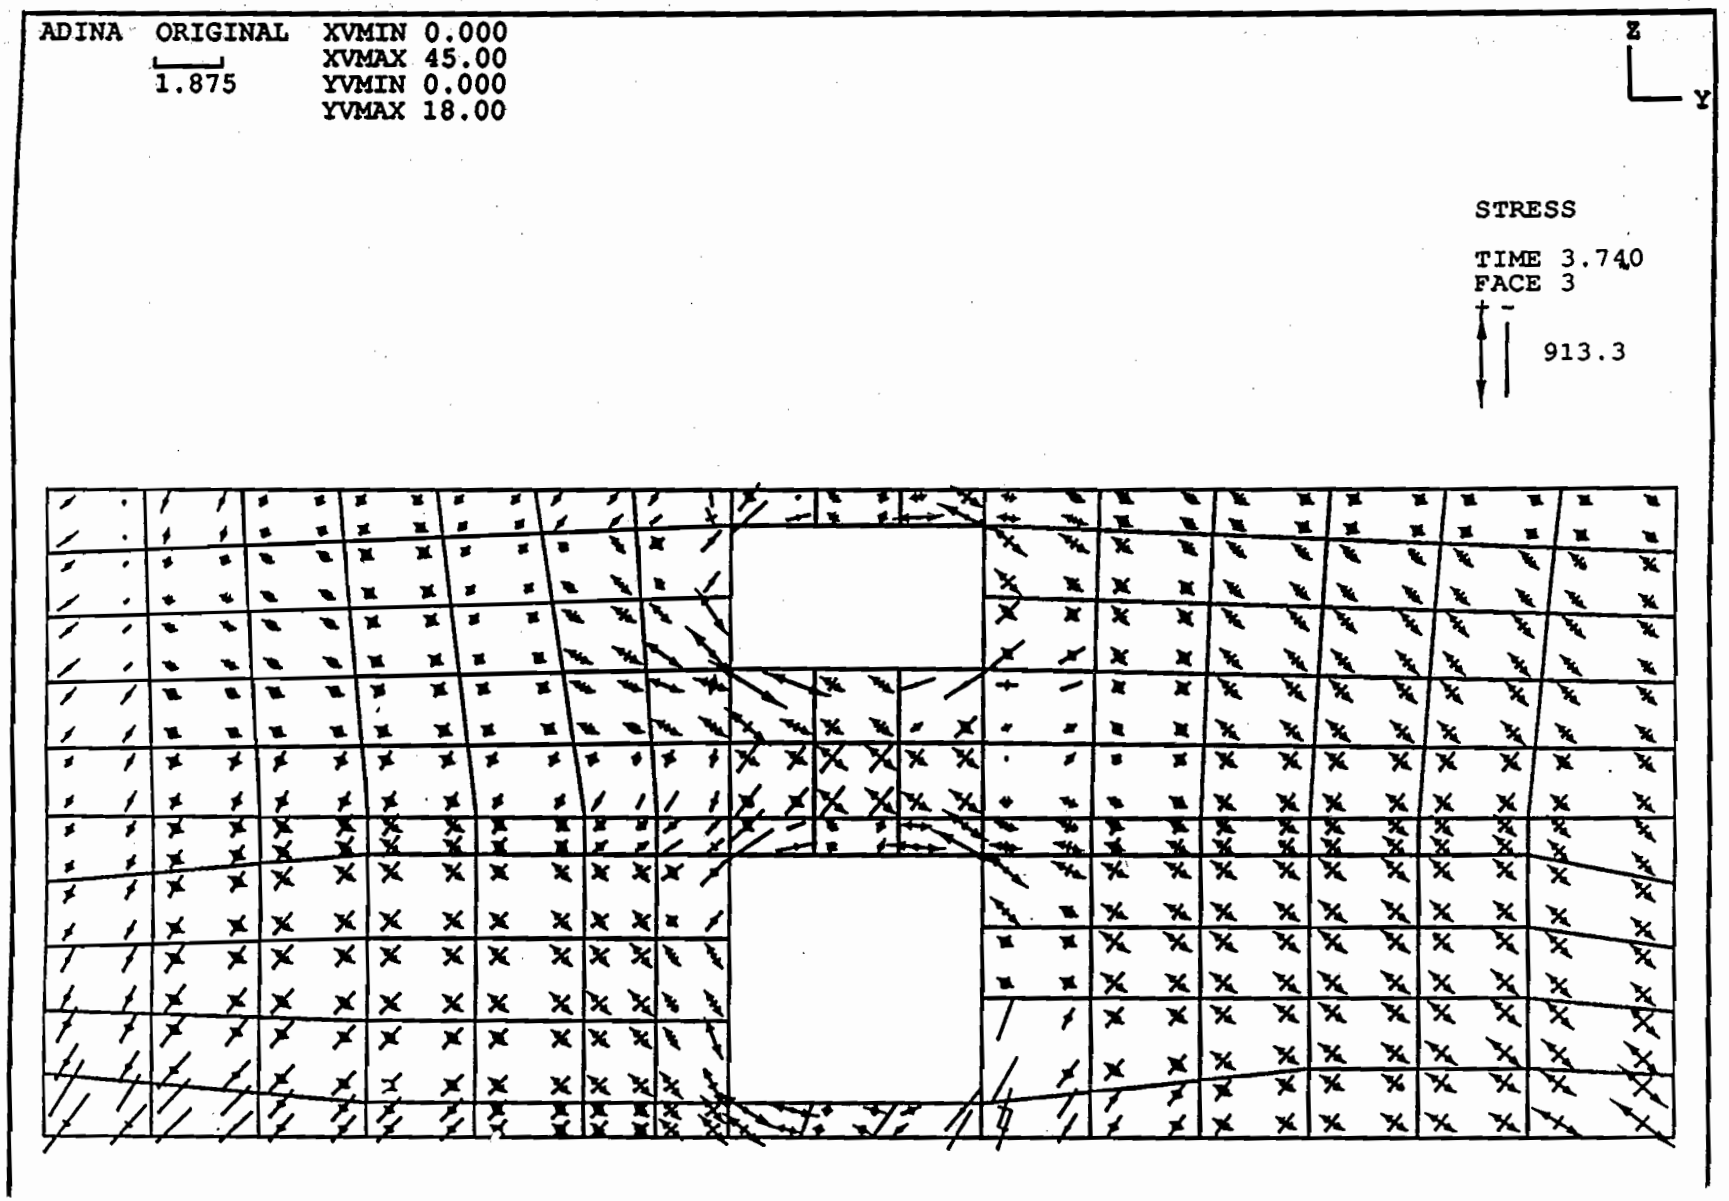
Figure 4.14 Principal stress-vector plot on interior walls of the two-story house (FE results)

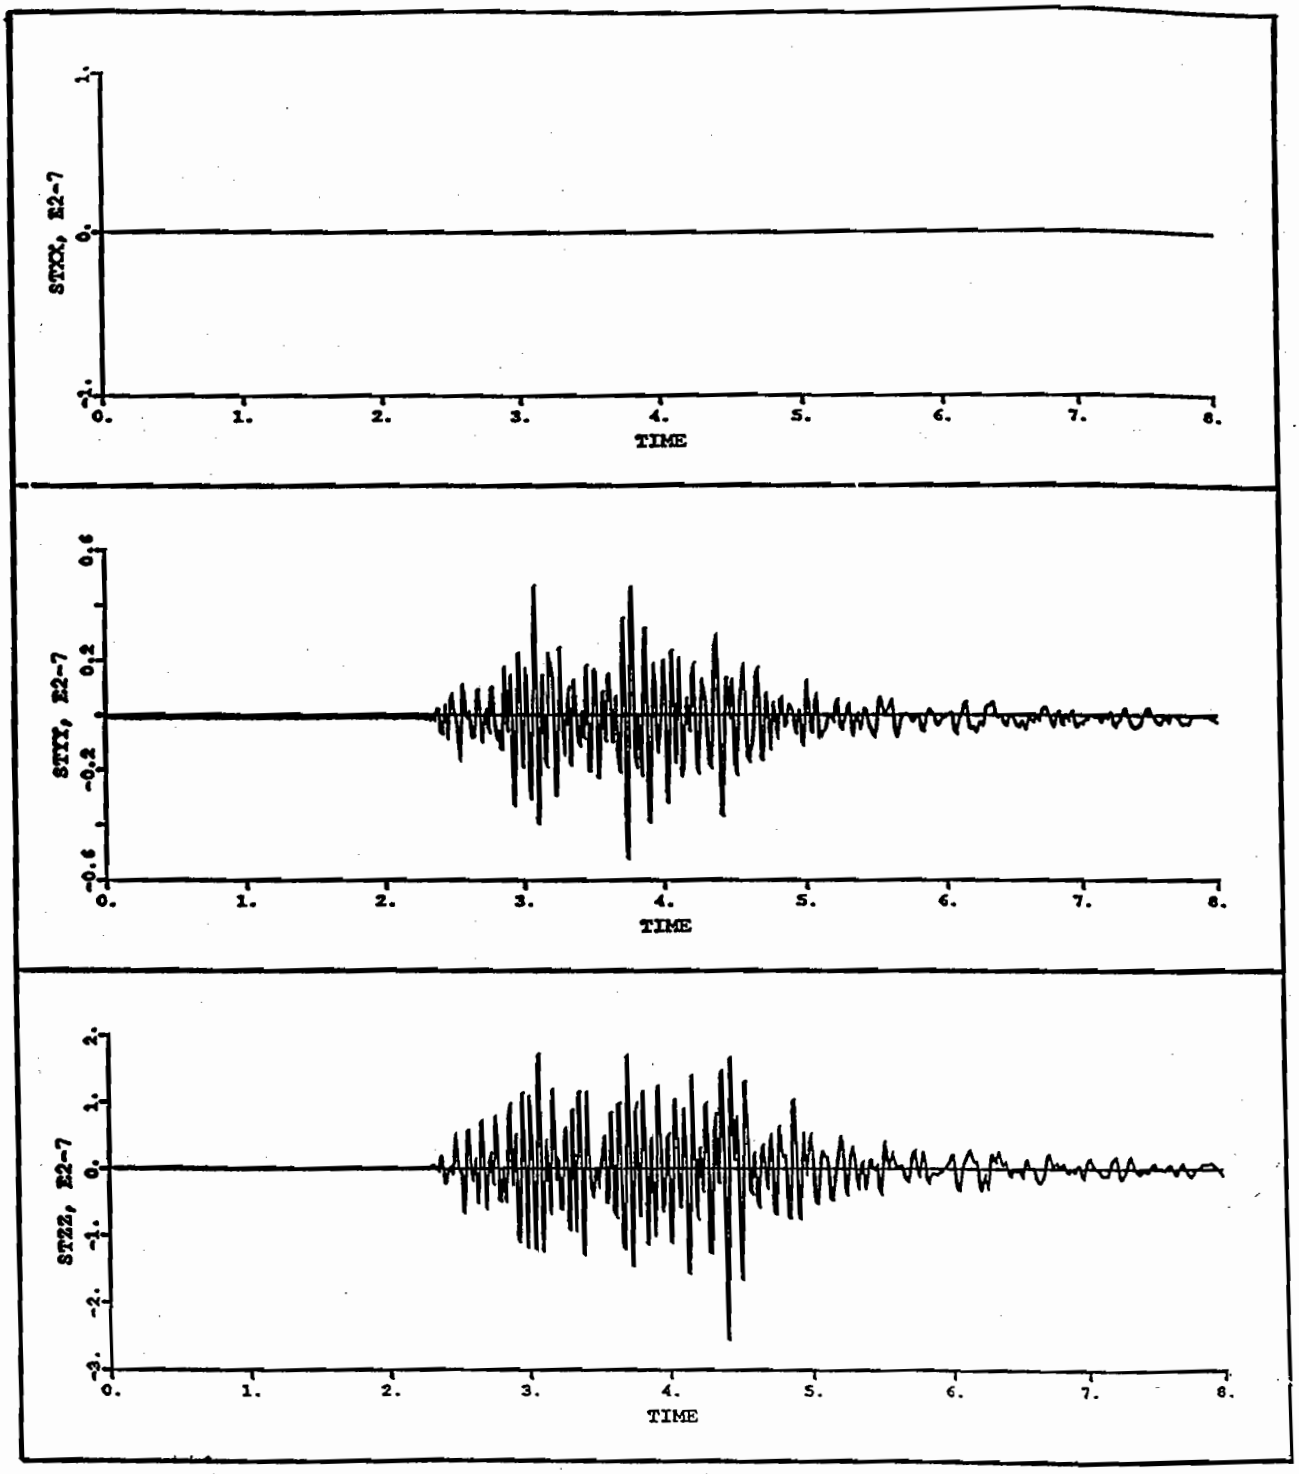
histories recorded at a location in the middle of the wall are shown in Figure 4.18. Figure 4.16 displays the stresses in the coordinate x, y, and z directions at a representative point in the middle of the wall. Figure 4.19 displays the principal stress time-history. The principal stress values are used for determining maximum tensile and compressive stresses, which can cause structural damage. For this study, the tensile stresses (psmax) are the stresses of interest since the material strength for tensile stresses is less than that for compressive stresses. The time-histories indicate several peak values which must be considered in determining stress values of interest. The stresses of concern for each time-history plot are the average of the highest six peaks.

Figure 4.16 Stress time-history in the coordinate axes of the two-story hous
(FE results)

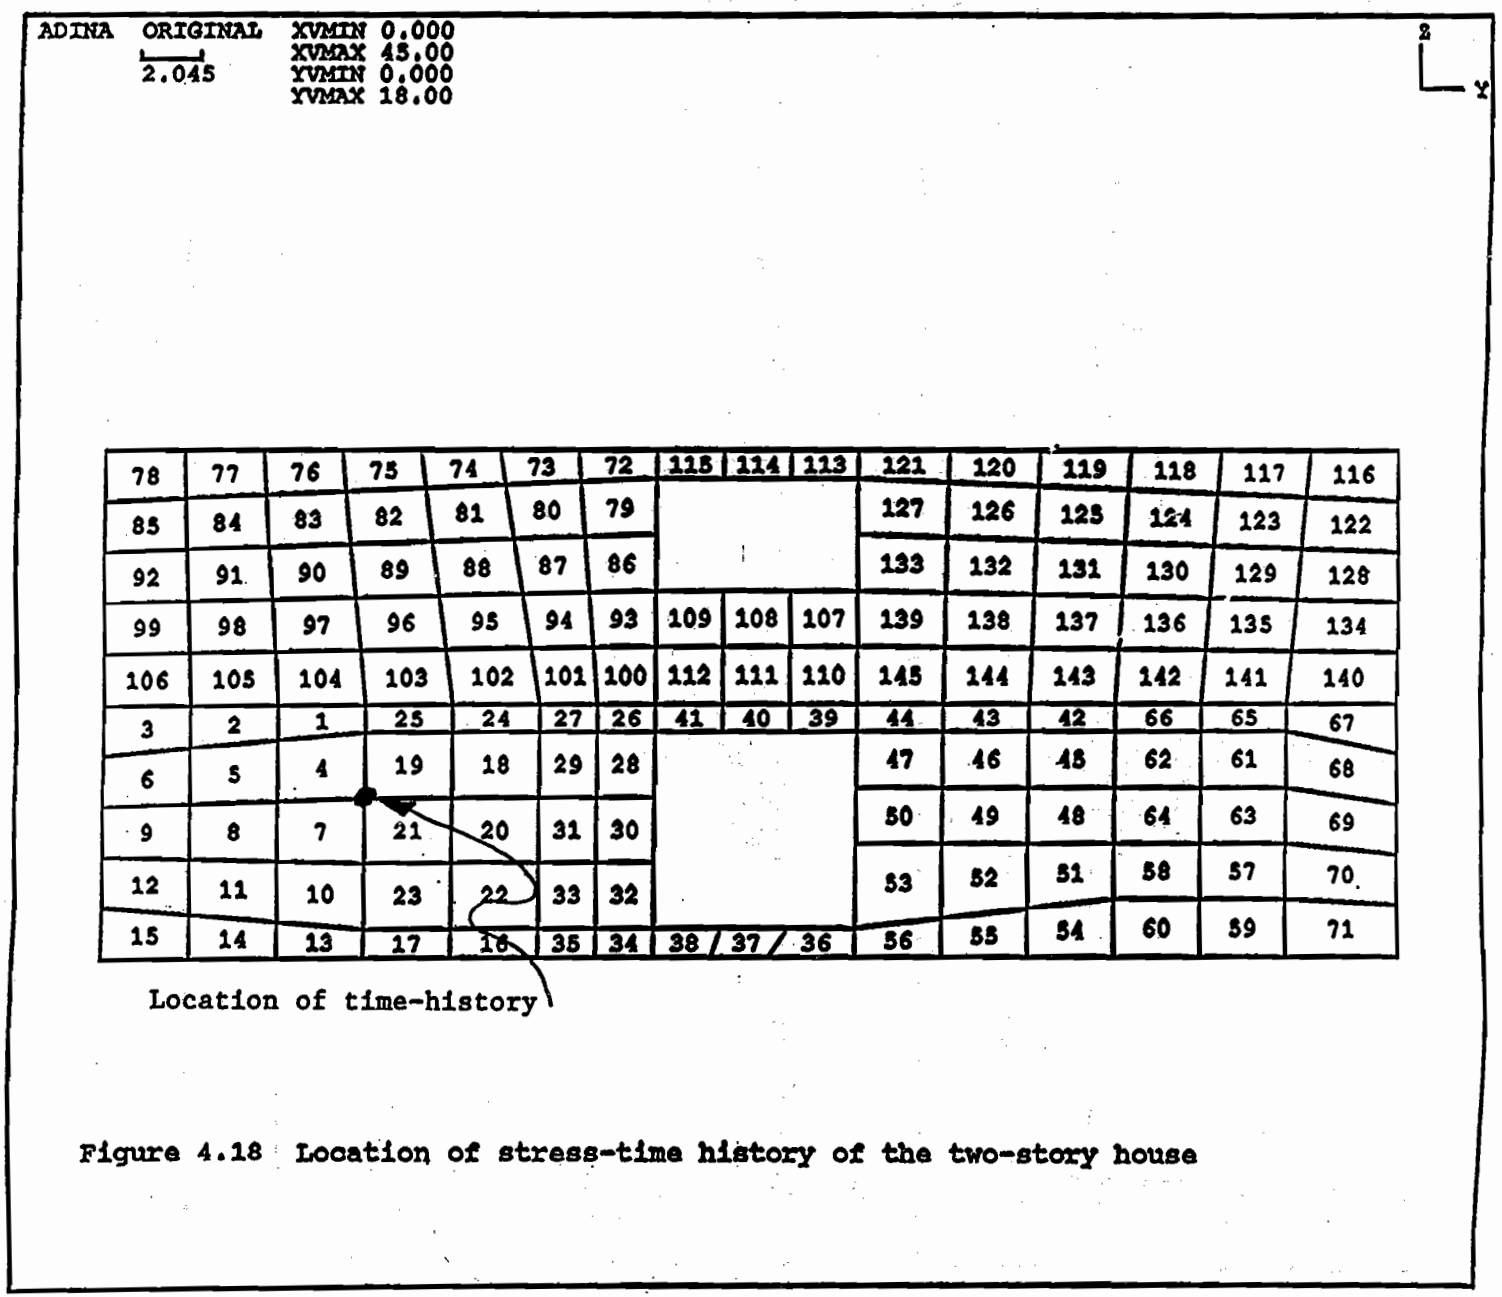
Figure 4.18 Location of stress-time history of the two-story house

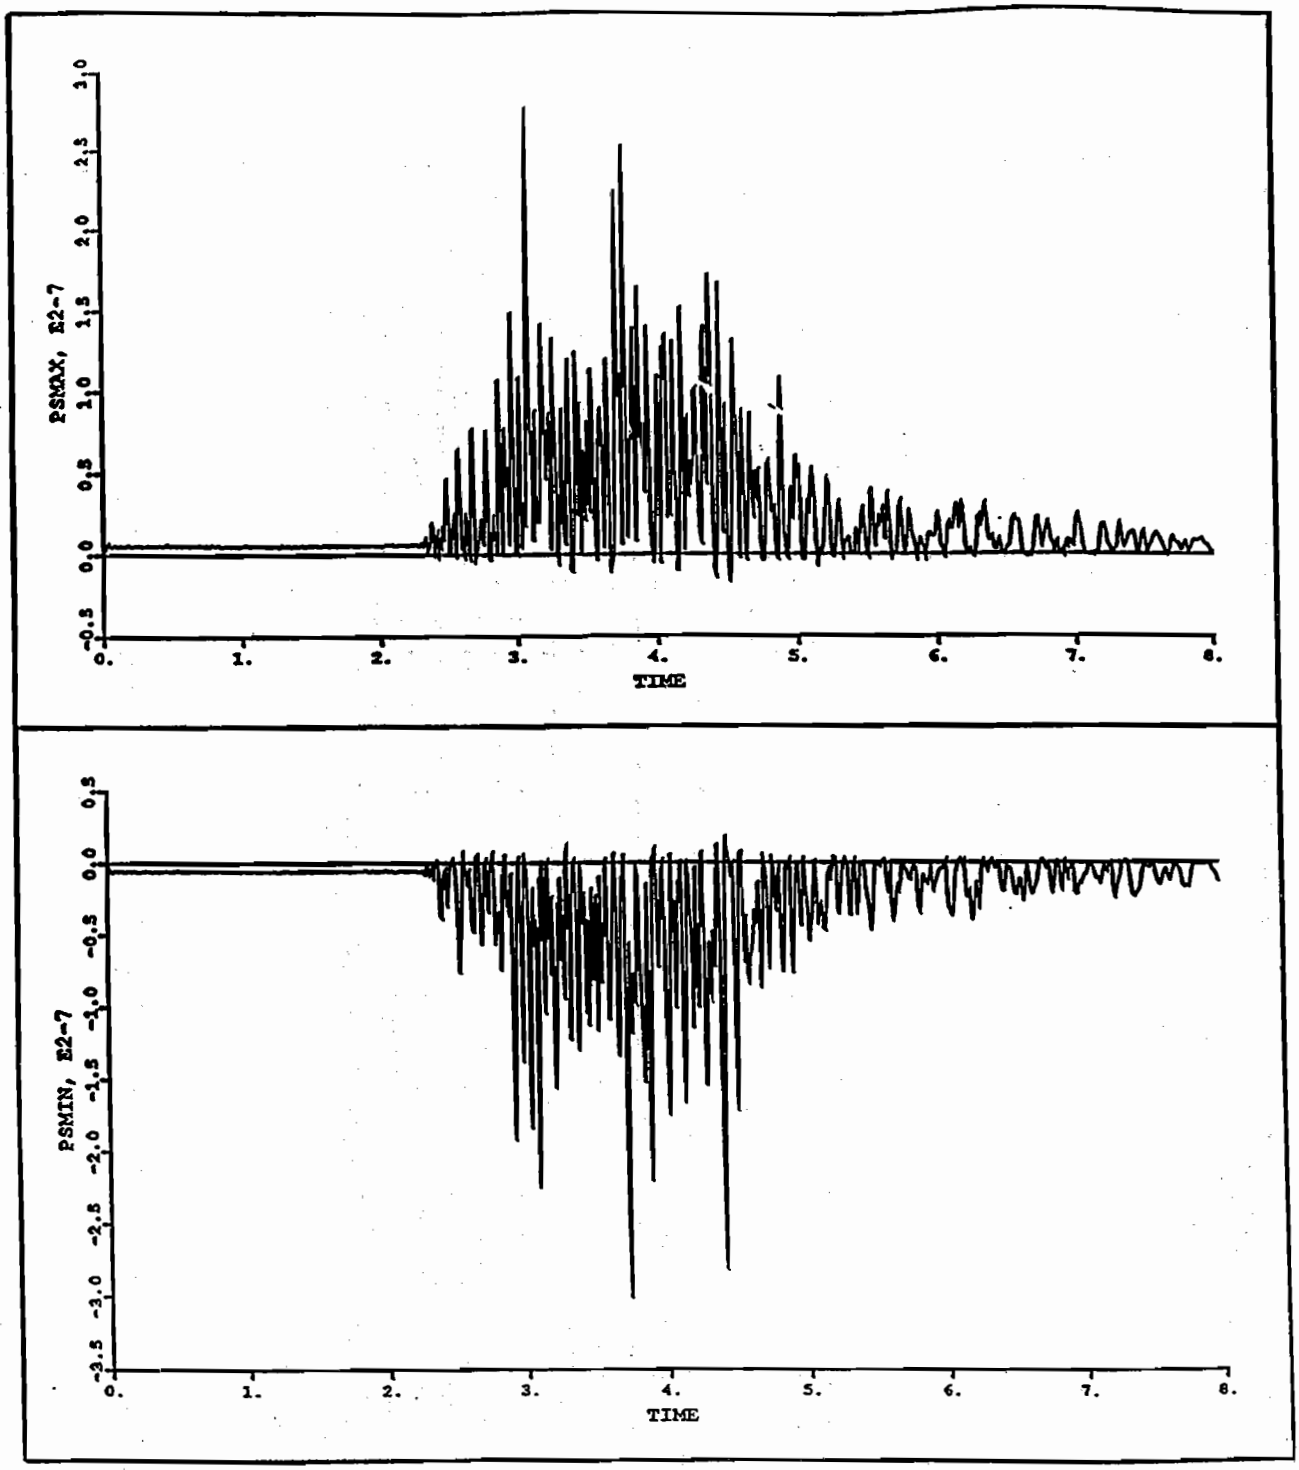
Figure 4.19 Principal stress time-history for the two-story house (FE results)

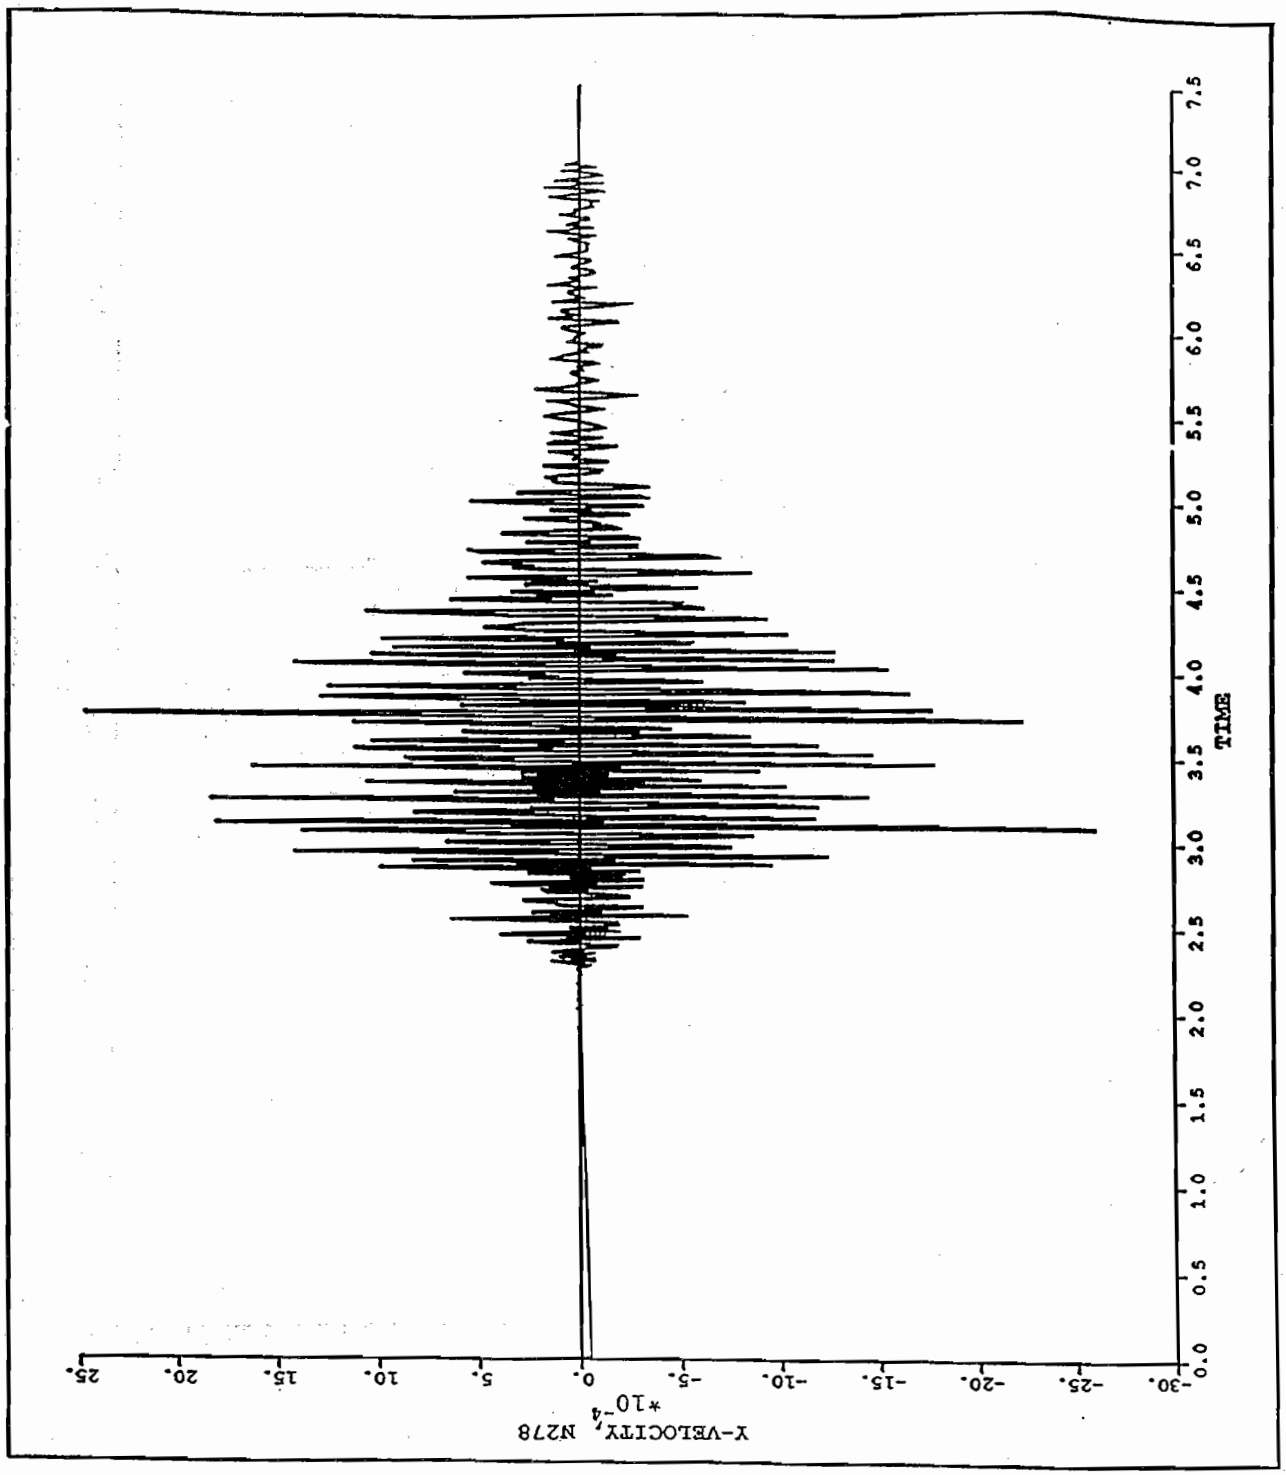
77. Figure 4.20 displays the lateral velocities and Figure 4.21 displays the vertical velocities at the location shown in Figure 4.18. The average of the six maximum peaks indicates a lateral velocity of 0.0018 in./sec which is 1.5 times greater than the lateral velocity of the ground motions. The 1.5 increase in lateral velocity corresponds to a dynamic amplification factor of 1.5.

Figure 4.20 Lateral velocity (ft/sec) for two-story house (FE results)
