TECHNICAL REPORT/1994

INVESTIGATION OF DAMAGE TO STRUCTURES IN THE McCUTCHANVILLE-DAYLIGHT AREA OF SOUTHWESTERN INDIANA

Part VII: Experimental and Analytical Studies of the Vibration Response of Residential Structures Due to Surface Mine Blasting.

Experimental and Analytical Studies of the Vibration Response of Residential Structures Due to Surface Mine Blasting.

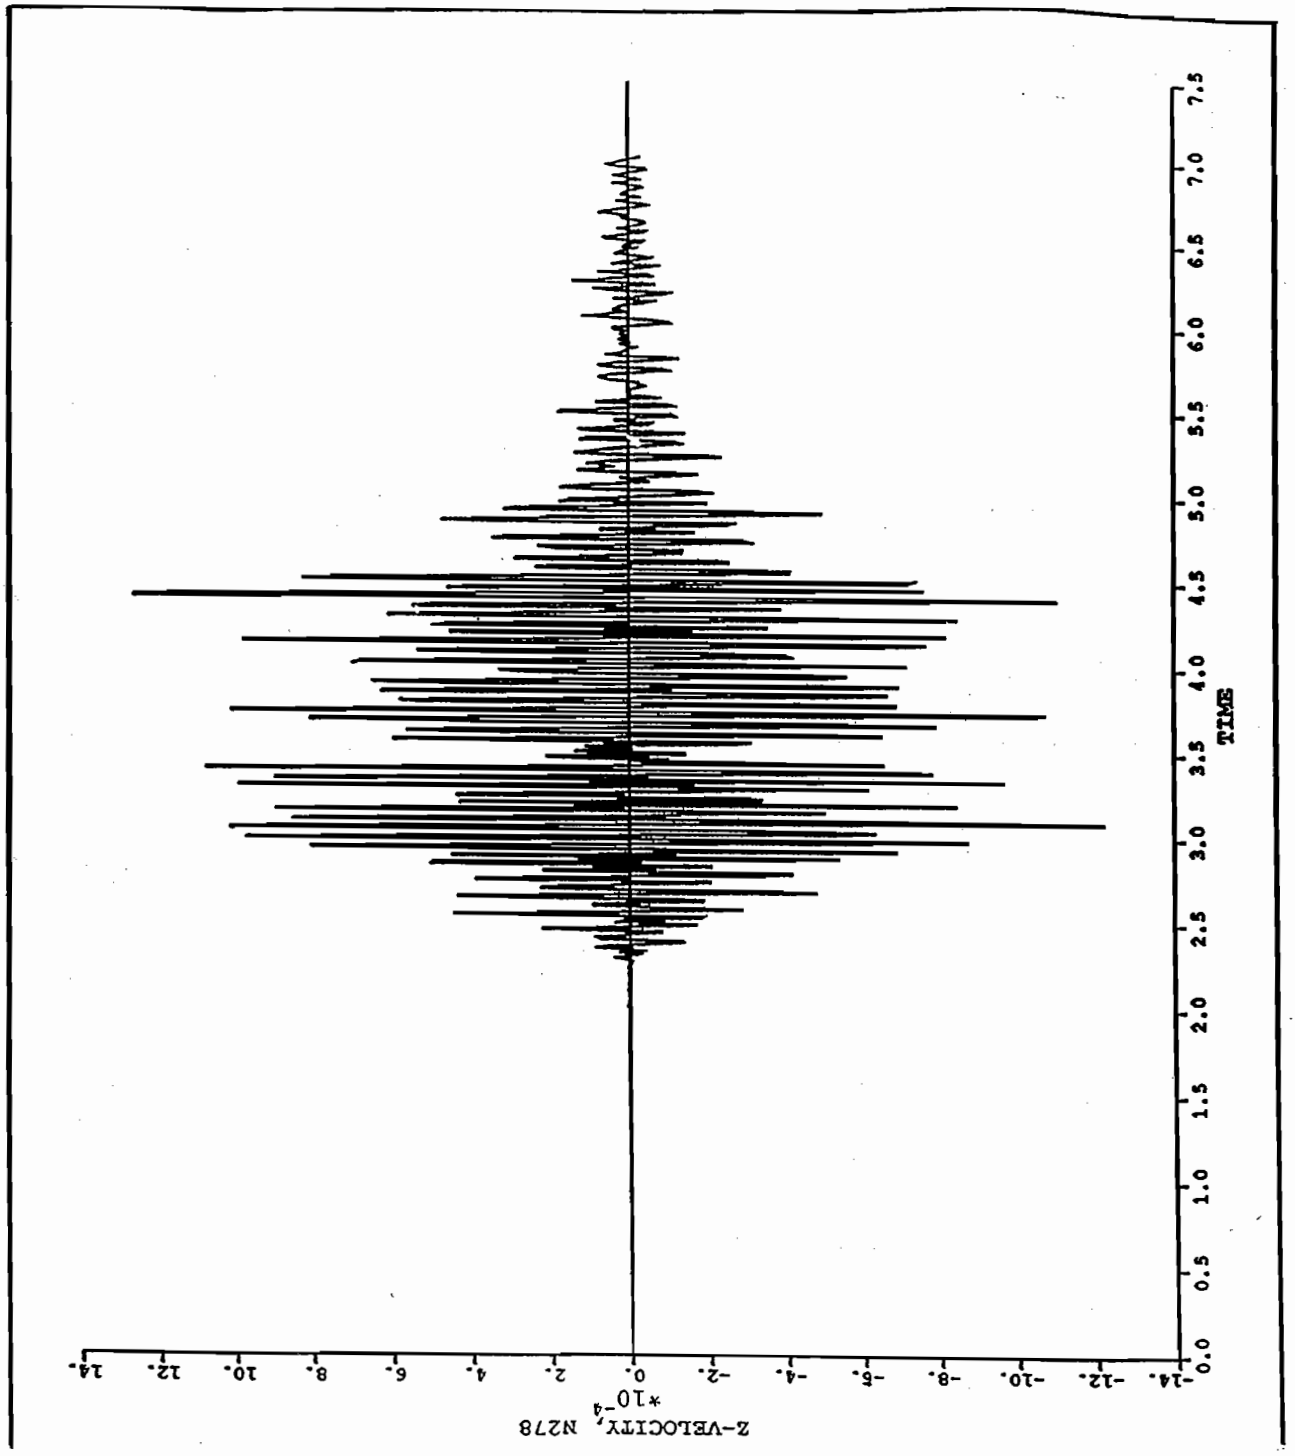
77. Figure 4.20 displays the lateral velocities and Figure 4.21 displays the vertical velocities at the location shown in Figure 4.18. The average of the six maximum peaks indicates a lateral velocity of 0.0018 in./sec which is 1.5 times greater than the lateral velocity of the ground motions. The 1.5 increase in lateral velocity corresponds to a dynamic amplification factor of 1.5.

Figure 4.21 Vertical velocity (ft/sec) for two-story house (FE results)

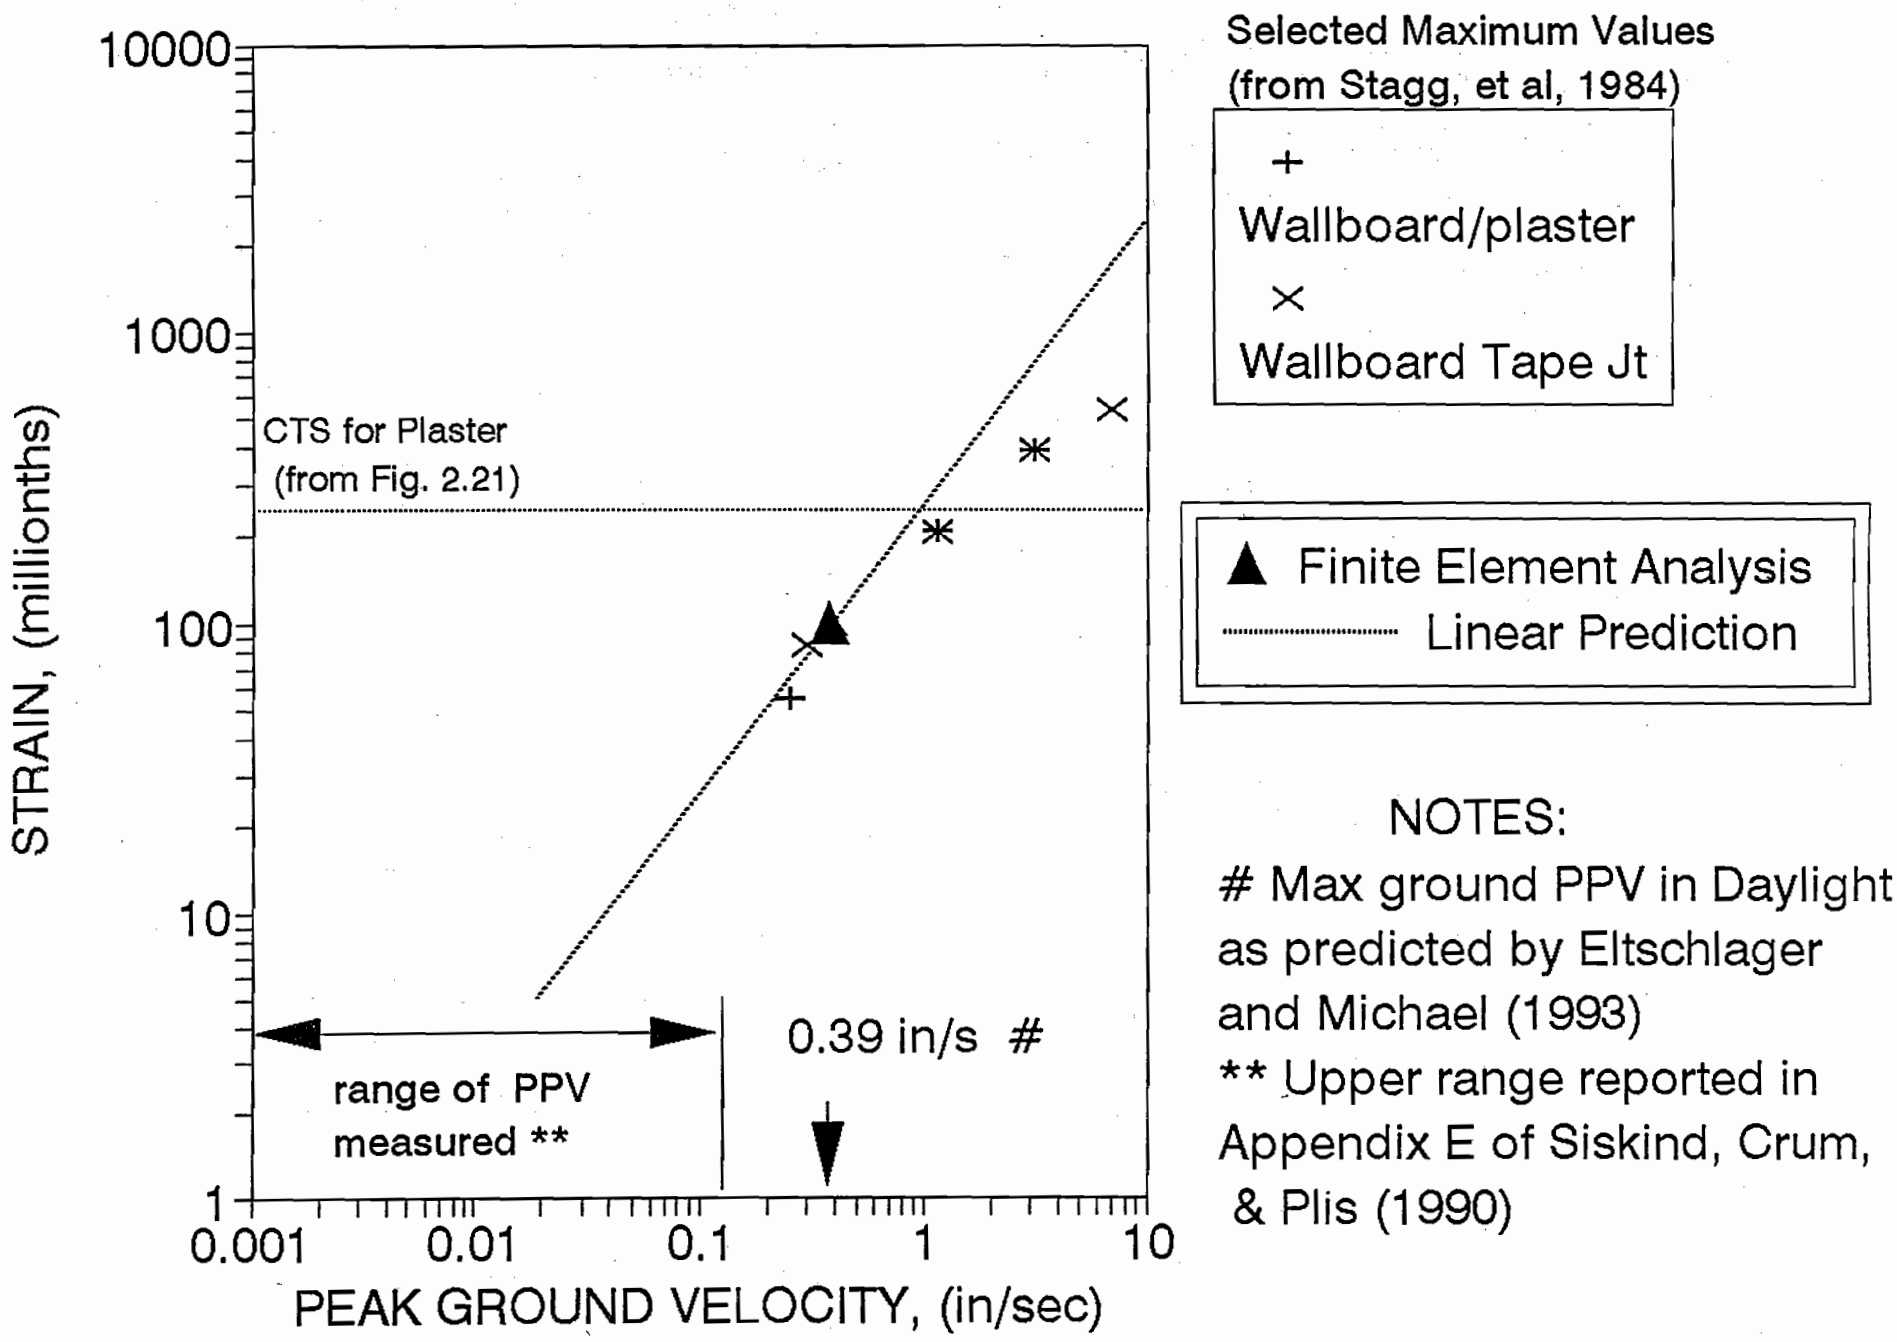
79. Figure 4.22 displays peak strains vs. peak ground velocity for wallboards while Figure 4.23 displays the envelope of peak strains vs peak ground velocity for block joints and brick veneer joints (Stagg et al. 1984). For the input velocity of 0.39 in./sec, the FE calculated strains in the wallboard and brick veneer joints for single-story house are shown.

80. The FE strains for wallboard are consistent with previous studies and below the CTS at a maximum ground velocity of 0.39 in/sec. Since the finite element analysis is linear elastic, the linear prediction is obtained simply by scaling the finite element result proportionately to any selected peak ground velocity divided by 0.39 in./sec (the scaled maximum amplitude of the selected ground motion). The resulting linear prediction is shown (Figure 4.22) by the inclined and dotted line through the finite element result. The correlation between the FE strain and the studies by Stagg et al. (1984) further verify the FE results and verify that study houses respond in the same manner as houses in previous studies.

Figure 4.22 Peak ground velocity versus strain

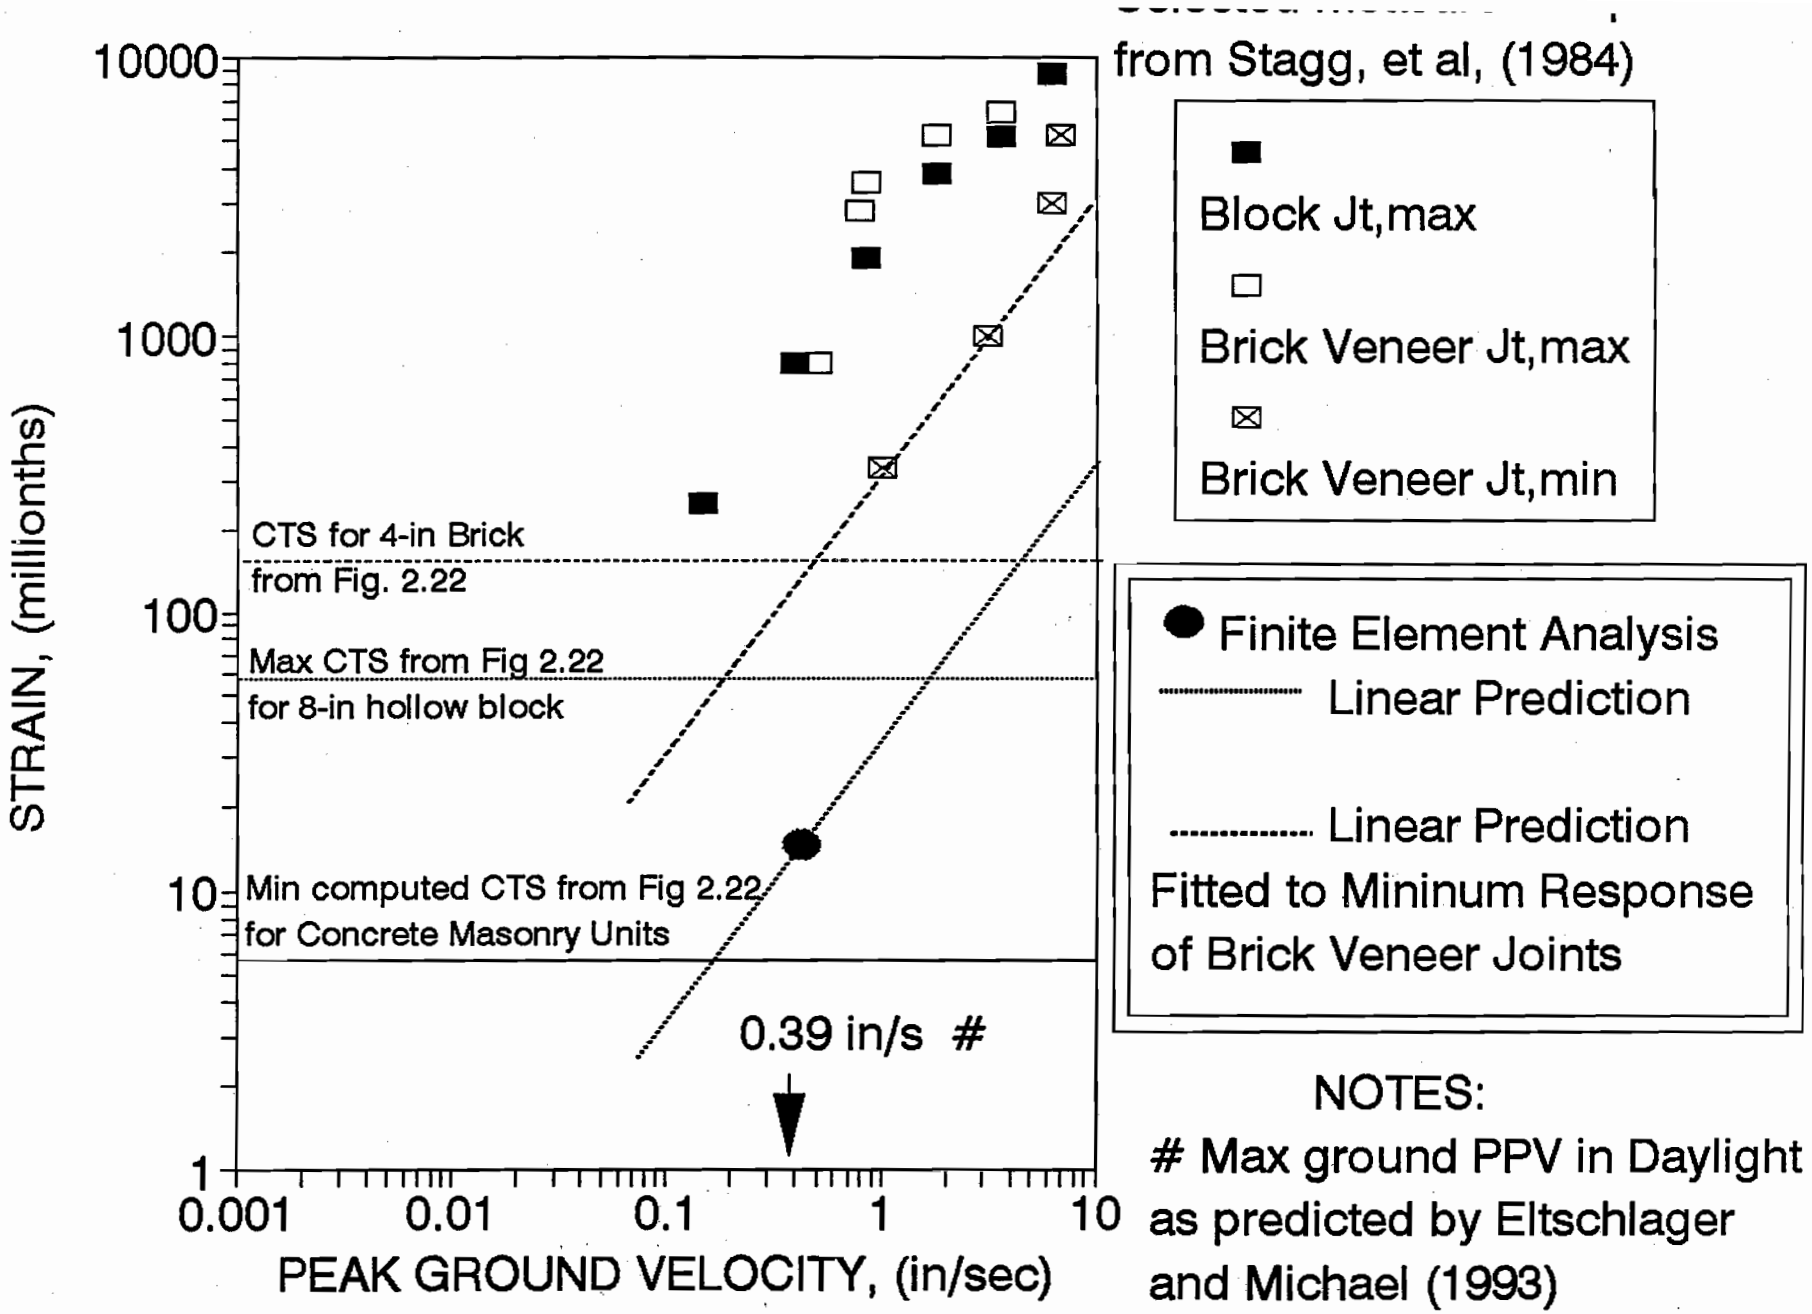
Figure 4.23 **Selected maximum responses of block joints and selected maximum and minimum responses for brick veneer joints measured by Stagg (Stagg, et al., 1984) and fitted linear predictions.**

82. The recorded brick and block response by Stagg et al. (1984) is above the highest level of CTS which indicates the possibility of cracking of the mortar joints. Also, Figure 4.23 shows a linear prediction based on fitting a line through the minimum recorded data. This fit exceeds the calculated response of a simple elastic model of a brick wall. Again, the recorded brick and block response includes strain resulting from the opening of cracks. The largest difference occurs at high peak ground velocities because of the increase of nonlinear behavior of the cracks. Differences are due to the simplicity of FE

modeling corners and the interaction with the framing members. However, even the conservative FE model predicts strain levels above the minimum computed CTS. This analysis leads to the same conclusion based on the recorded brick and block response data. This suggests that threshold damage of block and brick veneer joints may occur if the peak ground velocities equal or exceed 0.13 in./sec. The level of threshold material damage would not affect the ultimate load-carrying capacity of the block or brick wall.

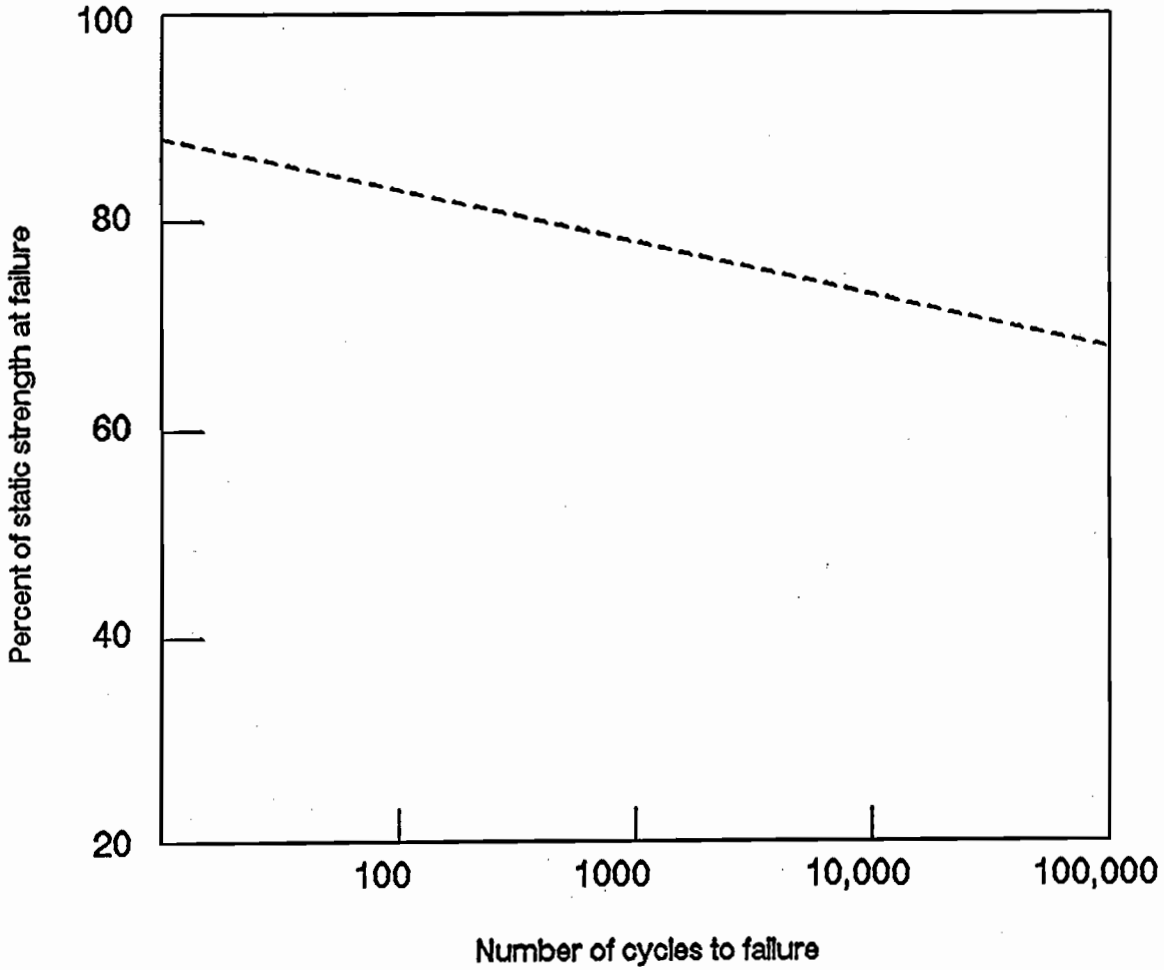
86. When evaluating material fatigue, it is important to understand that fatigue can occur only from cyclic loads which result in tensile stresses. As Figure 5.1 illustrates, the magnitude of the load as shown by percent of static strength at failure and the number of cycles to failure are the two critical parameters for determining fatigue loads. Figure 5.1 also indicates that for gypsum panels the cyclic load must exceed 70 percent of the yield strength for fatigue to be a problem at 100,000 cycles.

Figure 5.1 Fatigue behavior of gypsum panels (after Leigh, 1974)

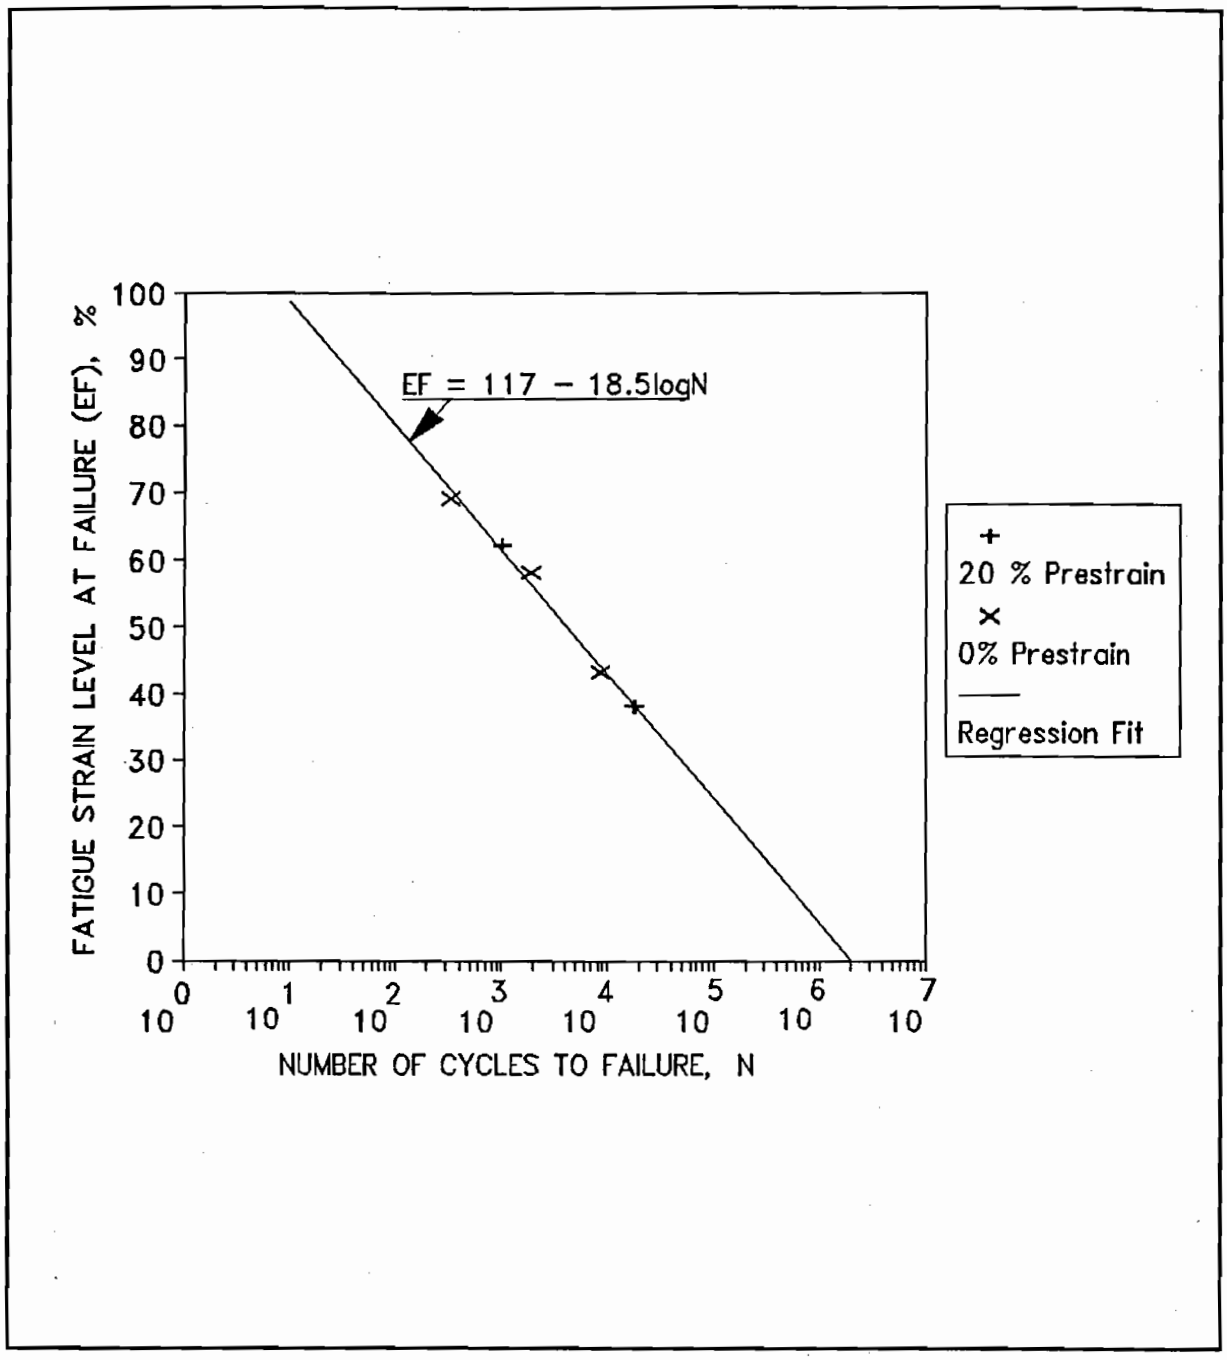
90. Table 5.2 and Figure 5.2 demonstrate the effects of prestrain (or stress) on the material prior to dynamic response. These data indicate that the existance of small prestrain has little effect on fatigue strain level of failure. Therefore, the data from the experiments, static analysis, and dynamic analysis, confirm statements by Stagg et al. (1984) which stated that large prestrain is needed to attain the cyclic failure stress level for house materials and that environmental factors, not blasting, are the major stress/strain producers.

Figure 5.2 Fatigue strain versus failure cycles for 5/8-in. gypsum wallboard. Data were taken from Table A-1 of Stagg, et al. (1984).
