Blast Vibrations and Other Potential Causes of Damage in Homes Near a Large Surface Coal Mine in Indiana

By David E. Siskind, Steven V. Crum, and Matthew N. Plis

BLAST VIBRATIONS AND OTHER POTENTIAL CAUSES OF DAMAGE IN HOMES NEAR A LARGE SURFACE COAL MINE IN INDIANA

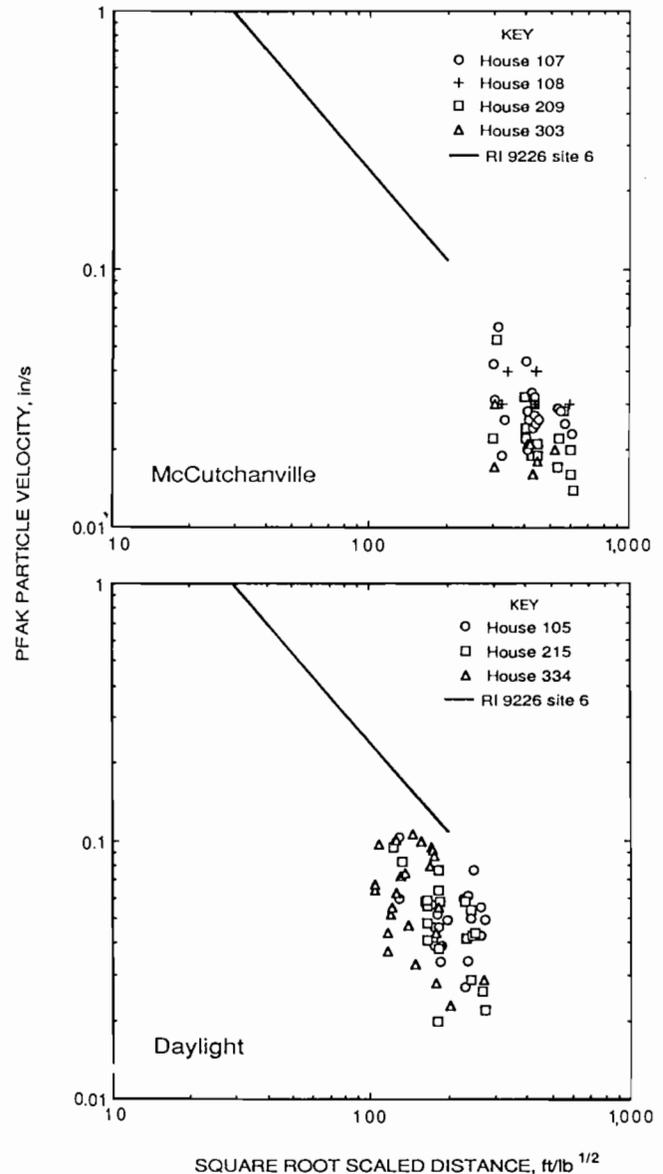
The maximum peak ground-vibration level recorded was about 0.1 in/s in the Daylight area and 0.06 in/s in the McCutchanville area. The McCutchanville data (fig. 19) are clustered from a scaled distance of about 300 to 650 ft/lb$^{1/2}$ and the Daylight data from near 90 to 300 ft/lb$^{1/2}$. The peak values overlap at the common scaled distance of 300 ft/lb$^{1/2}$ and are near or lower than the reference given by the RI 9226 study. Relative position of the blast in conjunction with the particular differences in site characteristics (surface geology, physical characteristics of the house, etc.) can most likely account for the slight differences in peak particle velocity within an area. In general, the peak ground-vibration amplitudes were a bit higher than would be expected at the relatively long distances to Daylight, McCutchanville, and Haubstadt, but are still very low compared with historical damage thresholds of 0.5 to 2.0 in/s.

Figure 19.—Bureau data on peak particle velocity for homes monitored in McCutchanville and Daylight.

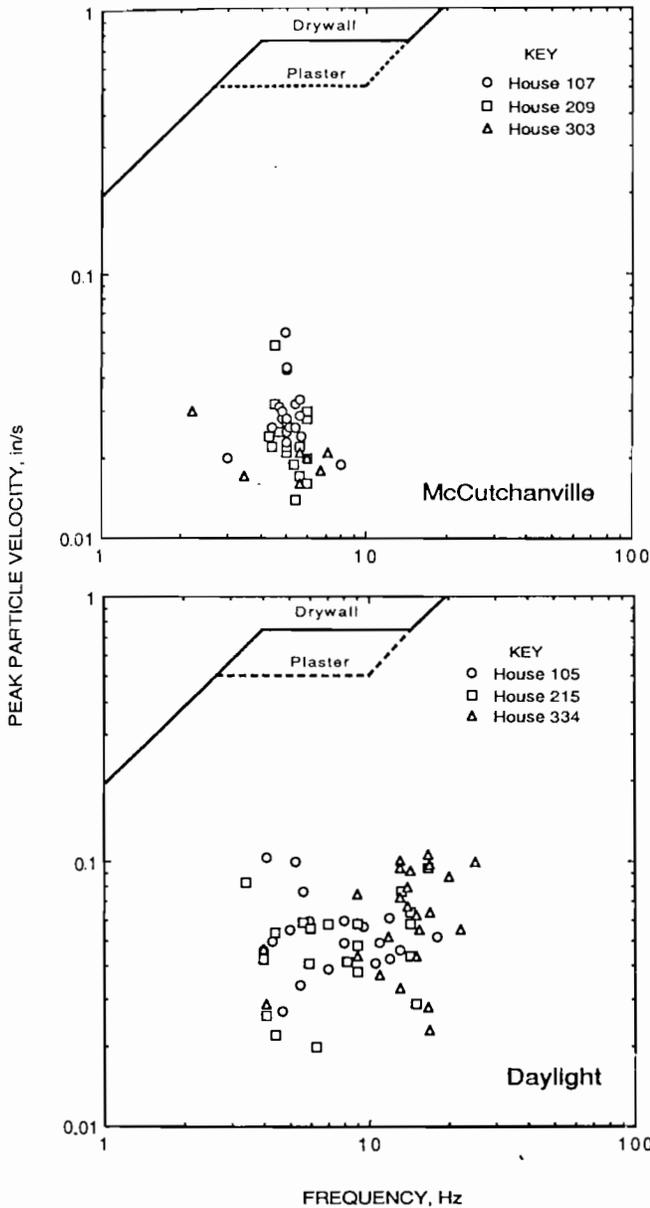
Figure 20 depicts frequency versus peak ground-vibration particle velocity levels in McCutchanville and Daylight. The frequencies were obtained from the ground-vibration time histories and calculated as the inverse of the period (in seconds) of the corresponding peak velocity wavelet. The curve in the upper left-hand corner of each

Figure 20.—Peak particle velocity and associated frequency for Bureau monitoring in McCutchanville and Daylight. Dashed lines in upper left are from appendix B of RI 8507 and represent safe limits recommended by the Bureau (3).

plot is the recommended Bureau limit from appendix B in RI 8507, which relates threshold damage levels to frequency and peak ground-vibration particle velocity (3). No frequency data were available for house 108.

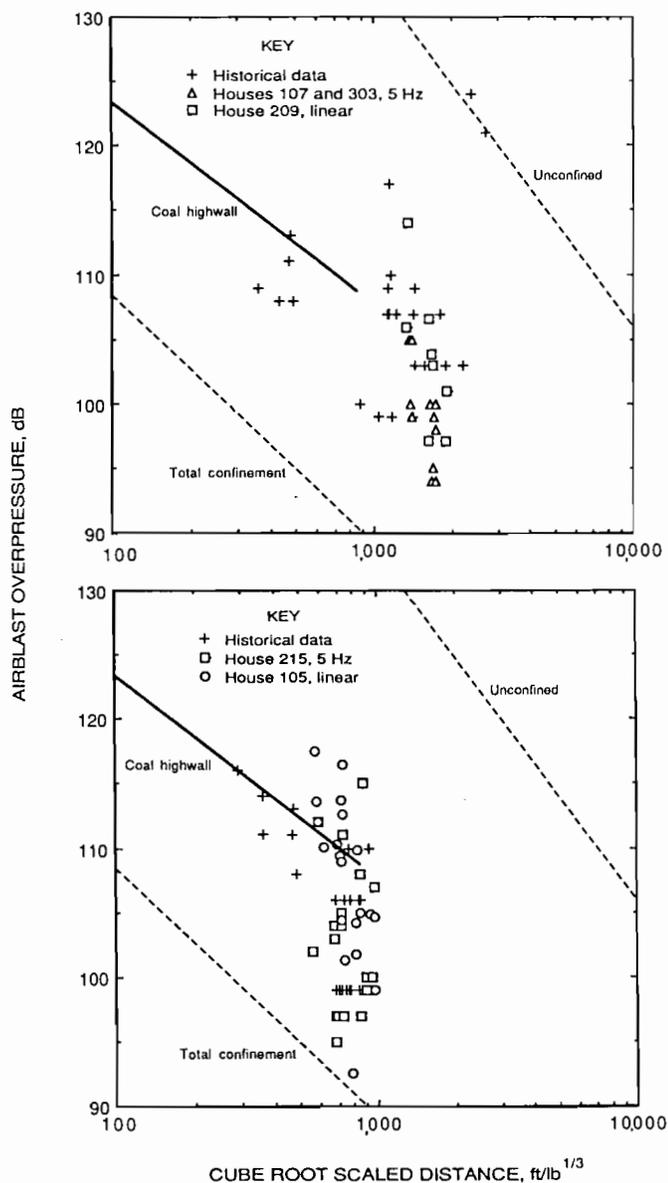
Historical data and Bureau monitoring of airblast overpressure recorded in the McCutchanville and Daylight directions are given in figure 21. Airblast data correspond to the same group of blasts used in the previous ground-vibration analysis (see figures 18 and 19 and discussion thereof).

Figure 21.—Historical and recent Bureau airblast overpressures for McCutchanville (top) and Daylight (bottom) directions.

The dashed lines of figures 21 represent upper and lower historical reference bounds for airblast levels for a totally confined blast (lower line) and unconfined blast (upper line), which could amount to a "blowout." The solid black line is the regression line calculated from other historical data for typical surface coal mine blasts. These three reference lines are from RI 8485 (5) and have also been presented in this text in figure 4. Peak levels obtained from the ST 4 recorders are identified in the plot key as "5 Hz" because this is the frequency rolloff of the airblast channel on these instruments. "Linear" refers to the sonic-boom detectors with the tape recorder systems, which have flat responses from 0.1 to 8,000 Hz. Airblast levels obtained from the 5-Hz system are about 8 dB lower than the levels measured with the linear system for the low-frequency airblasts observed from the relatively distant Ayrshire mine. All of the subsequent plots do not correct for this difference, although the type of system used is stated. Peak airblast values used in this report are also given in appendixes B and C. Airblasts with values stated as less than 100 dB were plotted at 99 dB.

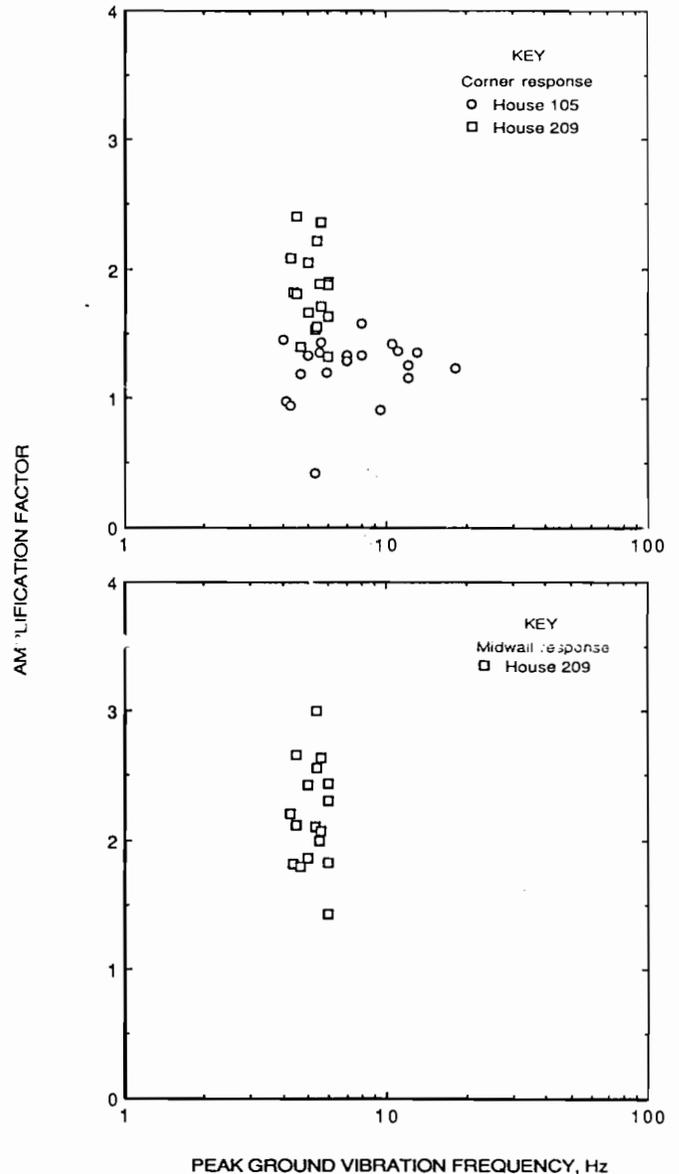
Response amplifications for the two homes monitored for structure response are shown in figure 22. House 209 in McCutchanville had ground-to-structure corner amplifications averaging nearly 2.0. House 105 was shorter, at one story, and had a typical amplification factor of 1.3 and a maximum of 1.6. This house was also subjected to a much wider range of vibration frequencies, as already mentioned for all the Daylight homes. Midwall amplifications were also measured in house 209 and ranged up to

Figure 22.—Amplification factors for blast-produced corner responses for houses 105 and 209 and midwall responses for house 209.

a factor of 3. All response values are within the bounds of previously studied homes, as shown in figures 38 through 40 in RI 8507 (3), and cannot be considered abnormal in terms of blasting vibrations.

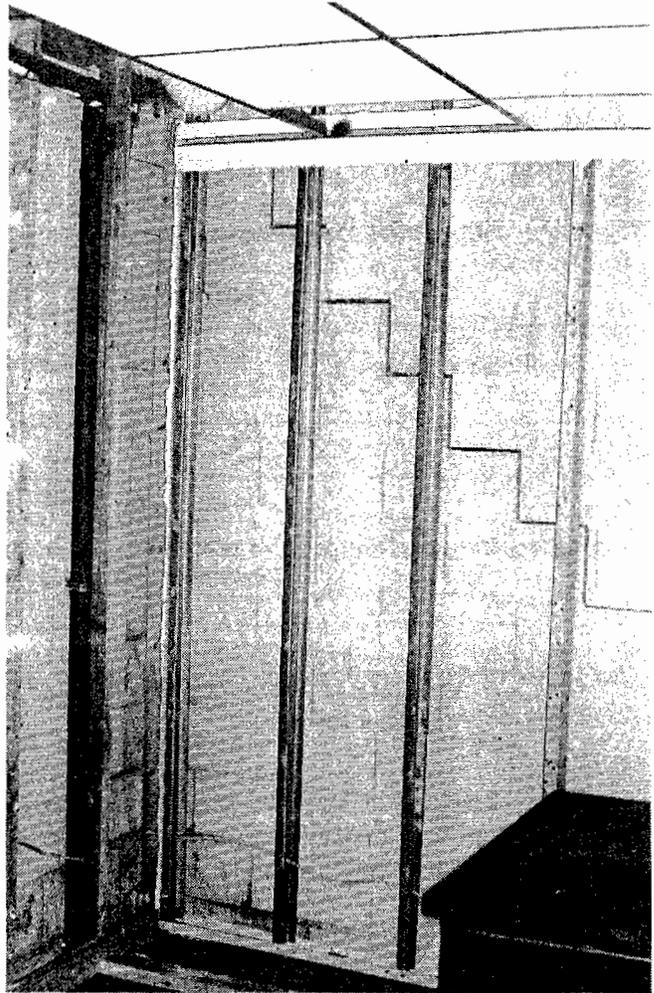
House 209 is on a hillside and has numerous superstructure cracks, mostly hairline. House 215 is in a flat area in Daylight and has both a few superstructure cracks and a few basement block wall cracks similar to those in house 105.

Figure 24.—Basement block wall crack on east wall of house 201.

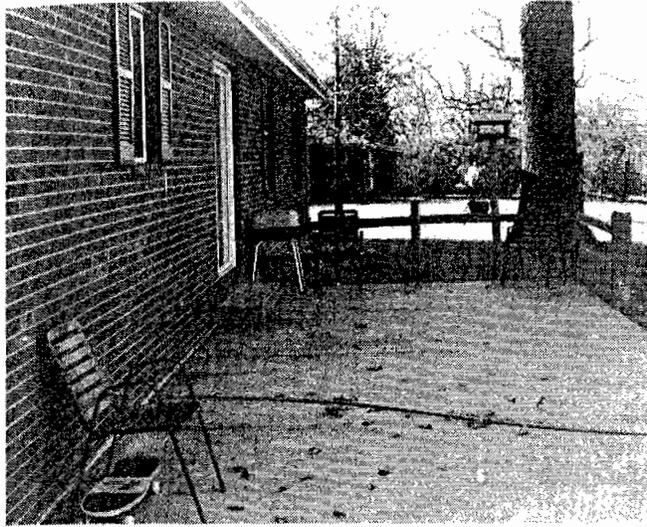
Figure 25.—Uncovered patio at house 201 with tilt toward house's north wall.

Figure 26.—Junction of north wall and patio of house 201 showing evidence of settlement.

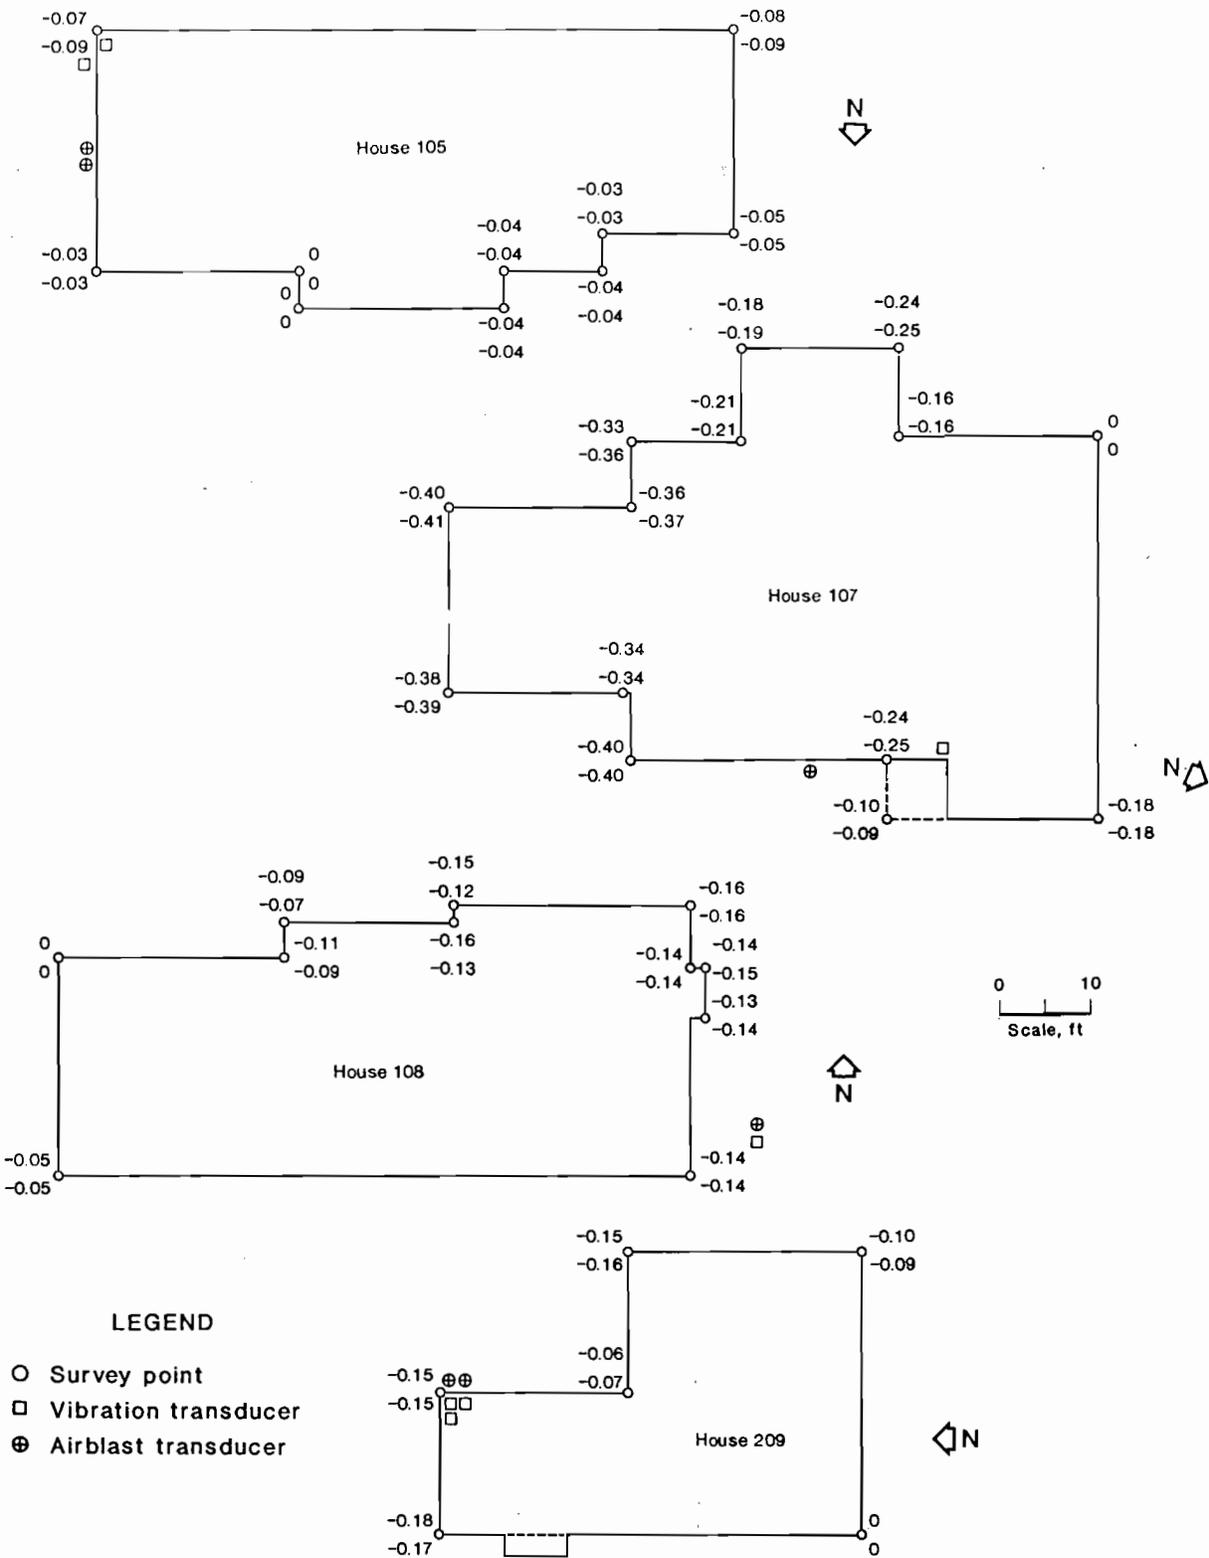
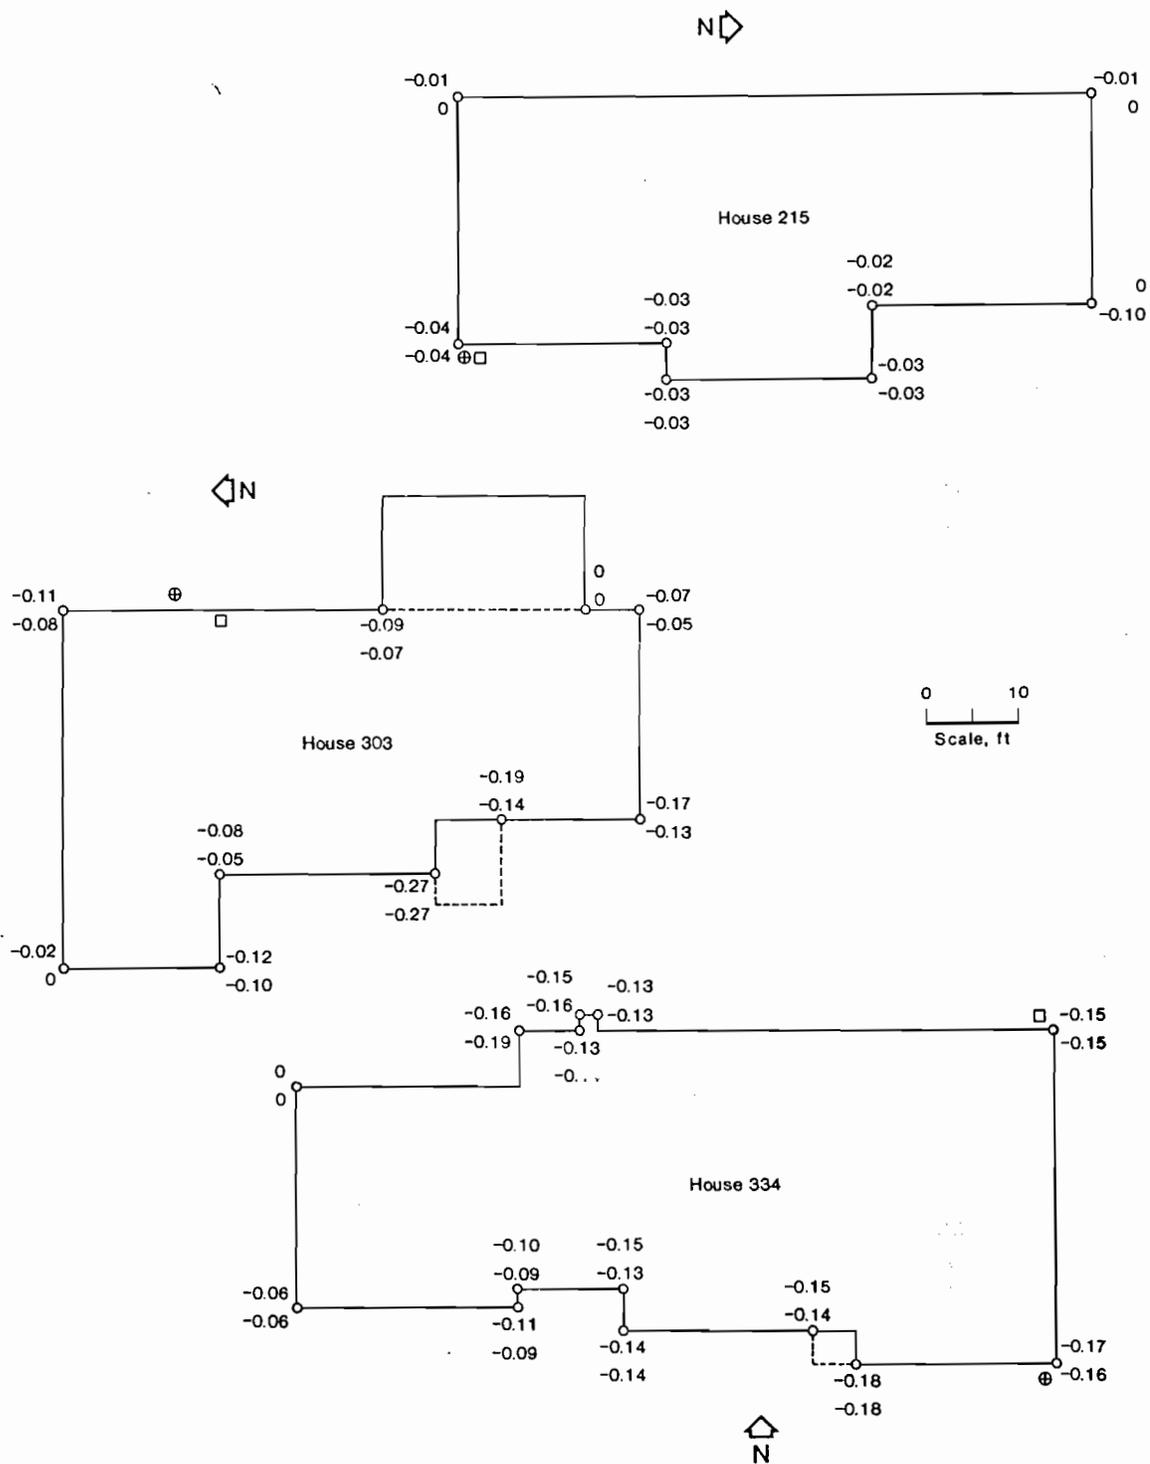
Structural damage	1:150
Cracking of panel and load-bearing walls	1:300
No cracking	1:500

Figure 27.—Level-loop surveys. In each pair of elevations, top is survey of October 1989 and bottom is survey of January 1990. Elevations are in feet.
