MEMORANDUM

TO: Monica Styles - ETP and Nick Bryan - ETP
FROM: Richard Wardrop, P.G., GES
CC: Dave Demko, P.G., GES
DATE: August 17, 2020
SUBJECT: Restart Report – Mariner East 2 HDD S3-0290
Milford Road / Little Connestoga Road
Upper Uwchlan Township, Chester County,
Pennsylvania

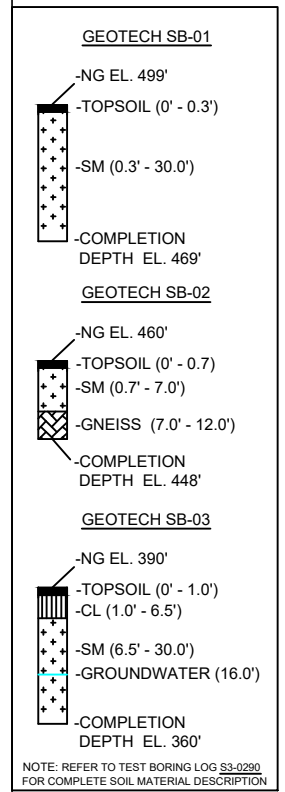
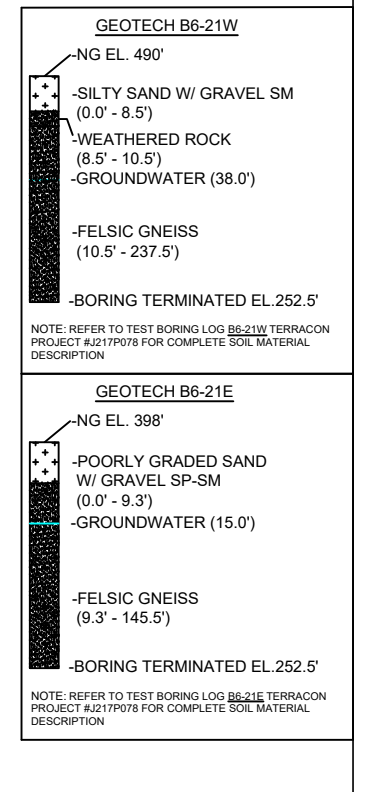
HDD IR OVERLAY

Attachment A shows the depth and position of the reaming bit when the IR was discovered on August 8, 2020. The 30-inch reamed hole had been advanced approximately 1,574 feet along the profile and was approximately 1,190 feet horizontal distance northwest of the location of the IR when the IR occurred. The depth of the bit was approximately 215 feet below ground surface.

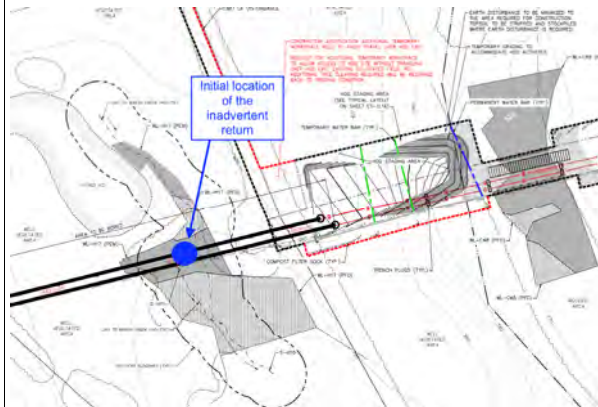
MAP:

C. DESCRIPTION OF THE RELEASE (PROVIDE DATES, TIMES, AND DURATION OF IR IF KNOWN, INCLUDE ROOT CAUSE(S))	On 8/10/2020 at approximately 1530, drilling fluid emerged within wetland WL-H17, and entered streams S-H11 and S-H10. The drilling fluid continued to flow down S-H10 and entered pond H3 (Marsh Creek Reservoir). The drill was in the ream phase at the time of release, with a volume of 8,163 gallons of drilling fluid released. Drilling was immediately stopped upon discovery of the IR. Two turbidity curtains were installed at the confluence of S-H10 (UNT to Marsh Creek) and pond H3 (Marsh Creek Reservoir). Twelve sand bag and silt fence dams were constructed within S-H10 (UNT to Marsh Creek). Crew members began clean up and recovery of the drilling fluid starting near pond H3 (Marsh Creek Reservoir) working their way east to the location of the IR release point. Crew members used pumps and hand tools to recover the drilling fluid and transport it to onsite storage tanks. Stream water was pumped and used to spray remaining bentonite pockets within stream S-H10 (UNT to Marsh Creek).
