BLUE GOOSE SOUTH Abandoned Mine Reclamation Project Contract No. OSM 11(4092)101.1

BLUE GOOSE SOUTH ABANDONED MINE RECLAMATION PROJECT CONTRACT NO. OSM 11(4092)101.1

FACT SHEET

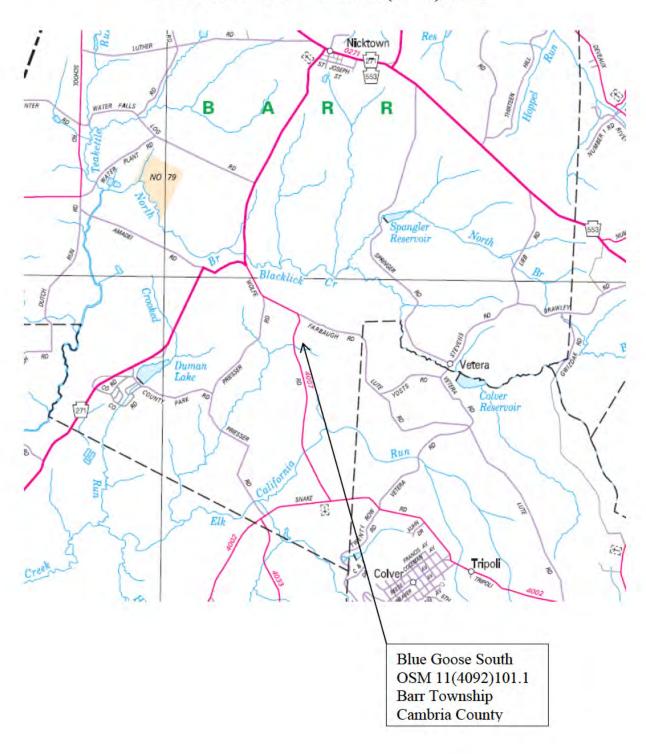
Pre-Construction

mine opening, which was a 21-foot-long by 14-foot-wide by approximately 450-foot-deep dual compartment mine shaft. The mine shaft was flooded and covered by deteriorated wood timbers and 1/4-inch-thick rusted sheet metal. The Pennsylvania Natural Diversity Index (PNDI) yielded an "Avoidance Measure" with the United States Fish and Wildlife Service (UWFWS) to ensure that Indiana bats or other bats were not adversely affected by this project. Appendix A of the Bat Survey Protocol was followed and a bat survey was dismissed because the mine shaft was prone to flooding and covered by the rusted sheet metal and deteriorated
