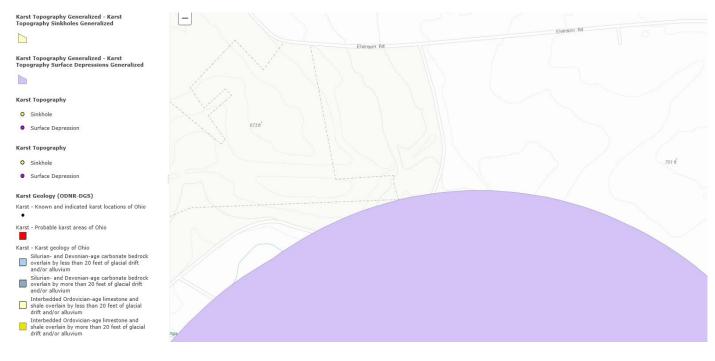
Below: Joanna Road, ArcGIS overlaid with Karst Geology

Left: Expanded view showing the extent of the HDD route through the Karst region. While not entirely a flawless photo it can be clearly seen that both the beginning and end of the HDD# S3-0250 lie within the identified Karst Region. The extremely sensitive and unstable region is particularly susceptible to geological and hydrological damages through the use of Horizontal Directional Drilling (HDD).
