**HORIZONTAL DIRECTIONAL DRILL ANALYSIS
EAGLEVIEW BOULEVARD
PADEP SECTION 105 PERMIT NO. PA-CH-0135.0000-RD-16
(SPLP HDD# S3-0321)**

**EAGLEVIEW BOULEVARD
PADEP SECTION 105 PERMIT NO. PA-CH-0135.0000-RD-16
(SPLP HDD# S3-0321)**

This analysis of the horizontal directional drill (HDD) No. S3-0321, which is the installation of a 16-inch diameter pipeline parallel to Eagleview Boulevard in Chester County, Pennsylvania, is in accordance with Stipulated Order issued under EHB DOCKET NO. 2017-009-L for HDDs listed on Exhibit 2 of the Stipulated Order.

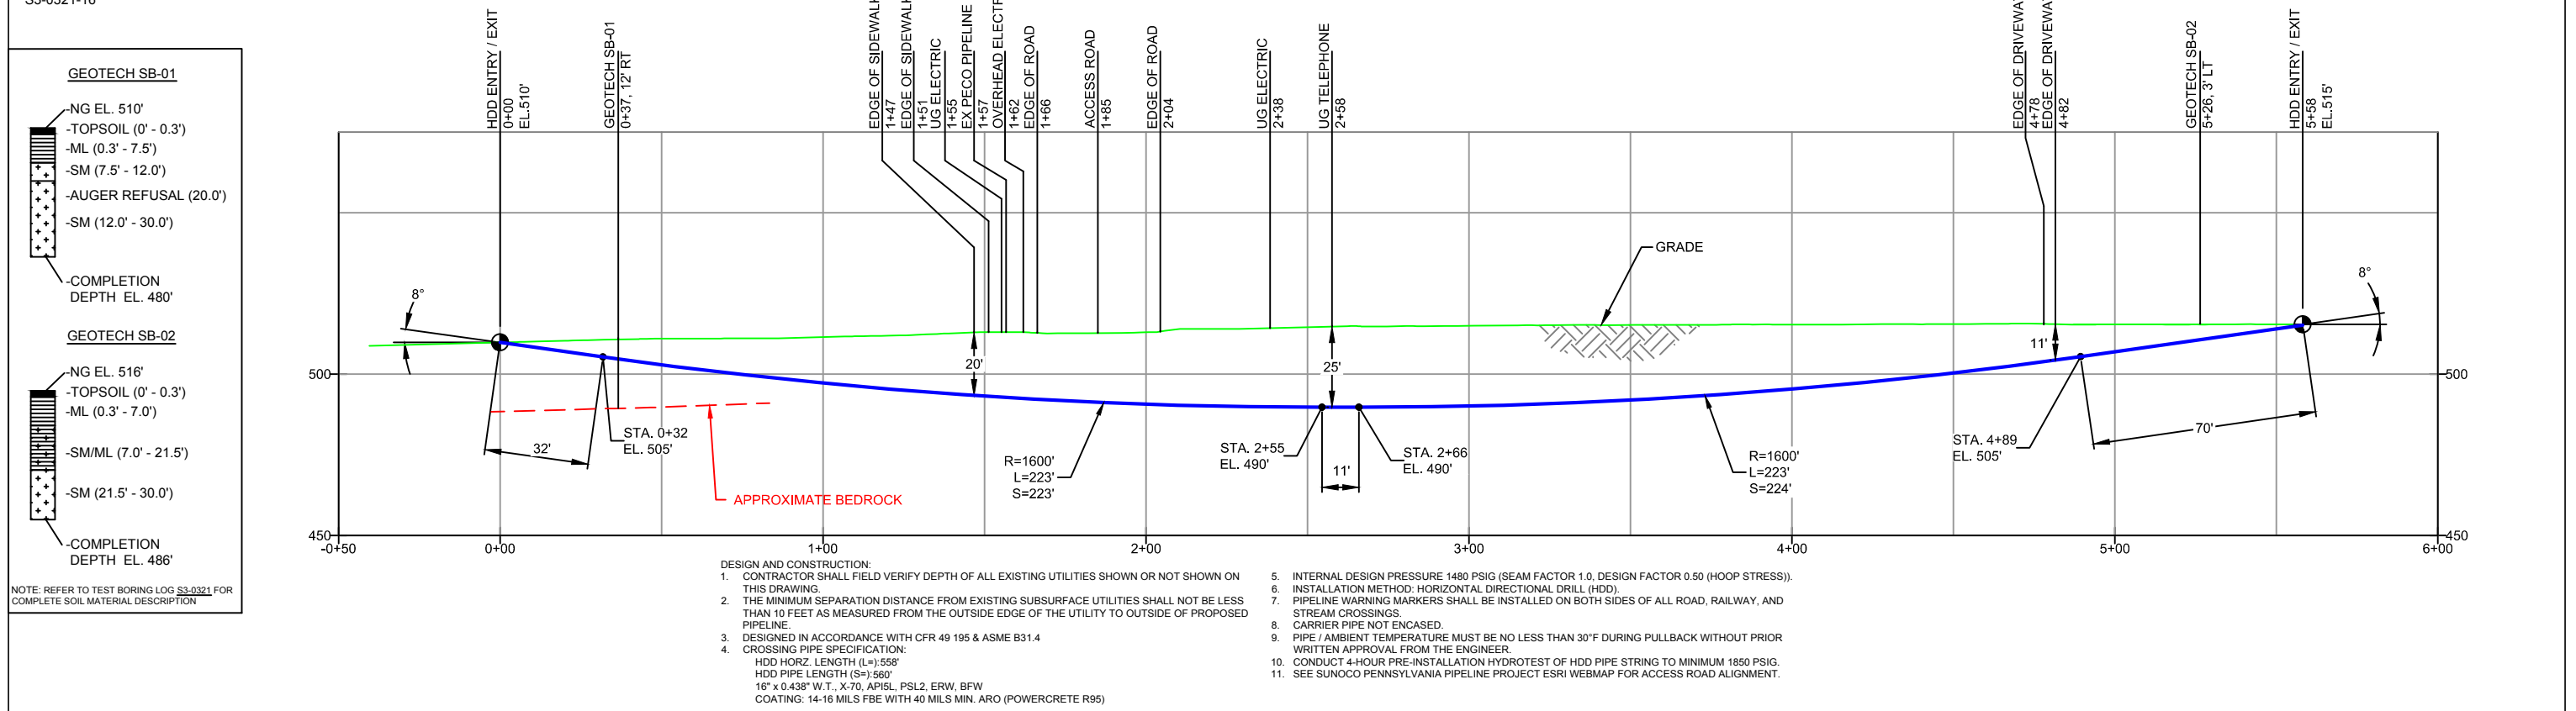
ORIGINAL HORIZONTAL DIRECTIONAL DRILL PLAN AND PROFILE

CHESTER COUNTY, PENNSYLVANIA - UWCHLAN TOWNSHIP
 S3-0321-16

PROFILE VIEW

- Horizontal length: 558 feet (ft)
- Entry angle: 8 degrees
- Depth of cover: 25 ft
- Pipe stress radius: 1,600 ft
