Re: Public Comments on Report for HDD PA-CH-0199.0000-RD (HDD #S3-0360)

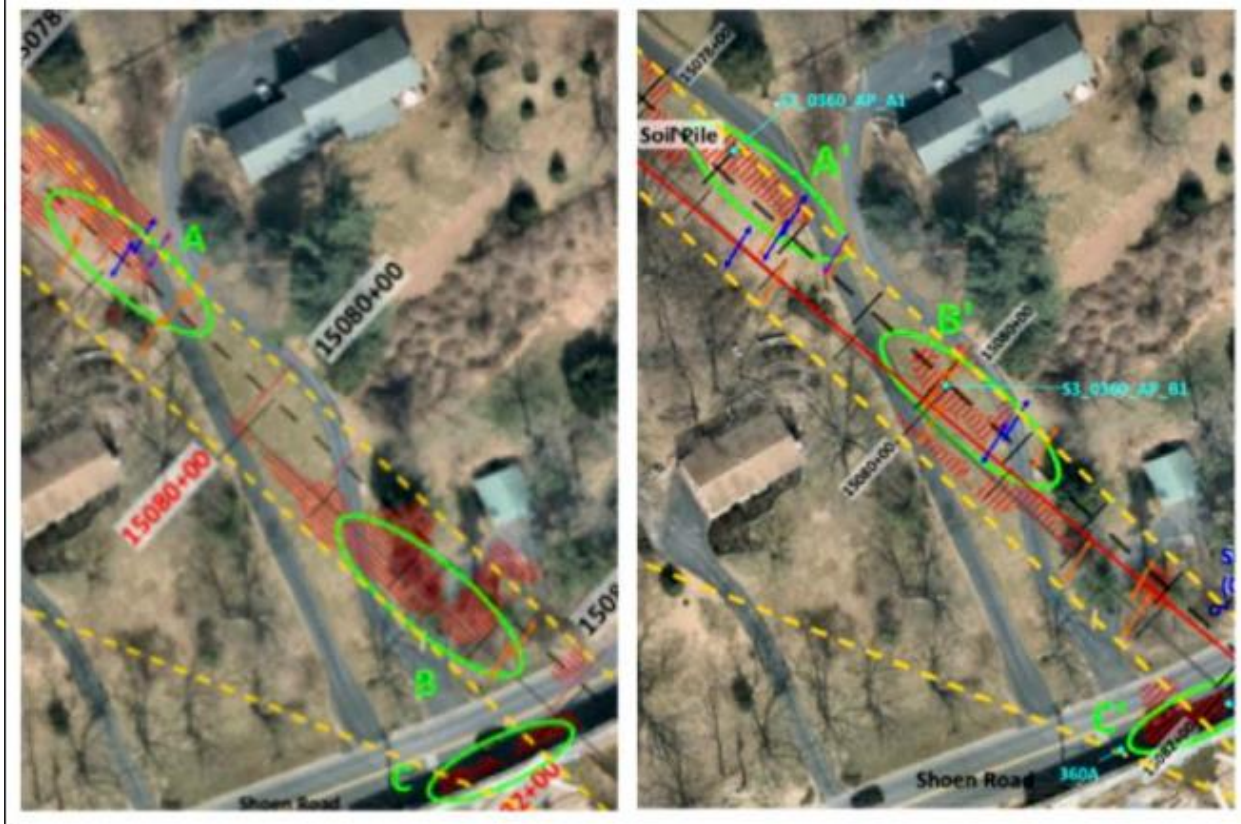
- Rettew states "these anomalies are roughly coincident with those detected in the previous [February 2020] geophysical study" (December 9, 2020, page 4) however the ovals appear to be significantly relocated without justification. In the photo below, Figure 7B (original geophysical survey) is on left and Figure 7A (repeat geophysical survey) is on right.

- Area A in Figure 7A (on right in photo below) excludes the fracture zone to the west
- Area B in Figure 7A also excludes the gravity low to the west and fracture zone to the south
- The proposed 20" path (grey line in 7A on right side in photo below) passes just west of Area A, along the western edge of Area B and through Area C. It passes through three possible fracture zones, one uphill from and behind our neighbors' house at 109 Shoen Road, one at the bottom of the hillside on our property at 103 Shoen Road and one in between.

- As stated in the PSI report “The strata shown on the logs represent the conditions only at the actual boring locations. Variations may occur and should be expected between boring locations”. Not only were there merely two borings on the hillside, they weren’t even conducted on the proposed path of the 20”. (The location of the borings is marked in light blue and the proposed 20” in grey on the figure on right side of photo above)
