Public Comments on Eldridge

The Title of the HDD Re-Evaluation Report is “**Eldridge Drive/North Chester Road Crossing**” which appears to reference two different drill site locations in East Goshen Township, PA. Further, the attached HDD Hydrogeologic Re-Evaluation Report, prepared by GES, simply refers to the location being evaluated as “S3-500 North Chester Road” and makes no reference by name to Eldridge Drive whatsoever. At a recent public meeting in East Goshen Township on September 19, 2019 a map bearing the Energy Transfer logo was presented to the Township Supervisors and audience, and referenced by Energy Transfer representatives, which clearly illustrated one drill site location labeled as Eldridge Drive HDD 500 (20”) and a separate drill site location labeled as North Chester Road HDD 521 (16” & 20”). If the First Report is only referencing the Eldridge Drive location it should be simply and clearly labeled as such. Although maps provided in the attached GES document show what appears to be the Eldridge Drive location, the name of their report clearly refers to an entirely different drill site location.

The Eldridge Drive/North Chester Road Re-Evaluation Report (First

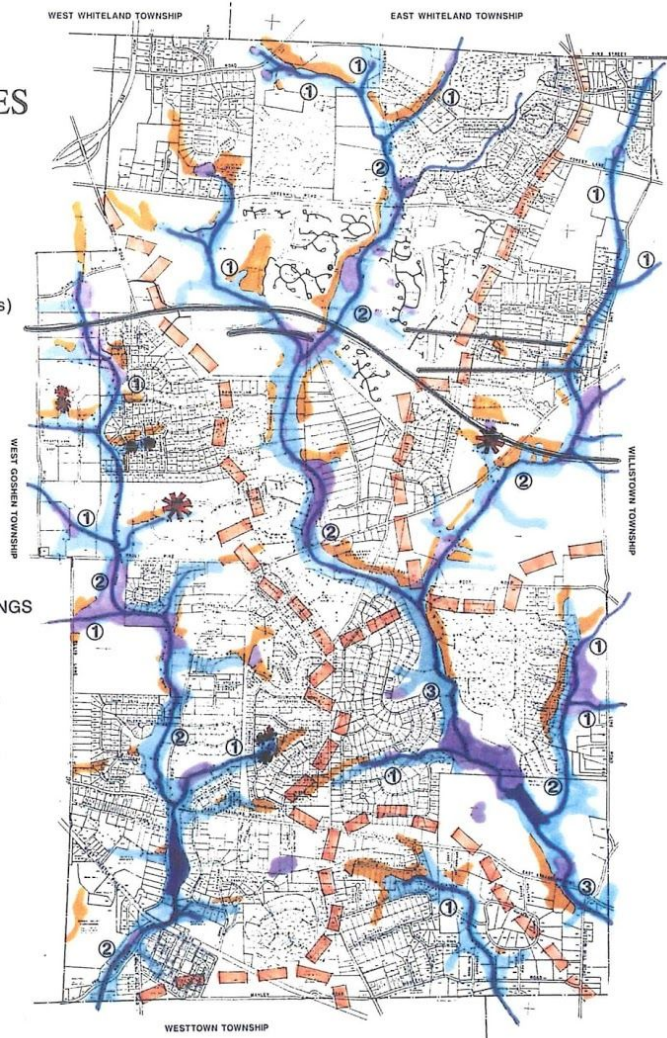
EAST GOSHEN TOWNSHIP CHESTER COUNTY, PENNSYLVANIA

- CRITICAL RESOURCES**
 - SLOPES >15%
 - GEOLOGICAL FRACTURES
 - ALLUVIAL SOILS
 - STREAM CORRIDORS
 - 100 YEAR FLOODPLAINS
 - WETLANDS

- RESTRICTED LAND**
 - HISTORIC SITES AND DISTRICTS

NOTE: This map is a culmination of the Protected Lands Map and the Resource Priorities Map. Its objective is to determine important environmental resources that are vulnerable to disturbance.

RECOMMENDATION: The “Adjacent Feature Analysis” is incomplete in insufficient. The DEP should not allow development in an area with 21 fracture traces, floodplain risk, substantial nearby wetlands and watersheds. No permit should be issued for work in this area.
