Re: Reevaluation Report Supplement
Yellow Breeches Creek Re-Evaluation (S2-0250)
Permit No. E21-449
Upper Allen Township, Cumberland County

WATER SUPPLY ILLUSTRATION (UPDATED)

Well Location Map
 HDD# PA-CU-0203.0000-WX
 Cumberland County, PA.

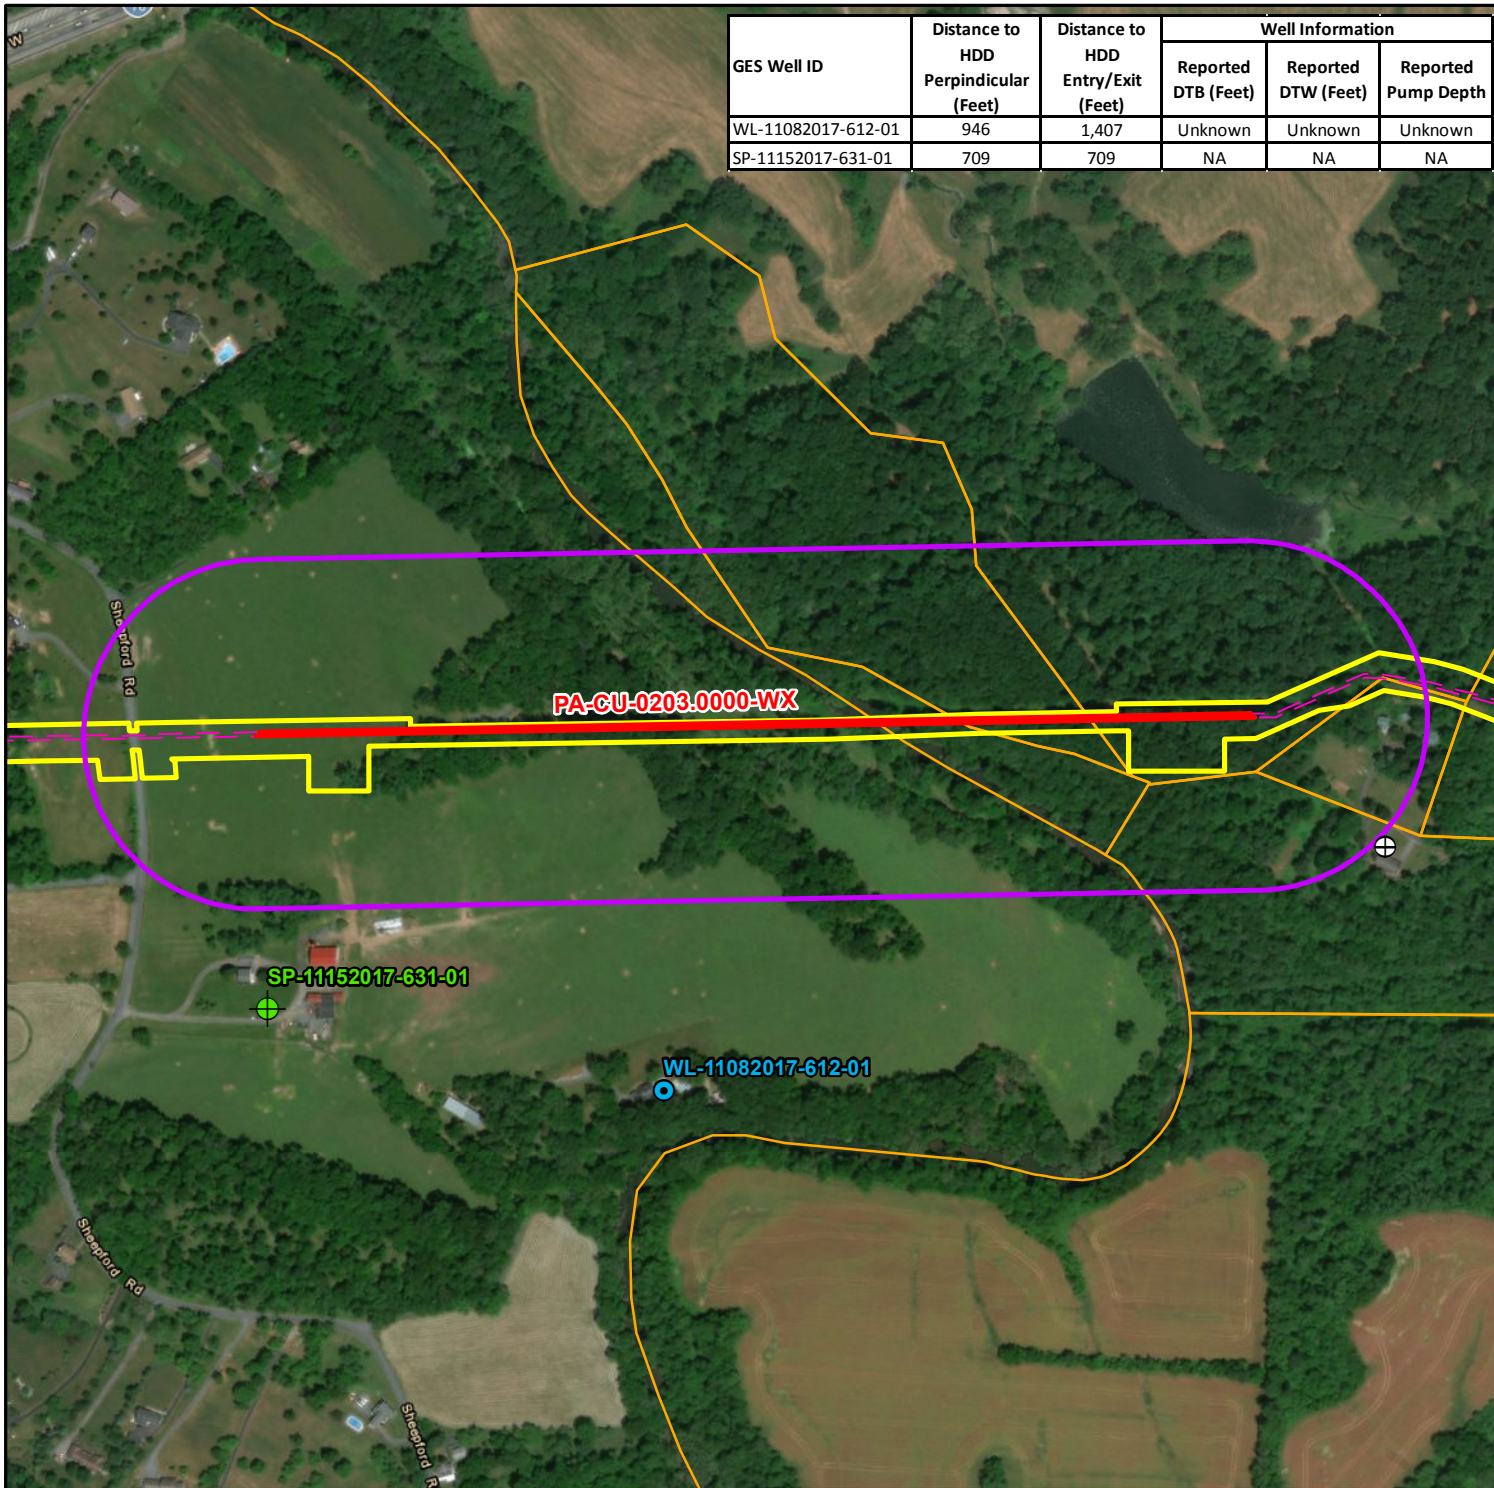
GES Well ID	Distance to HDD Perpendicular (Feet)	Distance to HDD Entry/Exit (Feet)	Well Information		
			Reported DTB (Feet)	Reported DTW (Feet)	Reported Pump Depth
WL-11082017-612-01	946	1,407	Unknown	Unknown	Unknown
SP-11152017-631-01	709	709	NA	NA	NA

Base Map: ESRI World Imagery, 09/24/2015
 Coordinate System: NAD 83 Stateplane, PA South, Feet

SPLP has completed the verification of all water supplies within 450 feet (ft) of the HDD profile. The attached supplemented Adjacent Features Analysis section from the Reevaluation Report and updated Water Supply Illustration presents this information.
