Project:	PennEast		
Our reference:	353754	Your reference:	Mud Run Slope
Prepared by:	D Chandler	Date:	September 24, 2019
Approved by:	M Wilcox	Checked by:	D Hartman
Subject:	Mud Run Slope Restoration

The purpose of this document is to present possible slope restoration methodologies at the proposed pipeline crossing of Mud Run Creek in Hickory Run State Park, Pennsylvania. These slope restoration methodologies are intended to minimize the risk of slope failure adjacent to Mud Run, and to address comment #37 in the technical deficiency letter from the Pennsylvania Department of Environmental Protection (PADEP) dated July 3, 2019. Representatives from PennEast and Mott MacDonald met onsite with a contractor that specializes in slope stabilization to evaluate the site conditions and discuss options. The overall engineering objective of restoring the slope at Mud Run is the long-term resiliency of the pipeline and to avoid the need to perform repeated maintenance or restoration procedures during the operation of the pipeline.

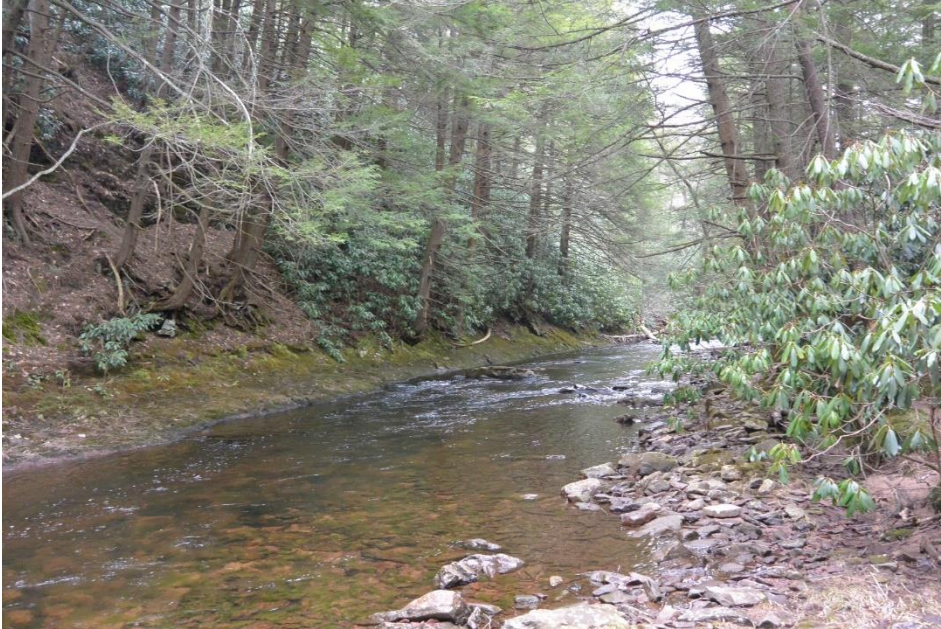
Figure 1: Looking in a north easterly direction, at the northern side of the Buckeye ROW showing exposed shallow bedrock on slope. February 2017.

The northern side of Mud Run is at a gradient of approximately 35° (70%) and is approximately 100 feet high. The south side of the crossing is at a gradient of approximately 17° (30%) and is unlikely to require use of any special restoration methods.

The ground conditions on the slope consist of a thin cover of clayey soil over shallow bedrock. The bedrock consists of interbedded sandstone, siltstone and conglomerate. These geological conditions were observed in crossing-specific boreholes and are typical of the mapped geological unit – Duncannon Member of the Catskill Formation. The Rock Quality Designation (RQD) values within the rock mass were highly variable, ranging from low (highly fractured) to very high (virtually intact).

Figures 1 and 2, below, provide images of the slope. Note that the PennEast pipeline is to be constructed to the left (west) of the existing Buckeye pipeline right-of-way (ROW).

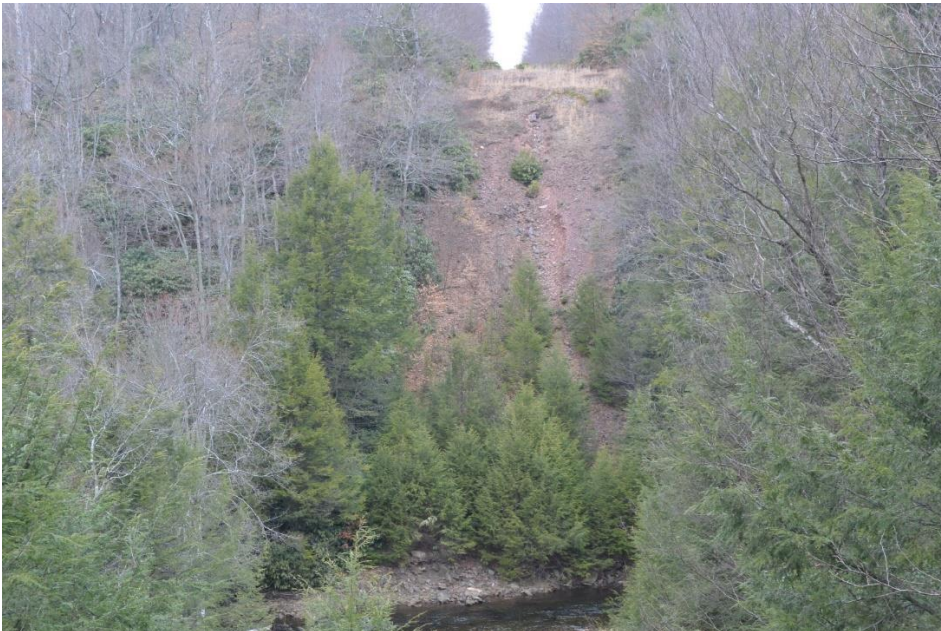
Figure 2: Looking in a north westerly direction along the Buckeye ROW. February 2017.

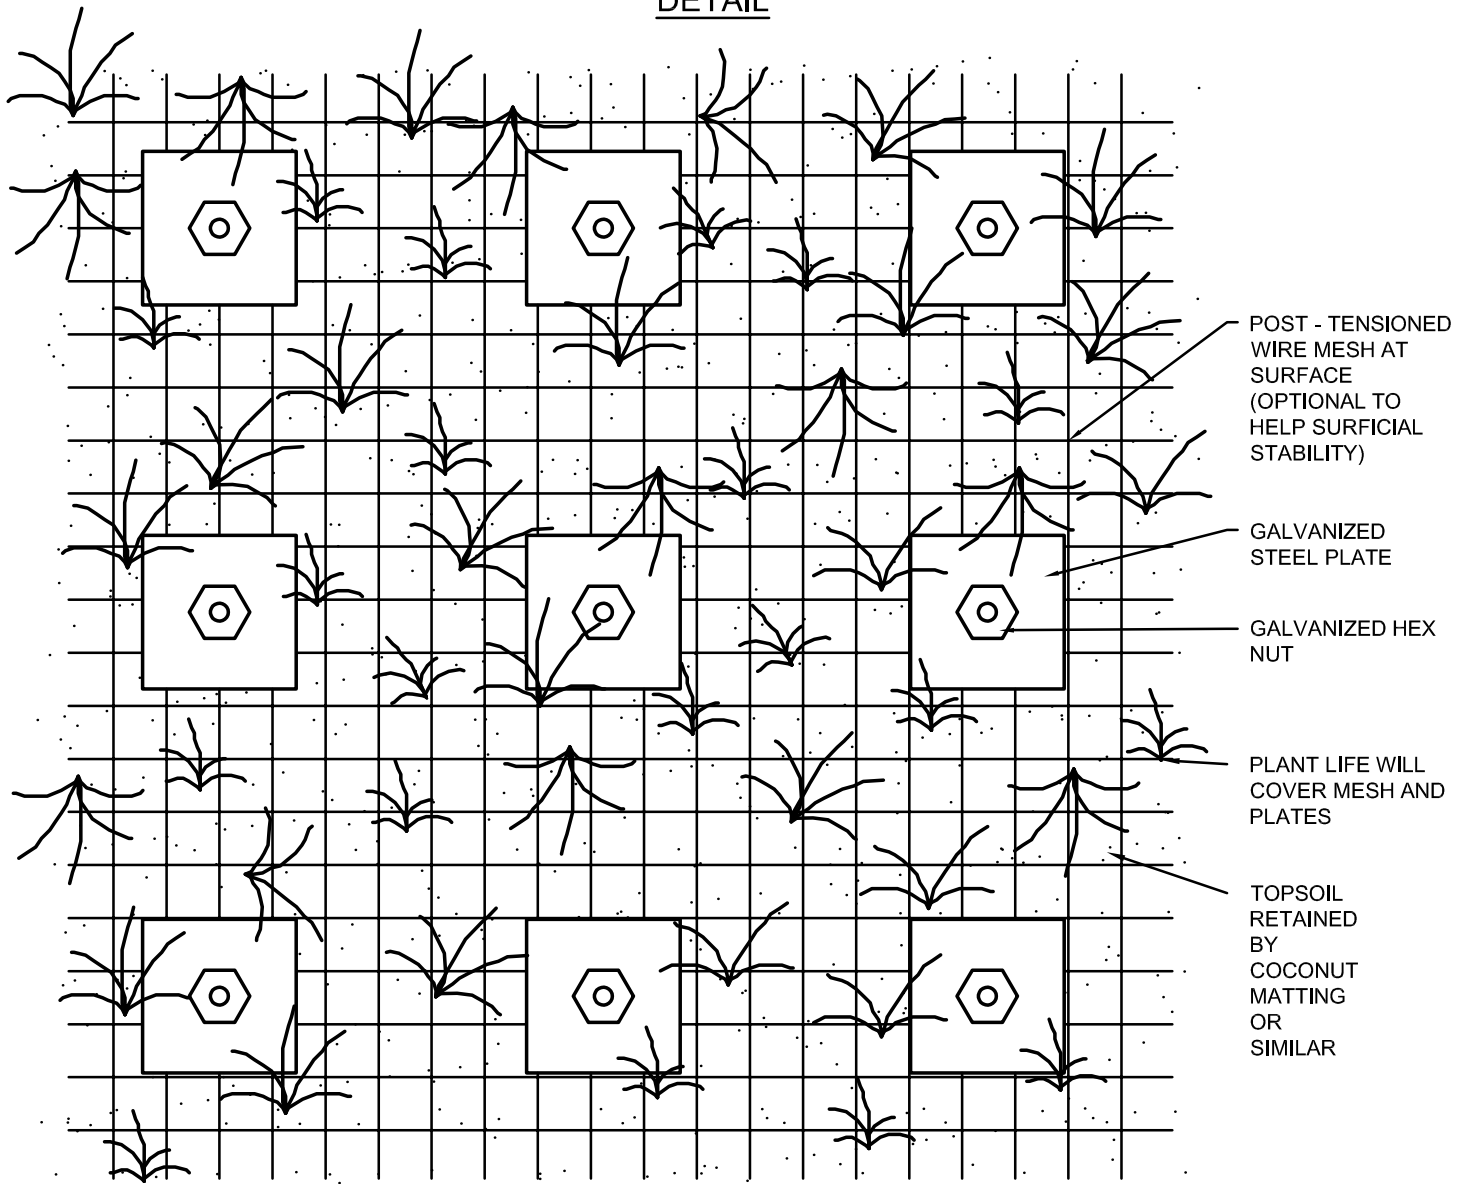
FIGURE 136A

**SOIL NAIL - WIRE MESH
DETAIL**

1. ROTATIONAL SLUMP.
2. SLOPE FAILURE WHICH CANNOT BE EXCAVATED DUE TO ASSETS ABOVE OR BELOW SLOPE.
3. INTENT IS TO SECURE UNSTABLE SOILS BACK INTO STABLE SOILS/ROCK DEEP WITHIN THE SLOPE.

See Figures 136, 136A & 136B of the geohazard mitigation plan for details depicting Provision A.
