Adelphia Gateway Project

Void Mitigation Plan for Karst Terrain and Underground Mining

May 2020

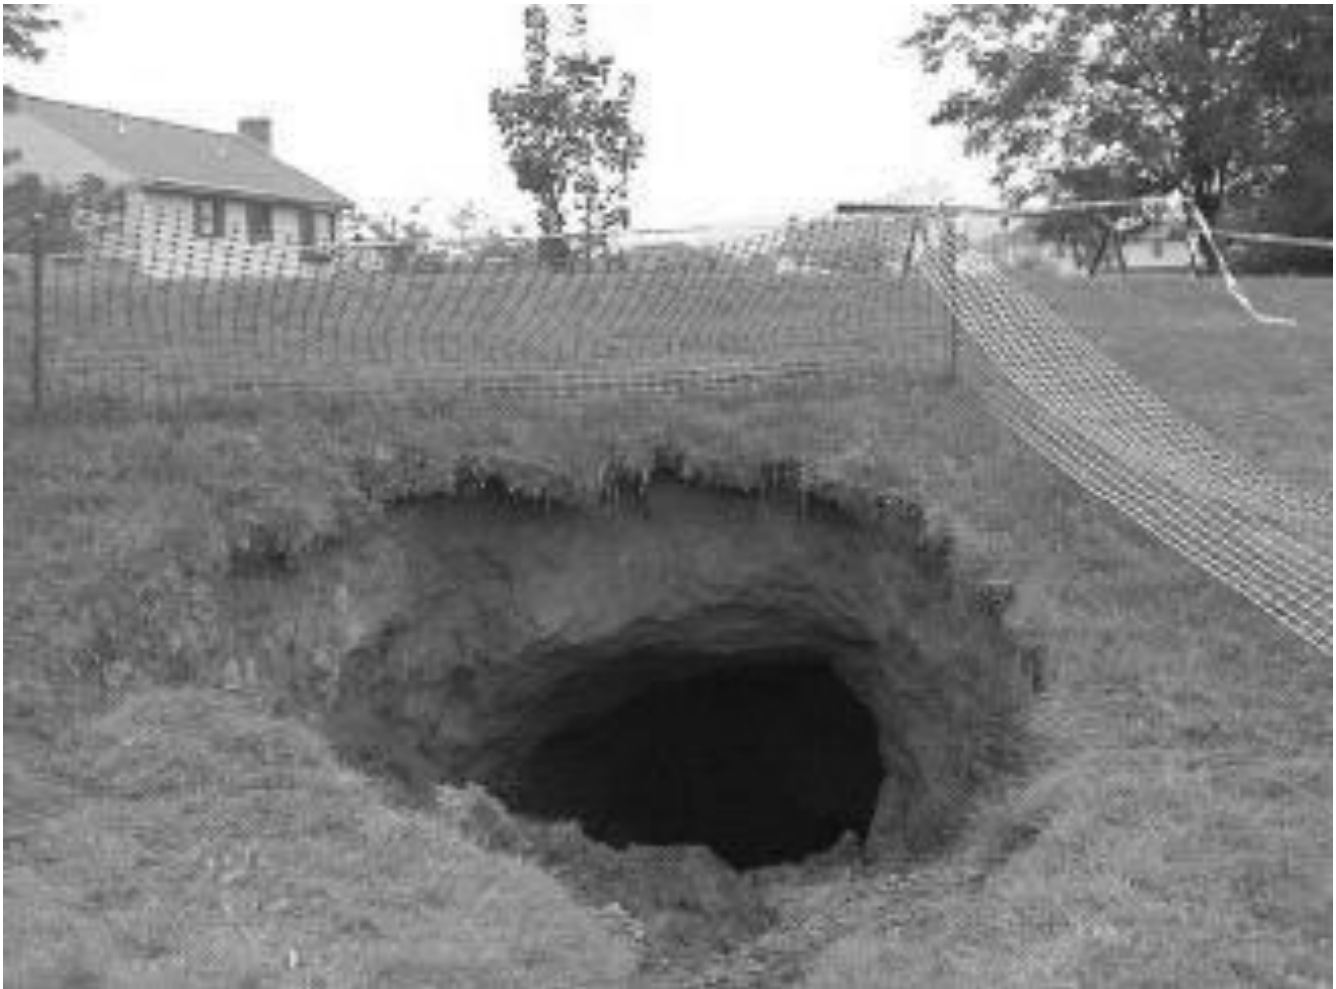
SINKHOLE REPAIR

Sinkholes vary greatly in size and nature. Therefore, specific methods of repairing sinkholes will depend on site conditions including but not necessarily limited to:

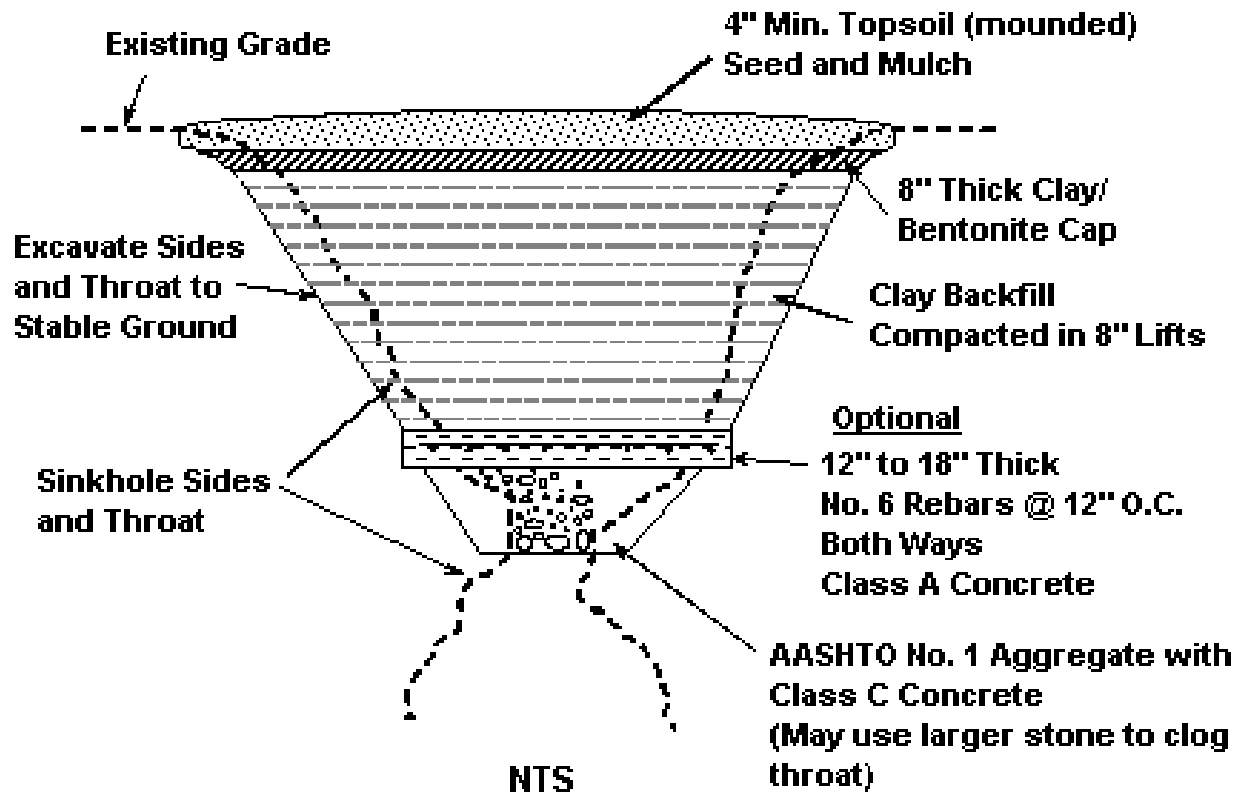
FIGURE 17.1
Sinkhole Repair with a Bentonite Cap

Loose material shall be excavated from the sinkhole and expose solution void(s) if possible. Enlarge sinkhole if necessary to allow for installation of filter materials. Occupational Safety and Health Administration (OSHA) regulations must be followed at all times during excavation.

Stones used for the "bridge" and filters shall have a moderately hard rock strength and be resistant to abrasion and degradation. Shale and similar soft and/or non-durable rock are not acceptable.

Due to the variable nature of sinkholes, they should be repaired under the direct observation and supervision of a professional geologist or licensed geotechnical engineer. Figures 17.1 through 17.4 are provided as general guidelines for the repair of sinkholes. They may be modified as necessary to accommodate specific site conditions. Site specific sinkhole repair plans will be reviewed on a case-by-case basis.

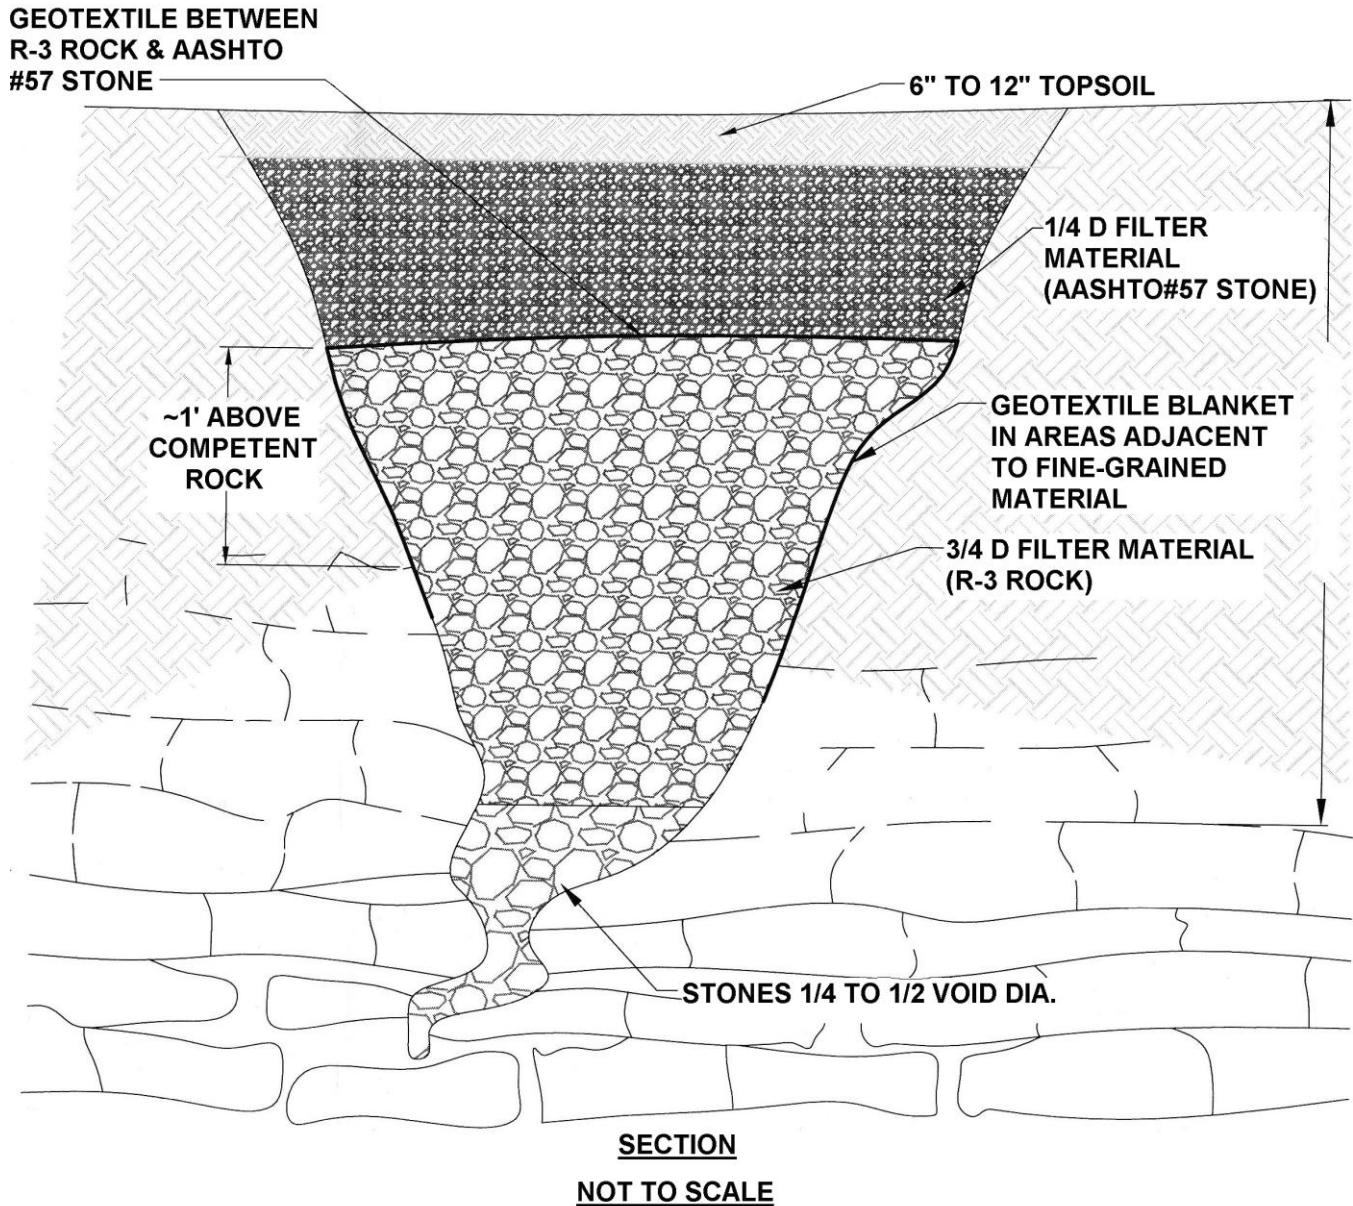
FIGURE 17.2
Sinkhole Repair with a Pervious Cover

Loose material shall be excavated from the sinkhole and expose solution void(s) if possible. Enlarge sinkhole if necessary to allow for installation of filter materials. OSHA regulations must be followed at all times during excavation.

Stones used for the "bridge" and filters shall have a moderately hard rock strength and be resistant to abrasion and degradation. Shale and similar soft and/or non-durable rock are not acceptable.

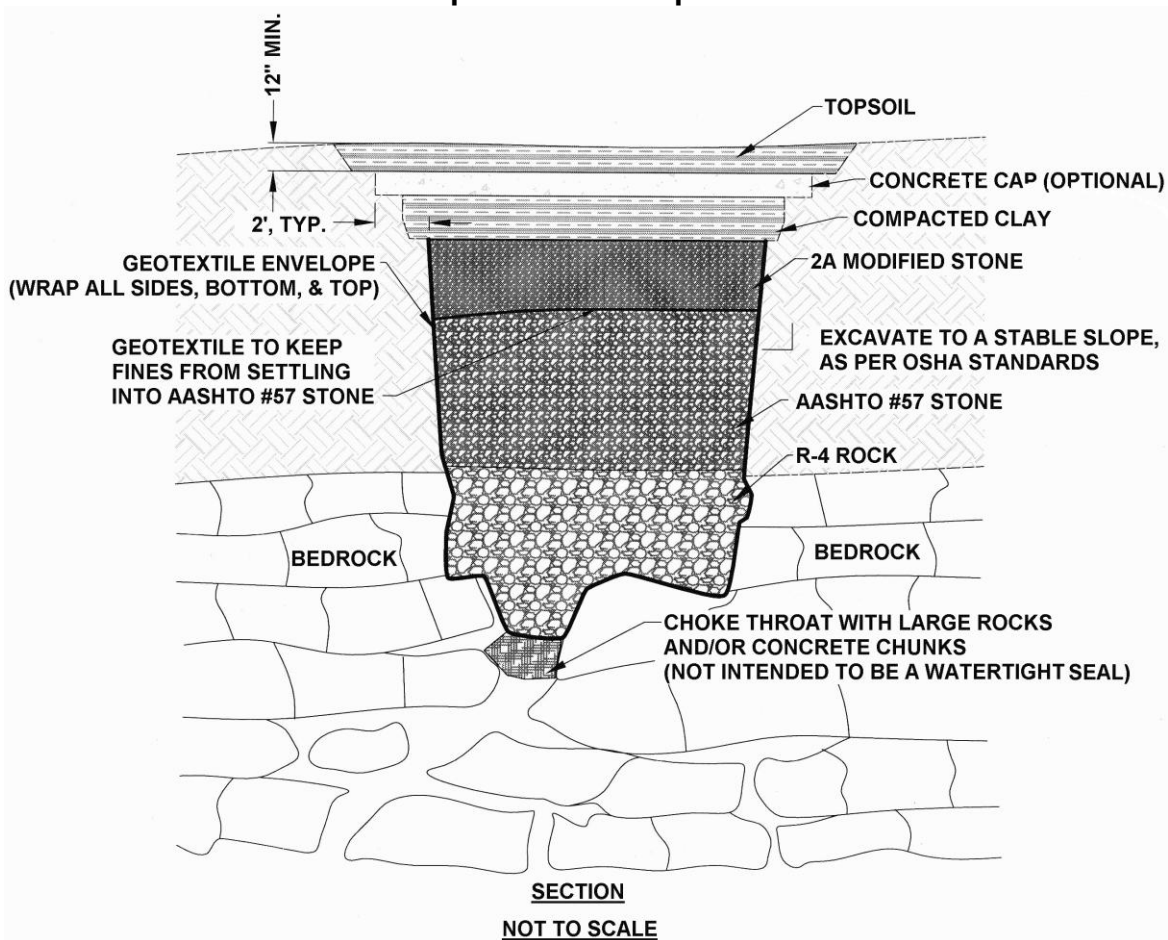
FIGURE 17.3
Sinkhole Repair with an Impervious Cover

Loose material shall be excavated from the sinkhole and expose solution void(s) if possible. Enlarge sinkhole if necessary to allow for installation of filter materials. OSHA regulations must be followed at all times during excavation.

Geotextile shall be non-woven with a burst strength between 100 and 200 psi.

Select field stone(s) about 1.5 times larger than solution void(s) to form “bridge.” Place rock(s) so no large openings exist along the sides. Stones used for the “bridge” and filters shall have a moderately hard rock strength and be resistant to abrasion and degradation. Shale and similar soft and/or non-durable rock are not acceptable.

Topsoil shall be a minimum of 12” thick. Grade for positive drainage away from sinkhole area.

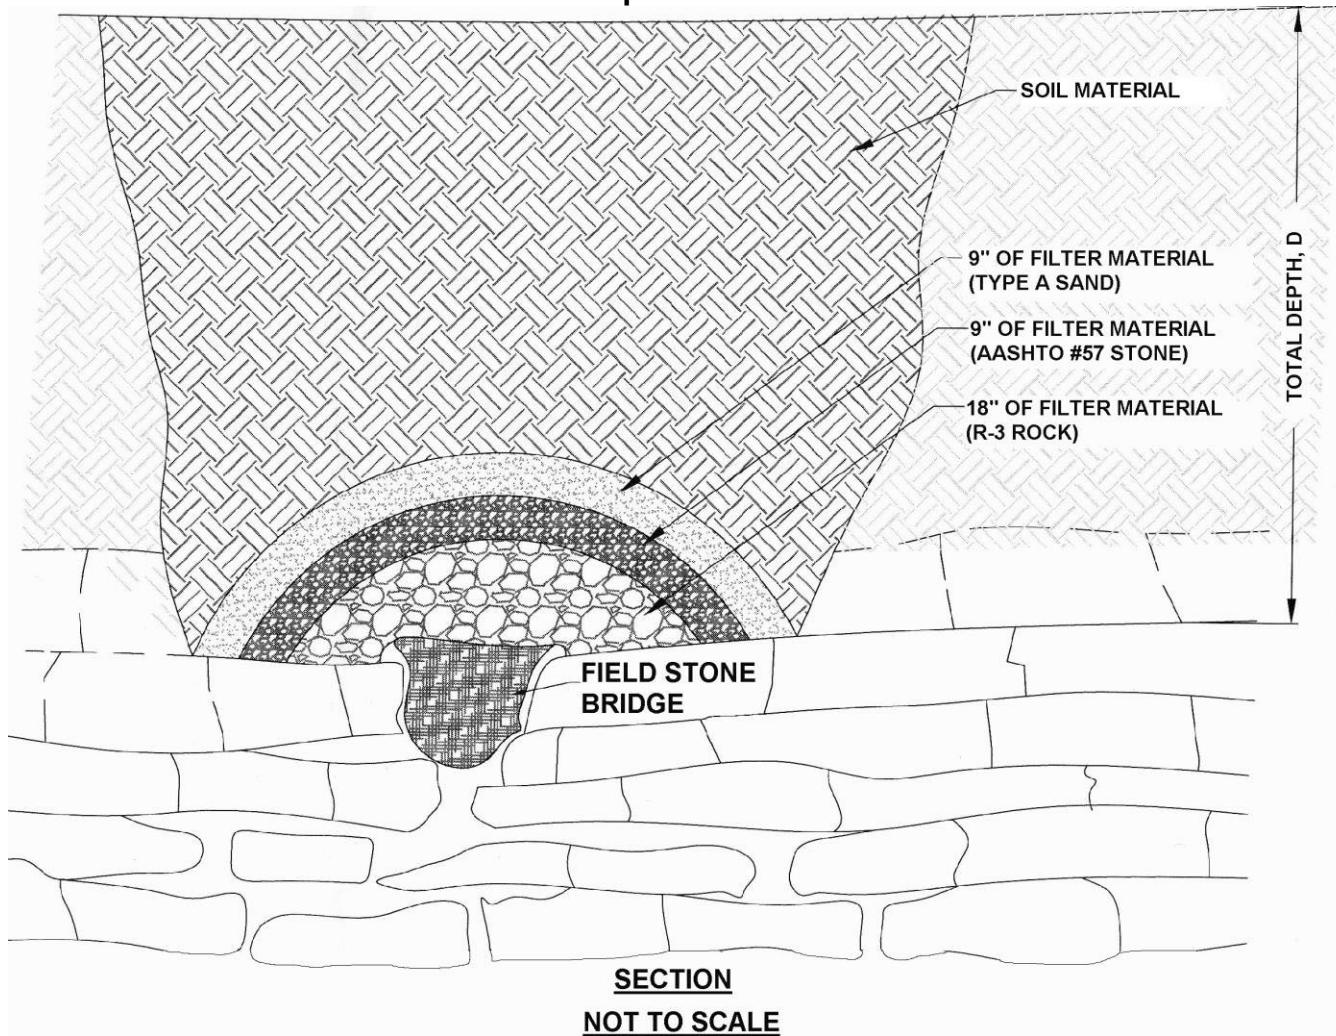
FIGURE 17.4
Sinkhole Repair with Soil Cover

Loose material shall be excavated from the sinkhole and expose solution void(s) if possible. Enlarge sinkhole if necessary to allow for installation of filter materials. OSHA regulations must be followed at all times during excavation.

Select field stone(s) about 1.5 times larger than solution void(s) to form "bridge." Place rock(s) so no large openings exist along the sides. Stones used for the "bridge" and filters shall have a moderately hard rock strength and be resistant to abrasion and degradation. Shale and similar soft and/or non-durable rock are not acceptable.
