Sľ	ΤE	PL	AN

2248-C-20

QUARRY DISCHARGE OUTLET PROJECT

Plate 3

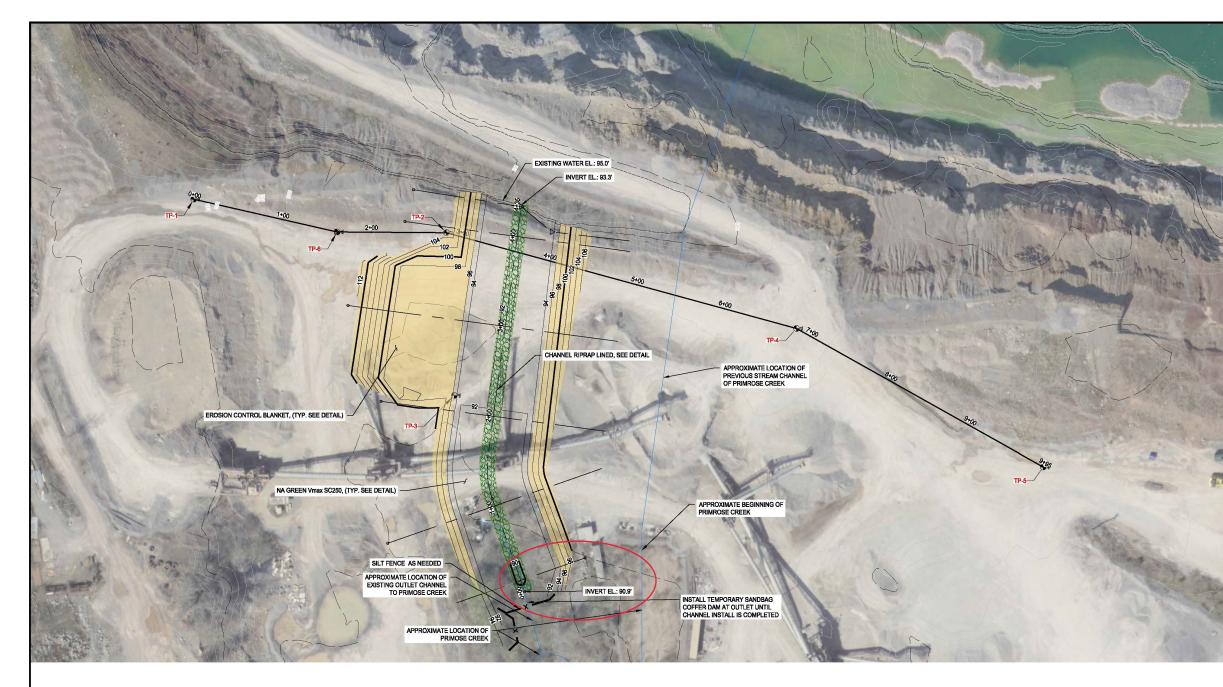
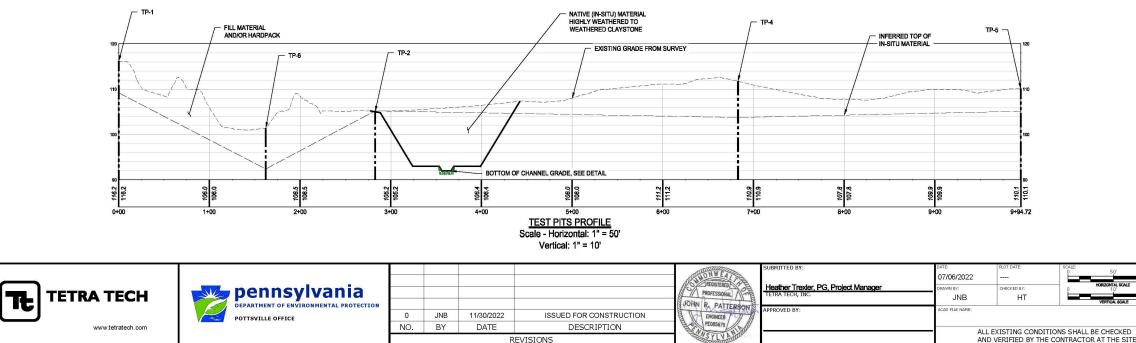
AERIAL IMAGERY SHOWN IS PER PASDA LIDAR MAPPING DATED 2018. THE LATEST POND ELEVATION IS AT APPROXIMATELY ELEVATION 95, WHICH IS NOT SHOWN ON THE AERIAL IMAGE.

3. TEST PIT LOCATIONS SHOWN WERE VISUALLY IDENTIFIED.
