# PA DEP Small Drinking Water Systems Engineering Services Services Program (ESP) Case Study

Client Name: Hazel Hurst Water Company  
Location: McKean County, Pennsylvania  
Project Name: Well Development and Treatment Upgrades

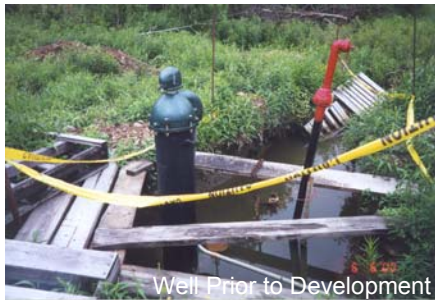
Well Prior to Development

The HHWC decided to drill an emergency well, the Marvin Creek Well, to supply water to the system. Pump tests indicated a rate of 60 gallons per minute (gpm) could be obtained from the well, which would provide more than sufficient quantities to meet the system's demand. However having depleted their financial resources, HHWC could not proceed with development of the new source.

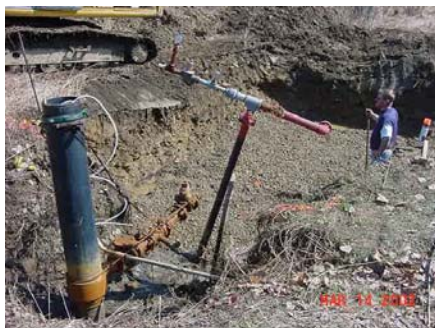
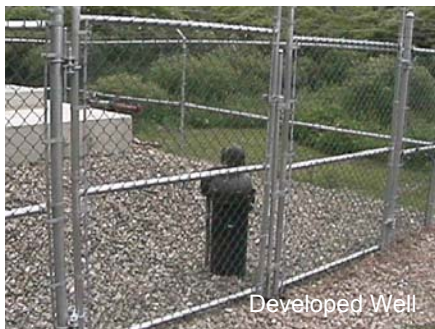
Developed Well

- The design included changes to the treatment process based on the water quality of Marvin Creek Well, adding a sequestering agent for manganese and a disinfection system utilizing sodium hypochlorite. A potential taste and odor problem caused by the presence of hydrogen sulfide was addressed through the installation of a diffused aeration system in the storage tank.

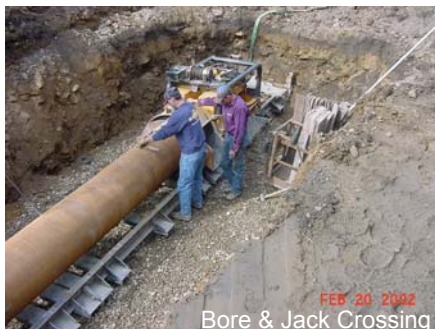
Bore & Jack Crossing

The Marvin Creek Well Development Project which included installation of a 3-inch PVC dedicated transmission pipe from the well to the existing treatment building was designed. The design included a bore and jack crossing of Historic Route 6.
