RESTORING THE BENNETT BRANCH SINNEMAHONING CREEK, CLEARFIELD AND ELK COUNTIES, PENNSYLVANIA¹

Eric E. Cavazza², P.E., and Richard L. Beam, P.G.

Abstract. Since 2004, the Pennsylvania Department of Environmental Protection (PA-DEP), Bureau of Abandoned Mine Reclamation (BAMR) has been working with multiple partners to restore water quality and reclaim abandoned mines in the Bennett Branch Sinnemahoning Creek. The primary water quality problems in the watershed are the result of uncontrolled and untreated discharges of acid mine drainage (AMD) from abandoned mine lands (AML) that have severely degraded the water quality in the lower 53.1 kilometers (33 miles) of the Bennett Branch and many of its tributaries. The primary objective of the Bennett Branch Restoration Project is to develop and implement a detailed mine drainage abatement and abandoned mine reclamation plan. The goals of the plan are to restore water quality in the main stem of the Bennett Branch, improve water quality in the AMD impacted tributaries, and maximize the reclamation of AML throughout the watershed. The restoration work is being pursued in conjunction with the PA Wilds Initiative which advocates economic dev

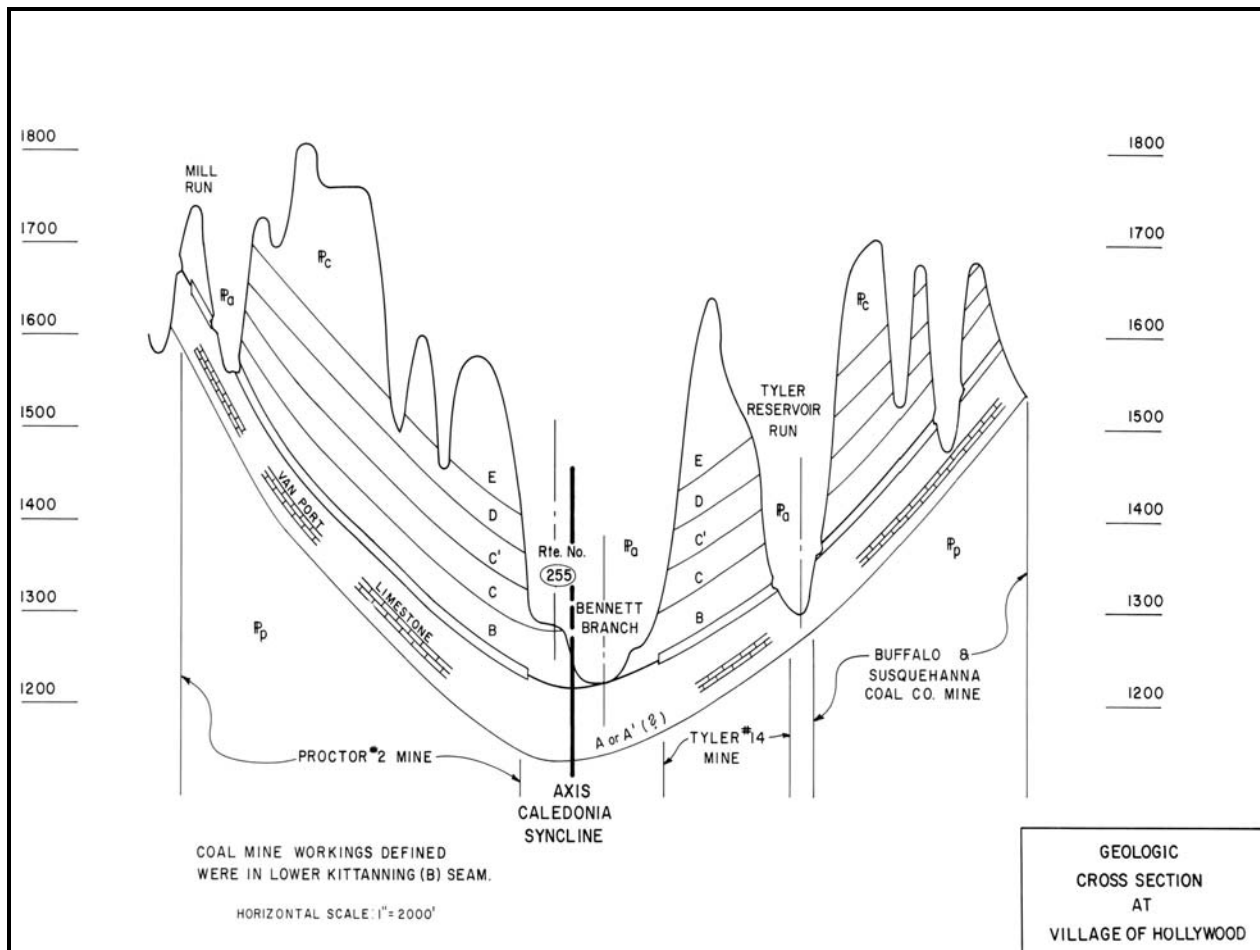
Figure 5. Cross section across the Bennett Branch stream valley near the village of Hollywood (Source: Berger 1976).

The main structural geologic feature within the watershed is the Caledonia Syncline. The Bennett Branch flows in a direction more or less parallel to the axis of this syncline, but in an opposite direction to the plunge (NE to SW) of the synclinal axis. Figure 5 is a cross section of the Bennett Branch stream valley near the village of Hollywood. Figure 6 is a profile along the axis of the Caledonia Syncline showing the plunge in the opposite direction of the stream flow. Surface and subsurface drainage is primarily controlled by the geologic structure underlying the watershed. Most of the underground mines operated in the watershed were driven up-dip from the axis of the syncline. The dip of the coal seams averages 5 to 6 percent, but reaches as high as 10 percent.

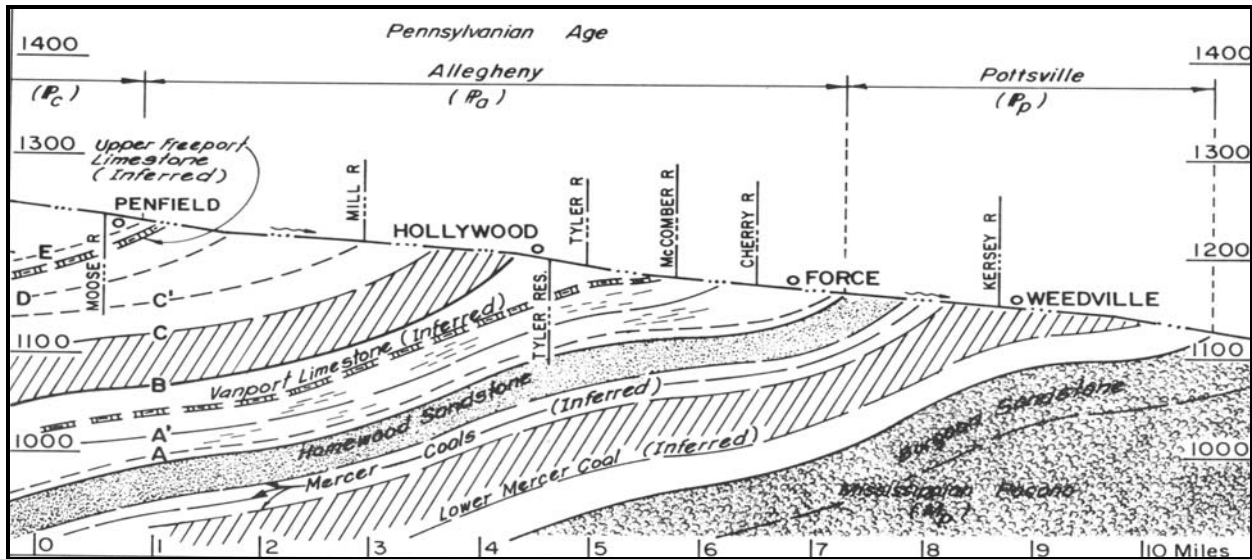
Figure 6. Profile along the axis of the Caledonia Syncline showing the plunge in the opposite direction of the stream flow (Source: Berger 1976).

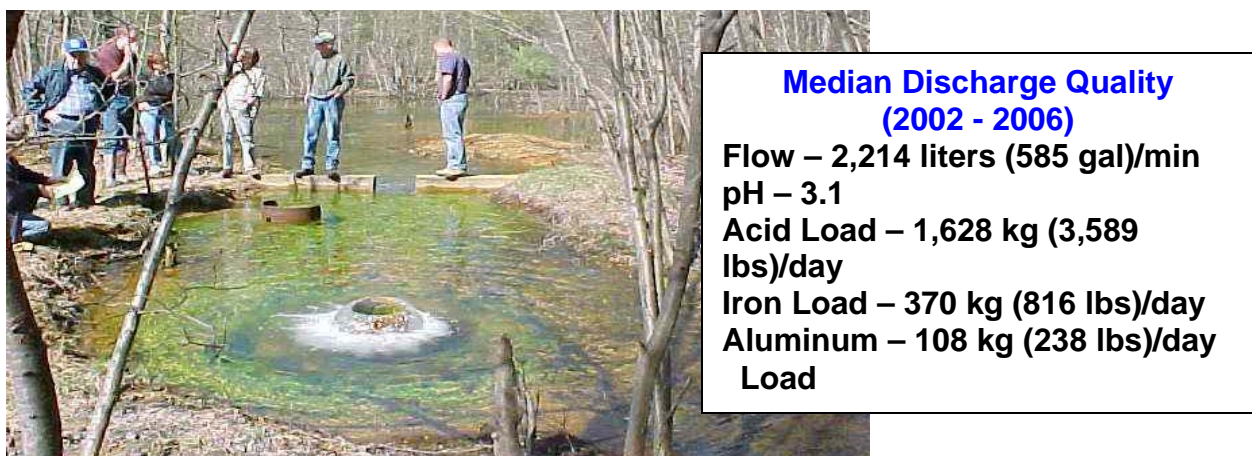
Figure 7. Mill Run Borehole discharges draining the Proctor No. 2 deep mine in Huston Township, Clearfield County.

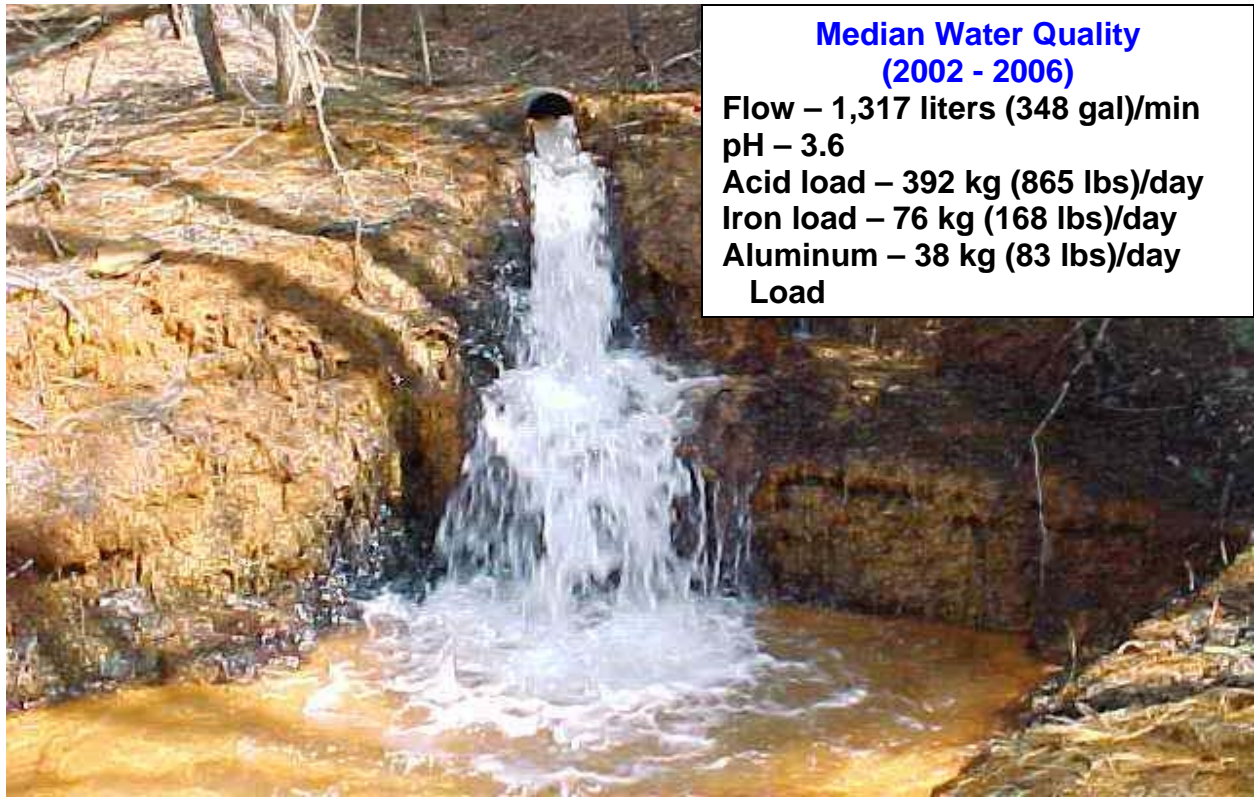
Figure 8. Deep mine discharge into Fridays Run in the Tyler Run Watershed near the village of Hollywood in Clearfield County.

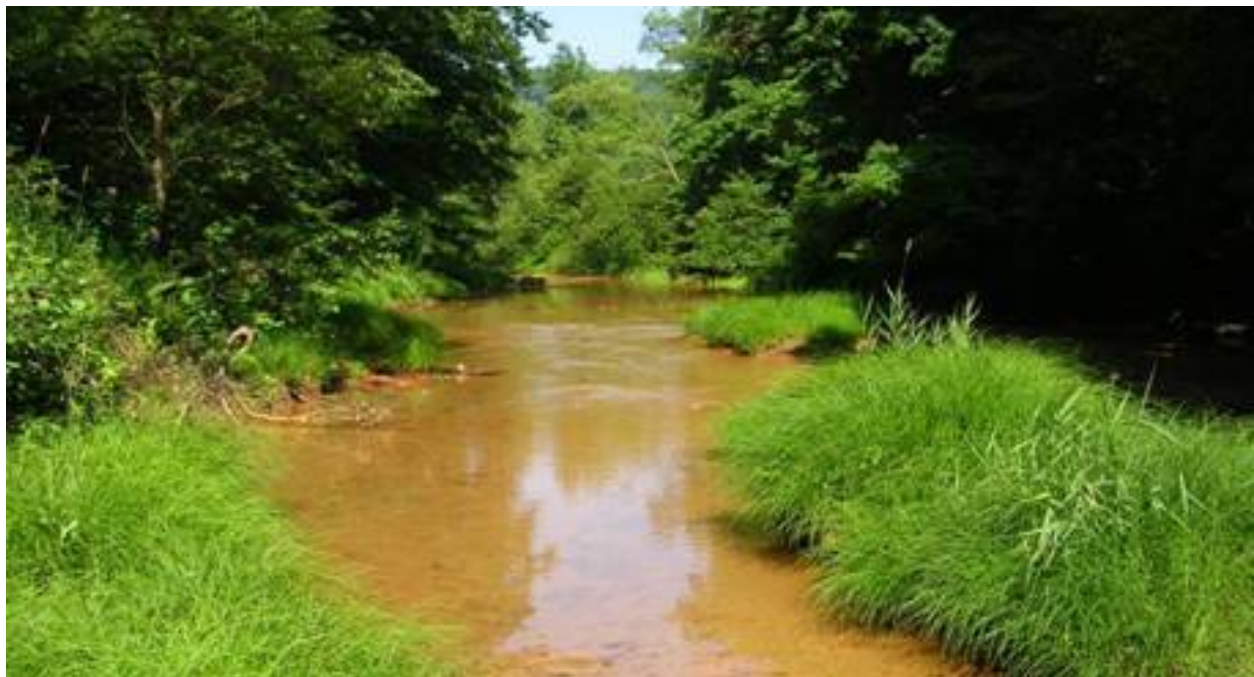
Figure 9. Bennett Branch downstream of the confluence with the Mill Run Borehole discharge in Huston Township, Clearfield County.

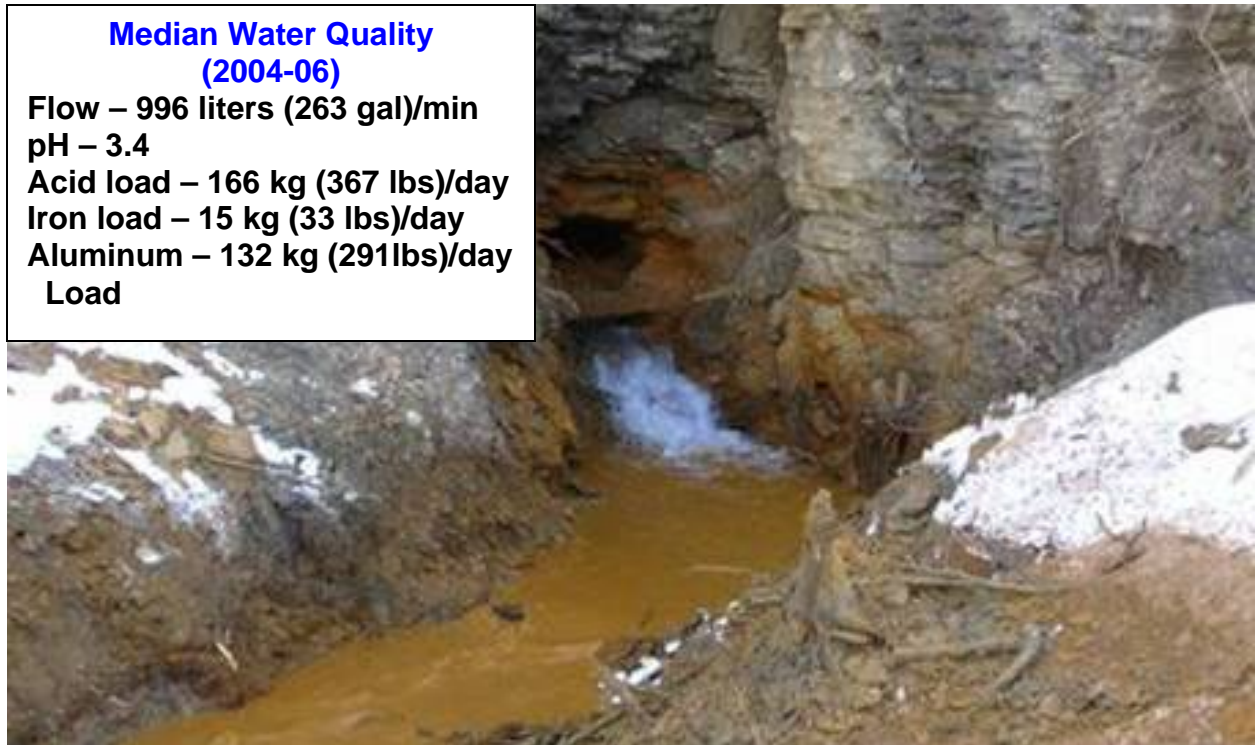
Figure 10. Deep mine discharge in the Caledonia Hollow Tributary impacting the mid-Bennett Branch stream valley, Jay Township, Elk County.

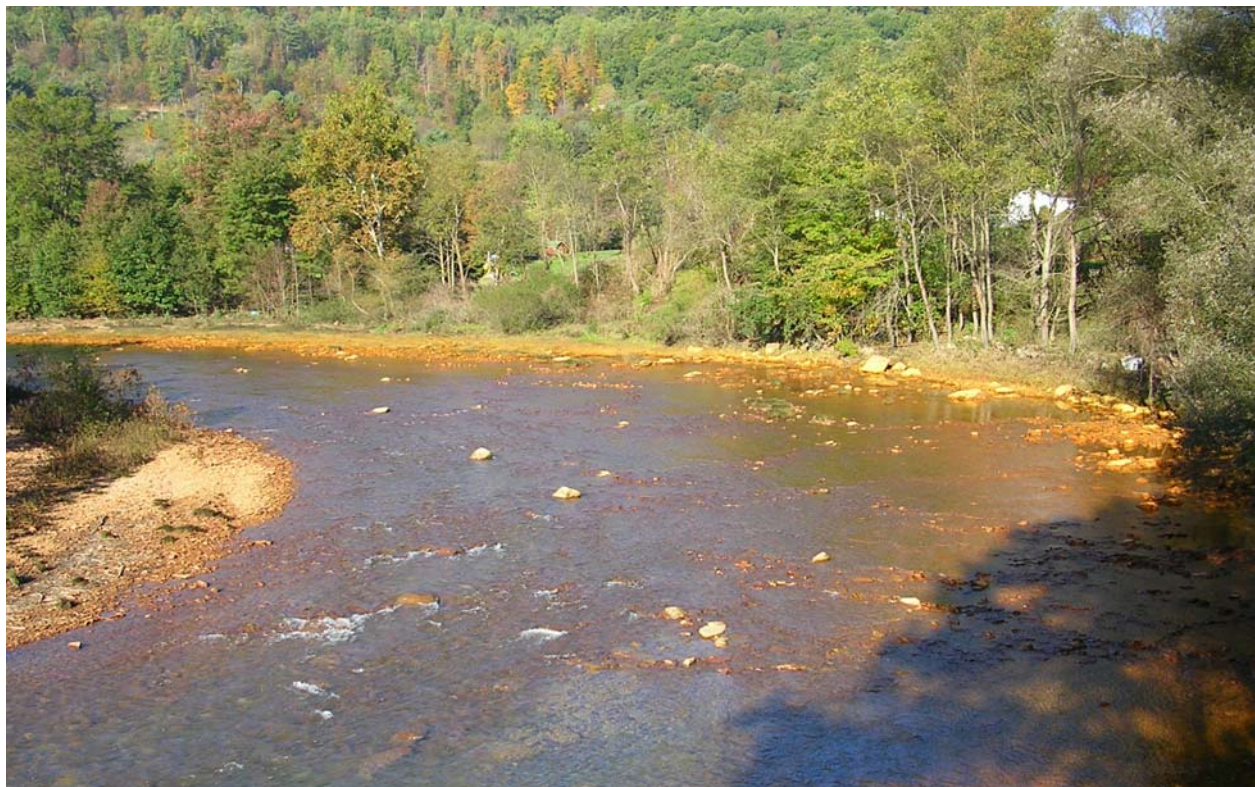
Figure 11. Bennett Branch stream valley near Caledonia in Jay Township, Elk County.

**Median Water Quality
(1993-2009)**

Flow – 397 liters (105 gal)/min

pH – 2.8

Acid load – 315 kg (694 lbs)/day

Iron load – 62 kg (136 lbs)/day

**Aluminum – 22 kg (49 lbs)/day
Load**

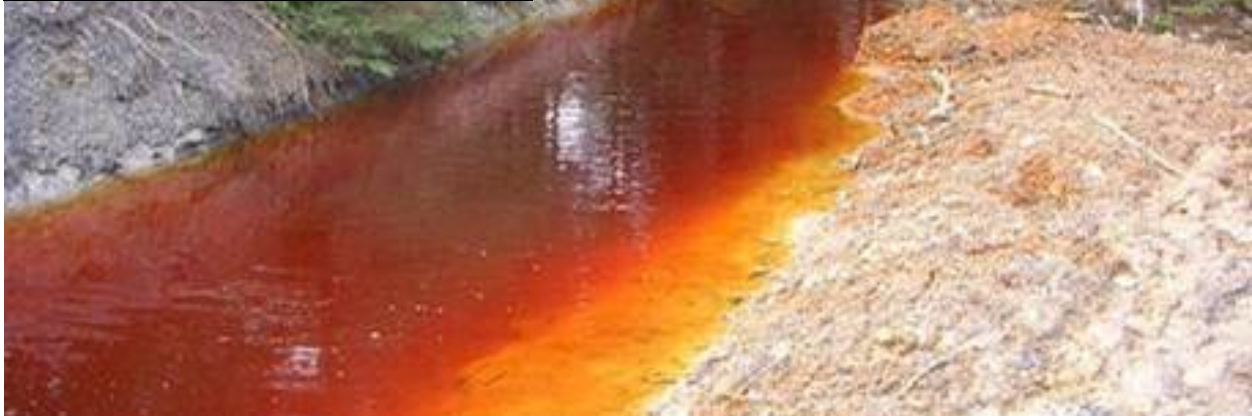
Figure 12. Deep mine discharge in the Porcupine Hollow Tributary of Dents Run impacting the lower Bennett Branch, Benezette Township, Elk County.

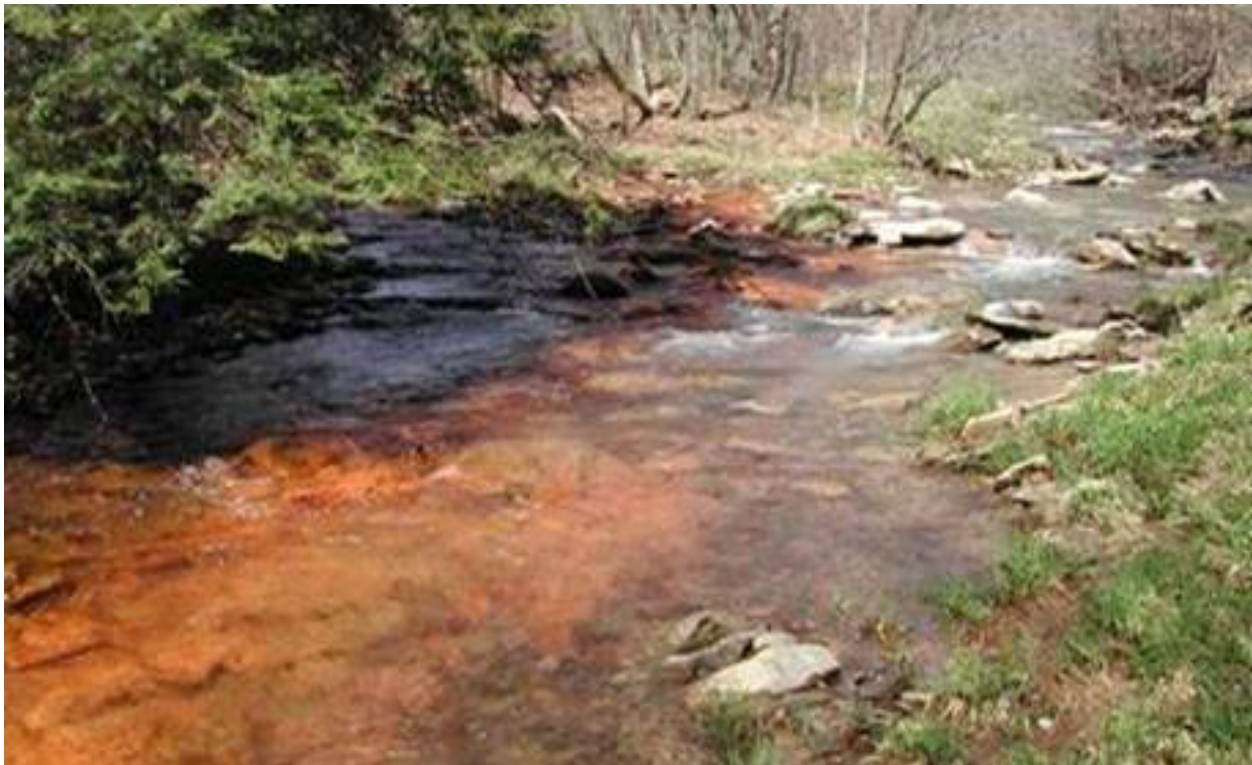
Figure 13. Confluence of Porcupine Run and Dents Run, Benezette Township, Elk County.

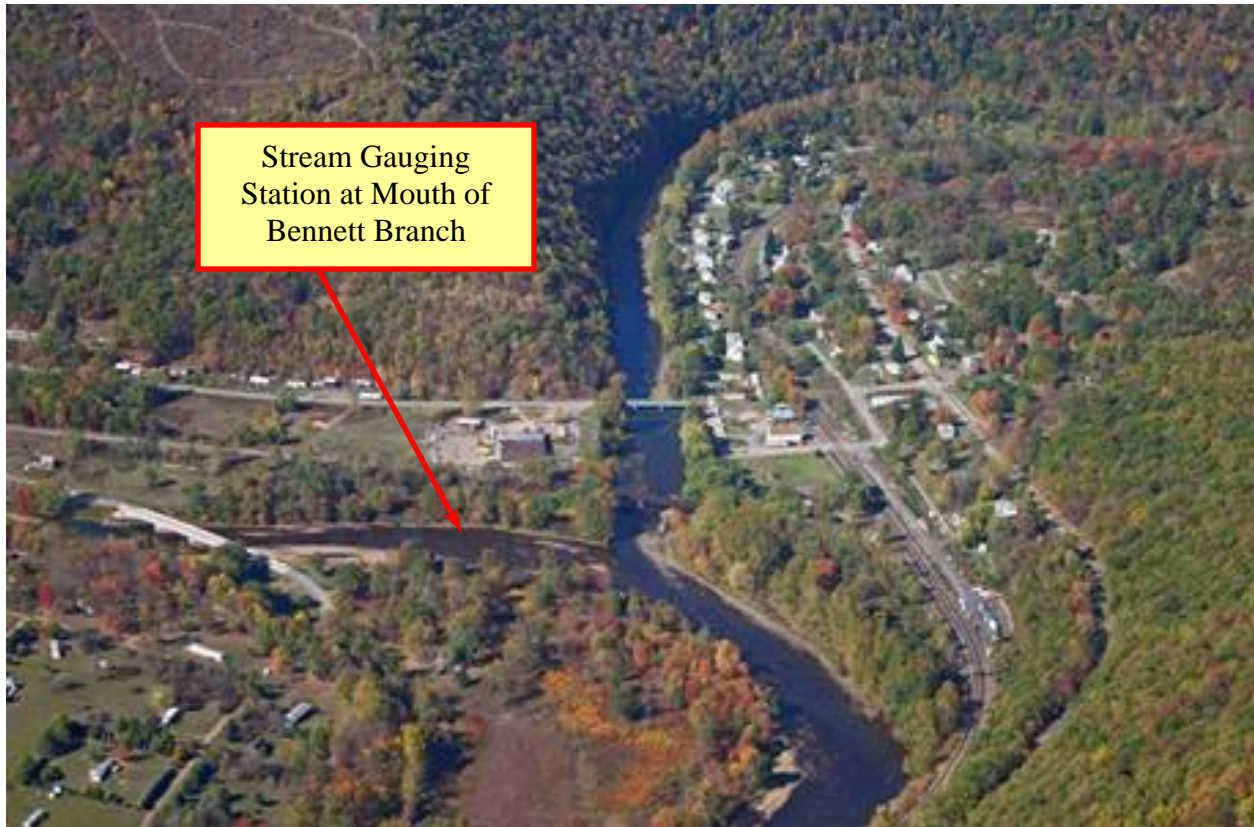
Figure 14. Confluence of the Bennett Branch with the Driftwood Branch to form Sinnemahoning Creek near the village of Driftwood, Gibson Township, Cameron County.

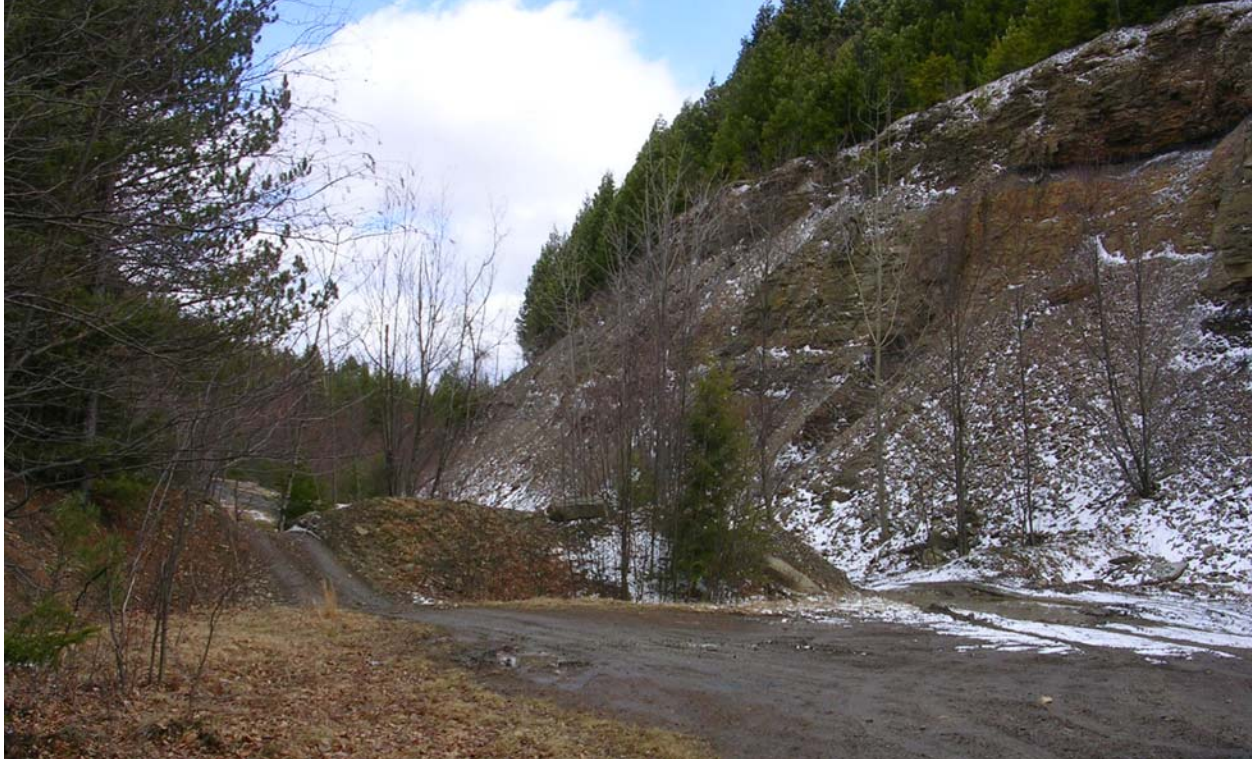
Figure 15. High-priority unreclaimed dangerous highwall located on State Game Lands in the Bennett Branch Watershed.

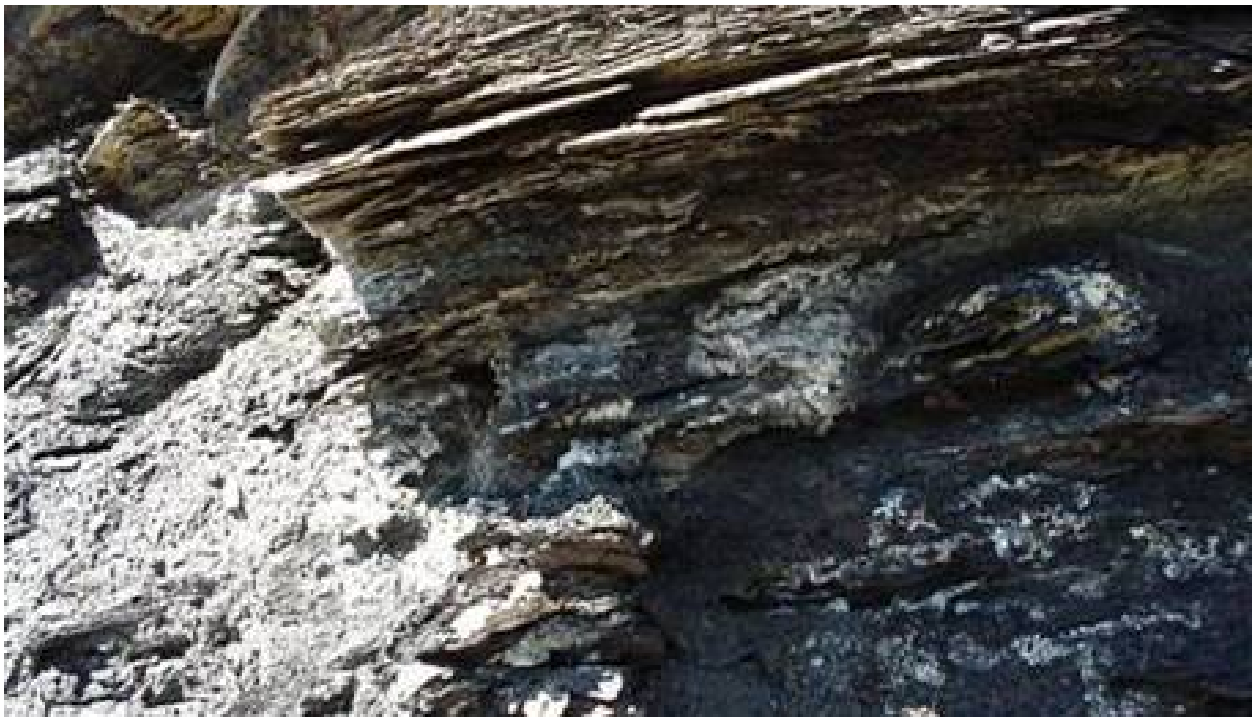
Figure 16. Sulfate salts crystallized on the rocks of an unreclaimed dangerous highwall located on State Game Lands No. 311 in the Bennett Branch Watershed.

The potential for remining, and/or refuse pile reprocessing was also evaluated. Several exploratory drilling projects were completed in cooperation with various coal companies to assess overburden quality, remaining coal resources, and groundwater conditions. Landowner contacts were made, and the potential for remining is actively being explored and pursued. The overburden analysis was used to determine alkaline addition application rates in accordance with both Pennsylvania and OSM guidelines (Brady et al. 1998). Alkaline addition is necessary to improve water quality for many of the AML sites due to the amount of acid forming materials present in the old spoil piles. Figure 15 shows example of one of the unreclaimed dangerous highwalls located in the Bennett Branch Watershed. Figure 16 shows sulfate salts crystallized on the rocks as a result of the weathering of the acid forming materials within the highwall at an unreclaimed surface mine located in the Bennett Branch Watershed.

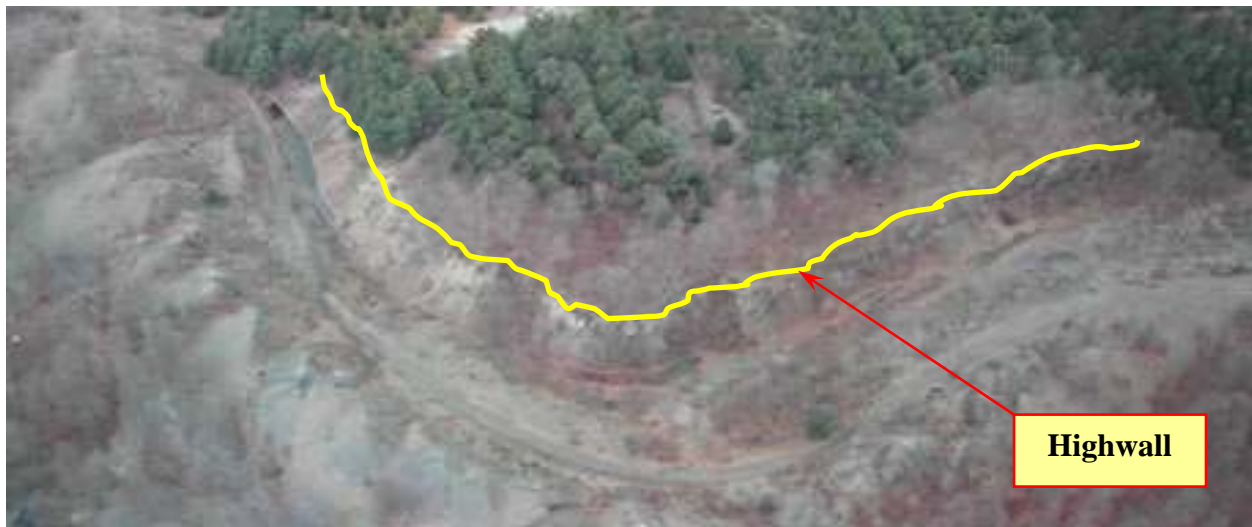
Figure 17. Aerial view of an abandoned surface mine on State Game Lands No. 311 in Benezette Township, Elk County prior to reclamation.

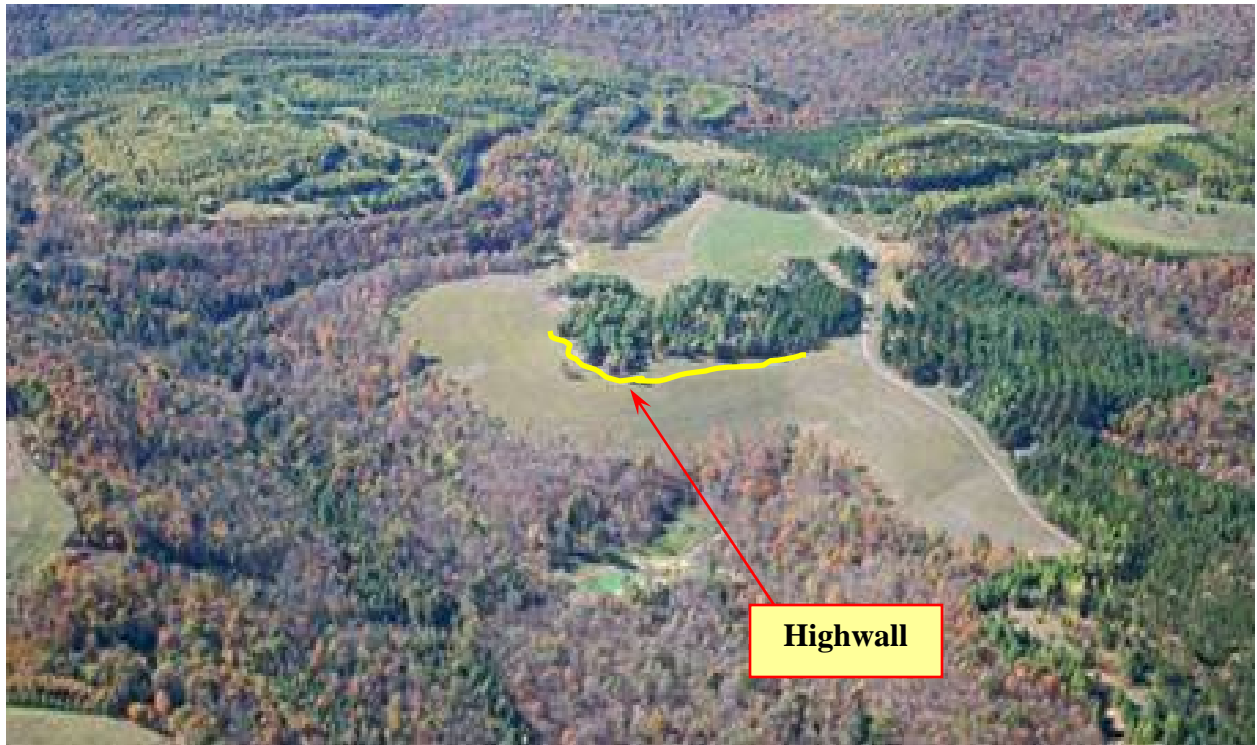
Figure 18. Aerial view of the same abandoned surface mine on State Game Lands No. 311 in Benezette Township, Elk County, following reclamation.

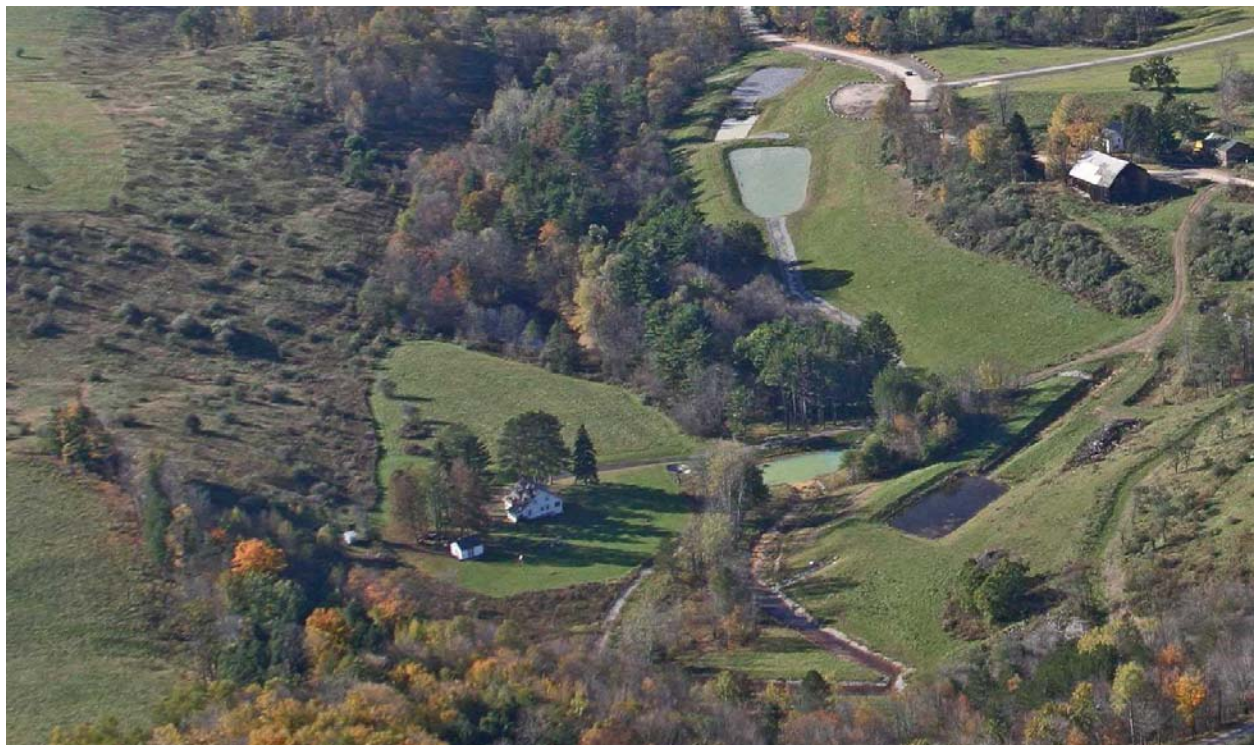
Figure 19. Completed passive mine drainage treatment system in the Porcupine Hollow Tributary of Dents Run.

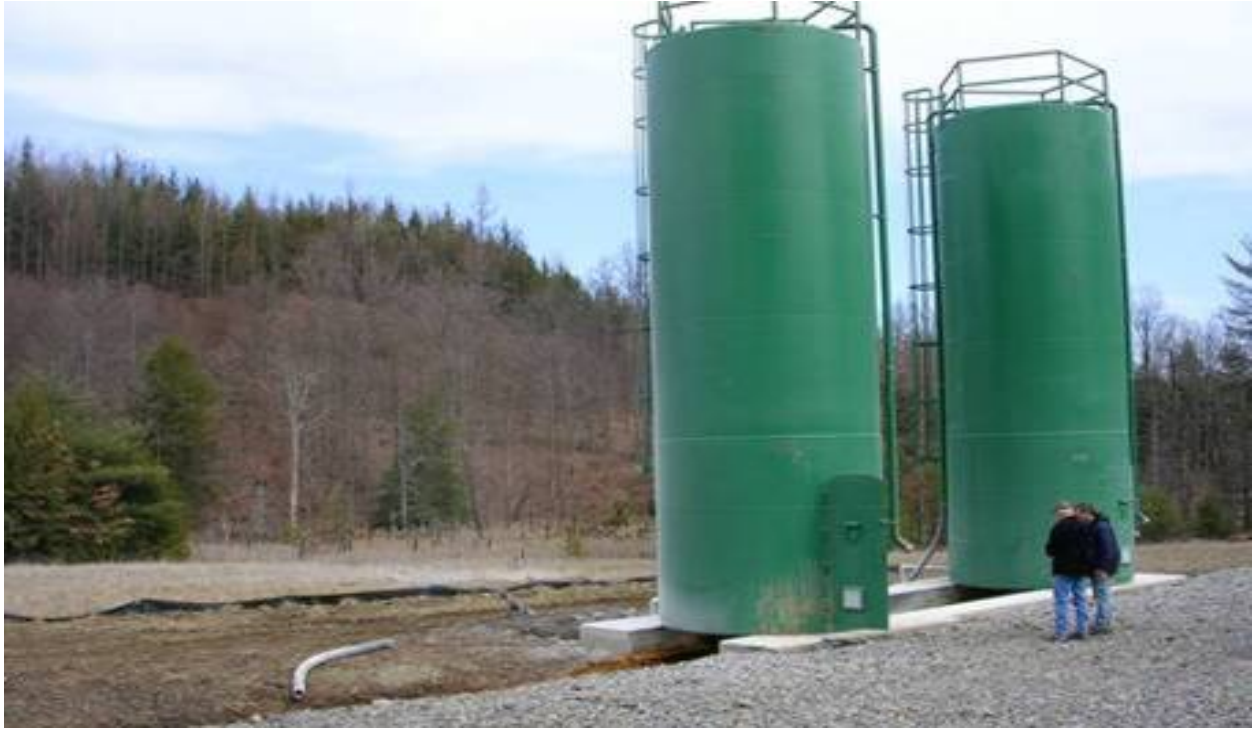
Figure 20. Lime silos for a tipping bucket lime doser treating another mine discharge in the Porcupine Hollow Tributary of Dents Run.

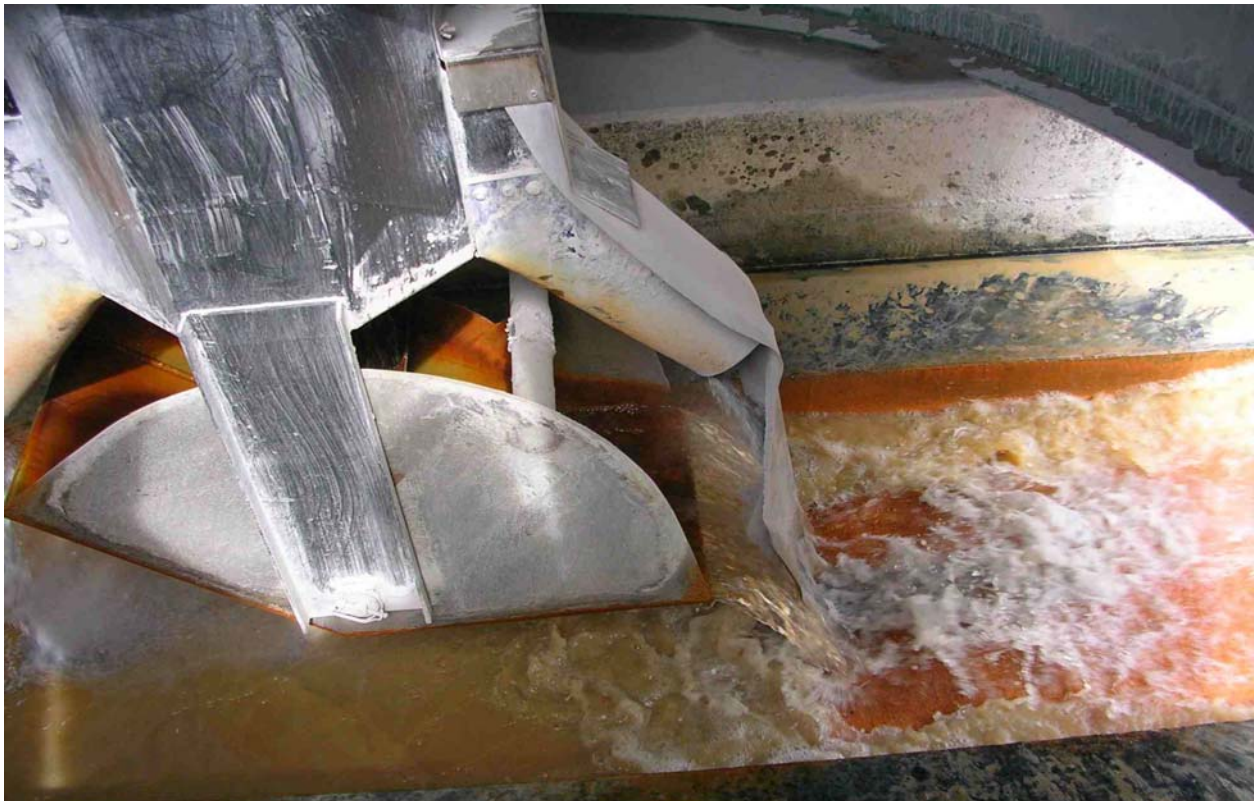
Figure 21. Tipping bucket mechanism dispensing lime to neutralize the highly acidic discharge.

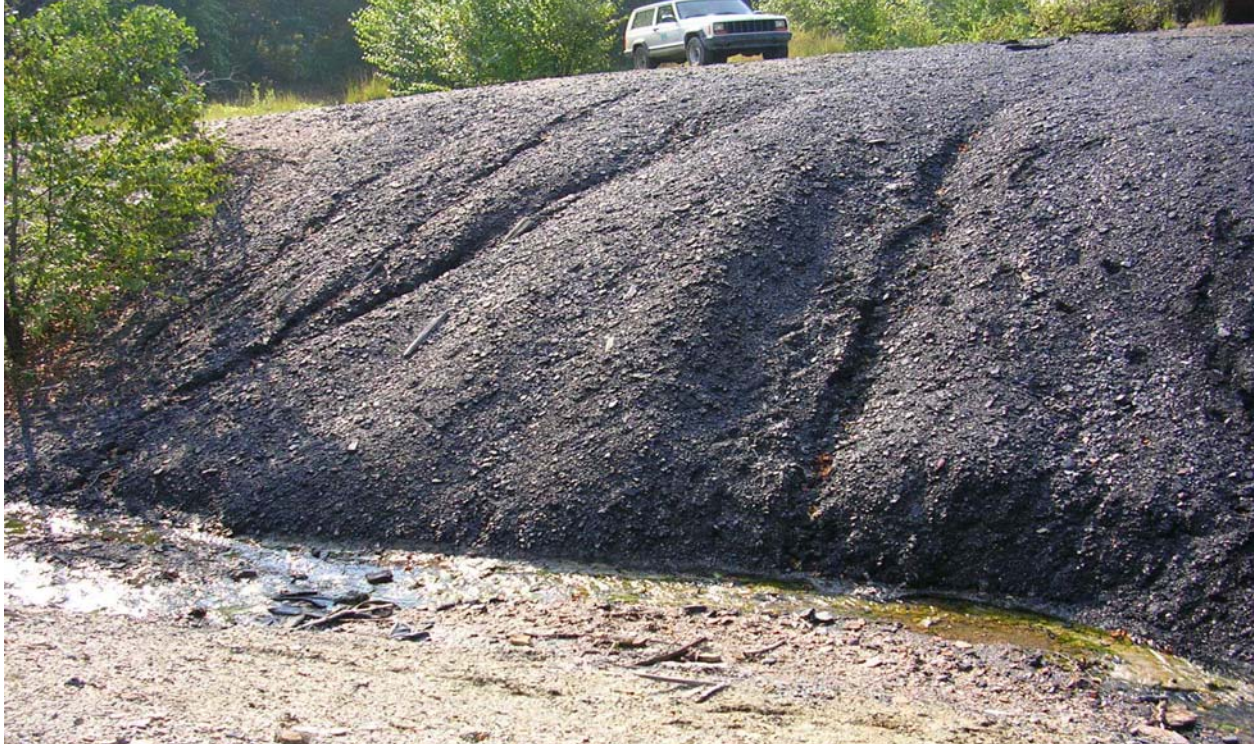
Figure 22. Refuse pile cast along Tyler Reservoir Run south of the village of Hollywood in Huston Township, Clearfield County.

Approximately 30 refuse piles located throughout the watershed were grab sampled at several points and analyzed for percent ash, Btu value, and percent sulfur. The results were compiled into an excel spreadsheet along with other site-specific data. The final report was made available to coal companies and cogeneration facilities to evaluate the potential for reprocessing each pile as a potential fuel source. Property owners for each were also identified and contacted to determine interest in having these piles reclaimed. Several refuse piles have been reprocessed and reclaimed at no cost to Pennsylvania's AML Program as a result of this effort and several other refuse piles are being considered for reprocessing by local coal companies. Figures 22 and 23 show two of the refuse piles located in the Bennett Branch Watershed.

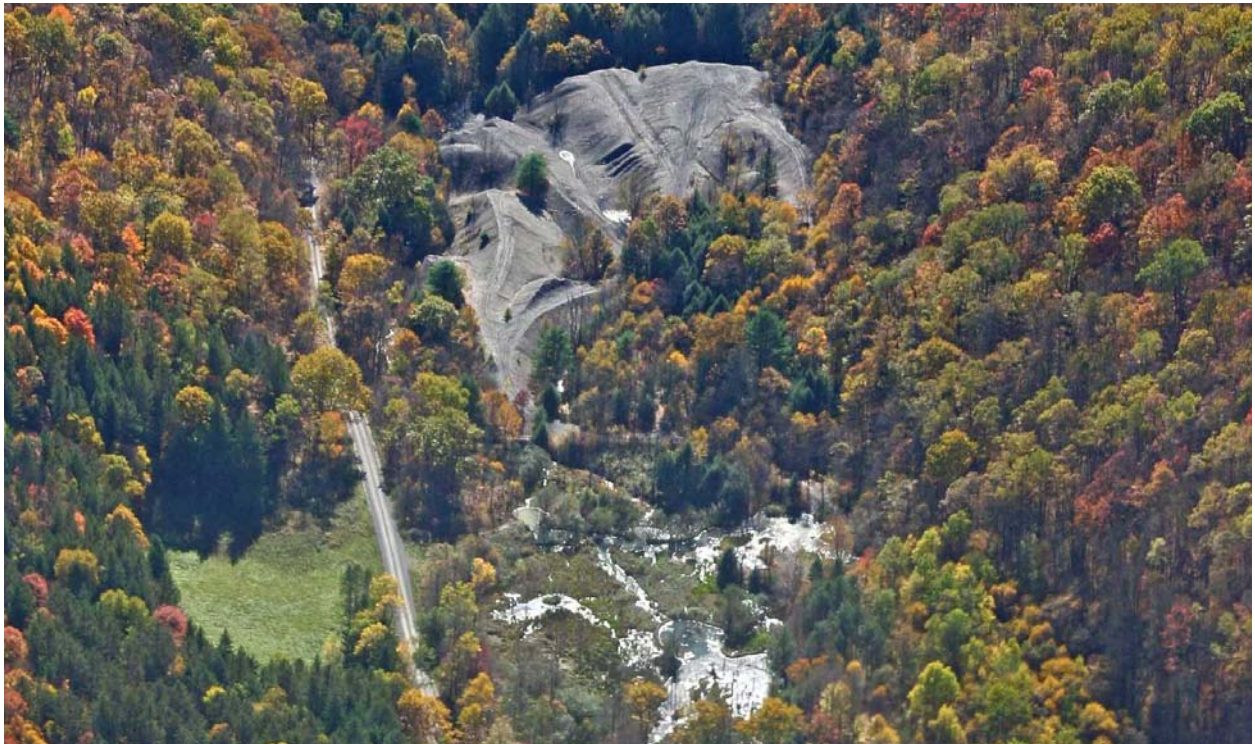
Figure 23. Refuse pile cast directly into stream valley near the headwaters of Mill Run in Fox Township, Elk County.

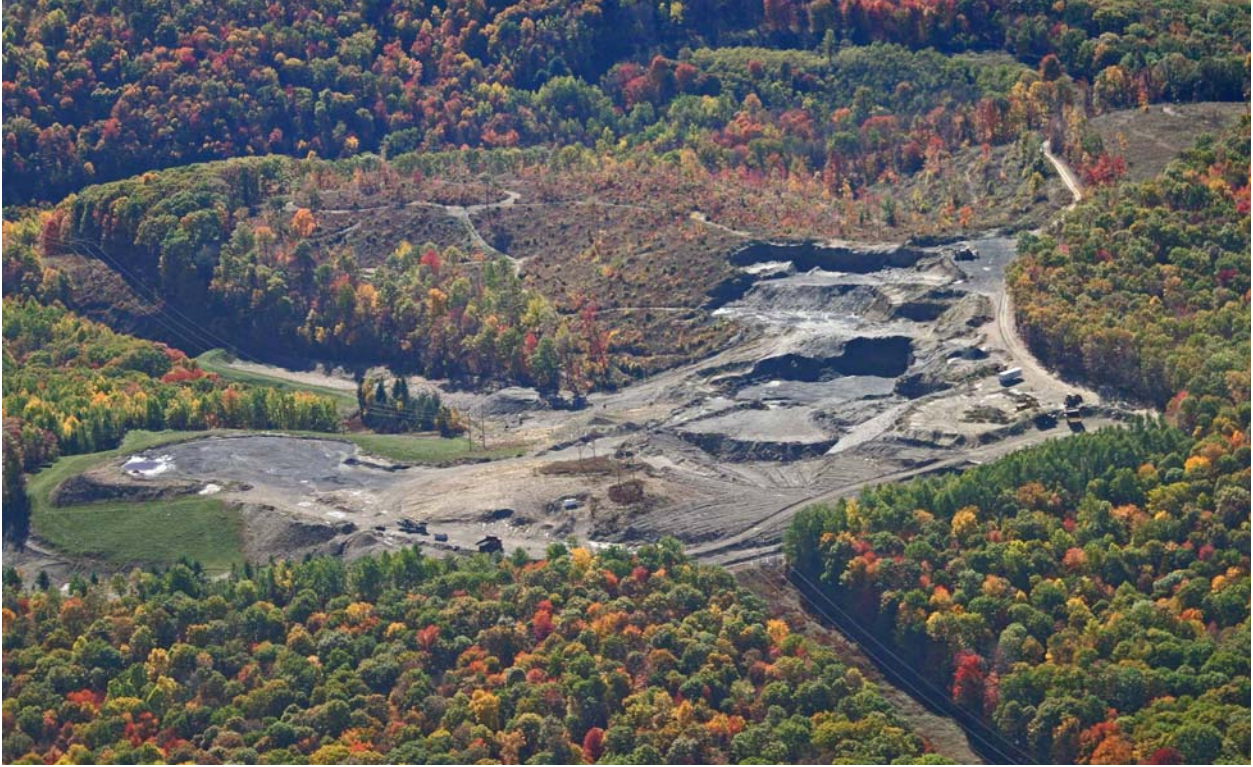
Figure 24. Amfire Mining Company surface mine in the Mill Run Tributary to Bennett Branch in Huston Township, Clearfield County.

Contacts with a number of coal companies with various surface or mineral interests in the area were completed, and meetings were held to jointly evaluate remining potential at several AML sites. Opportunities for partnering with the active mining industry are being pursued to maximize reclamation and watershed restoration, and to reduce overall project costs. Figures 24 through 26 show various remining operations currently being conducted within the Bennett Branch Watershed. To date, the active mining industry has completed restoration or reclamation work that totals more than 15 percent of the total estimated cost of implementing the Bennett Branch restoration plan. Additional partnering is expected to increase the contribution of the active mining industry to the restoration effort.

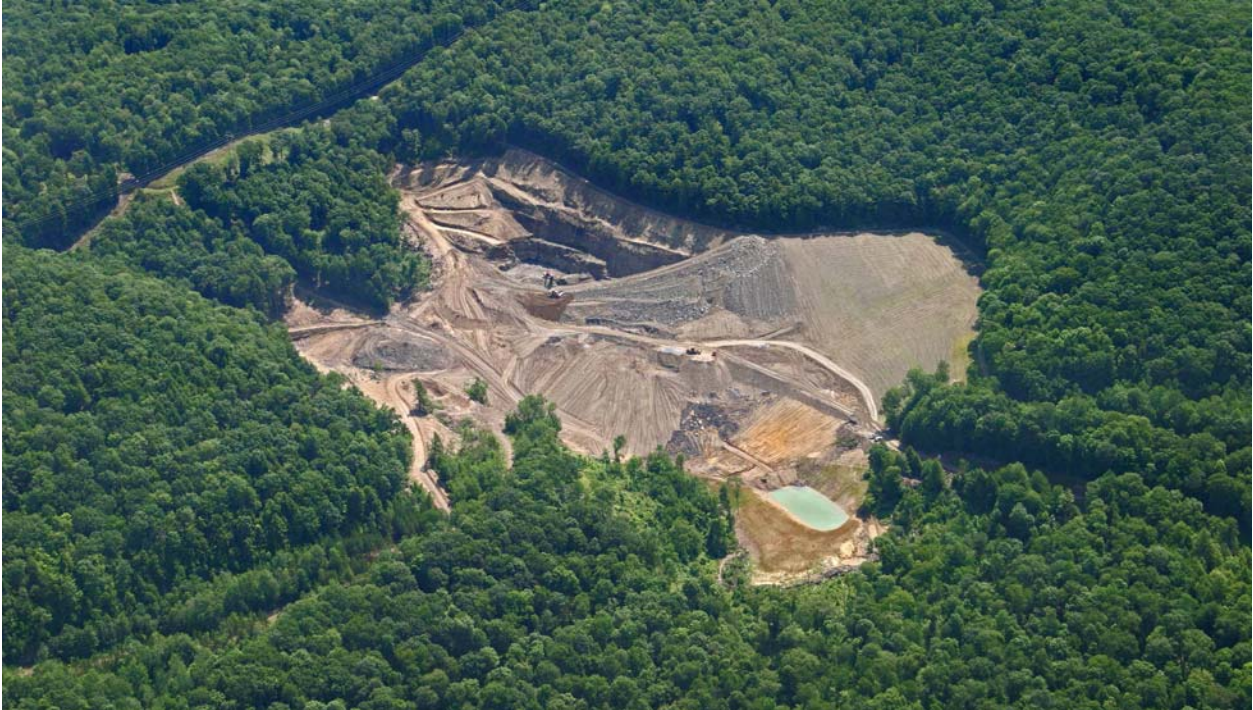
Figure 25. Waroquier Coal Company surface mine in the Caledonia Run Tributary to Bennett Branch in Jay Township, Elk County.

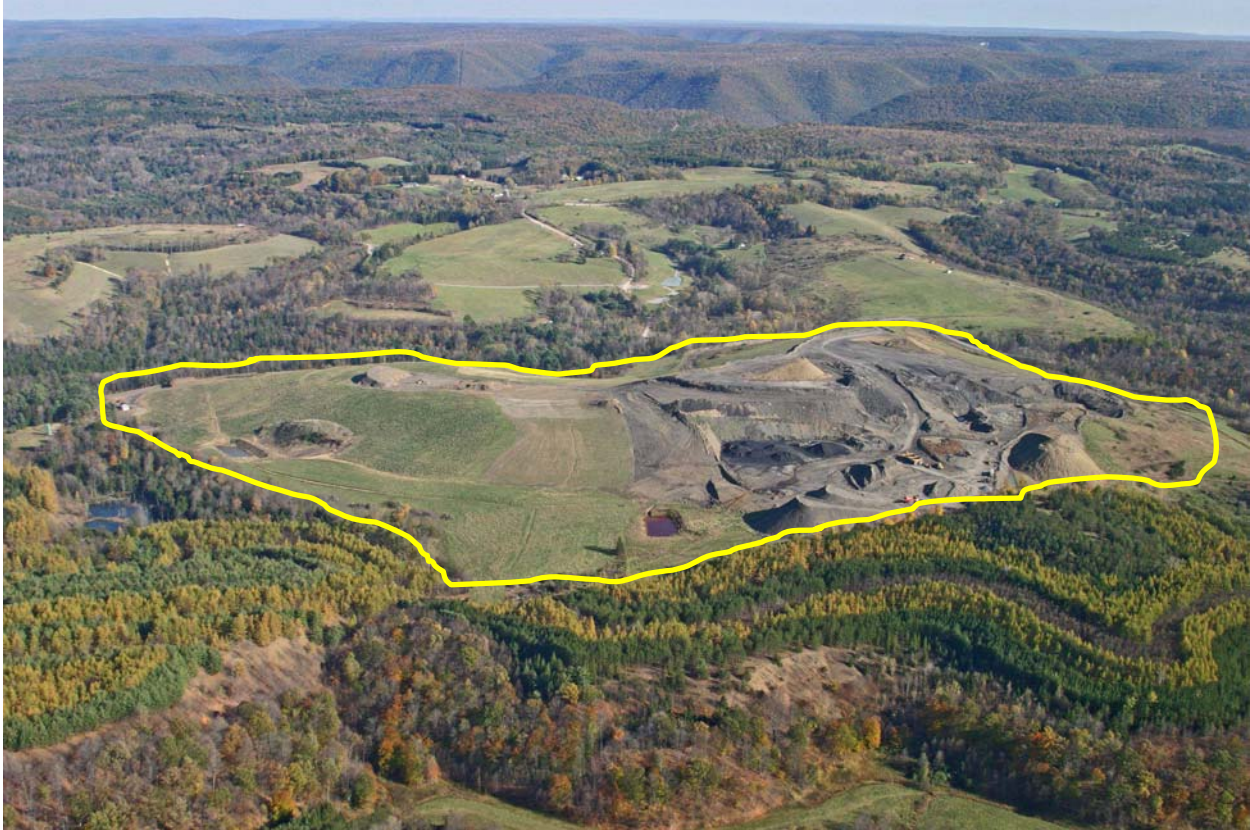
Figure 26. P&N Coal Company surface mine in the Dents Run Tributary to Bennett Branch in Benezette Township, Elk County.
