RESTORING THE BENNETT BRANCH SINNEMAHONING CREEK, CLEARFIELD AND ELK COUNTIES, PENNSYLVANIA¹

Eric E. Cavazza², P.E., and Richard L. Beam, P.G.

Abstract. Since 2004, the Pennsylvania Department of Environmental Protection (PA-DEP), Bureau of Abandoned Mine Reclamation (BAMR) has been working with multiple partners to restore water quality and reclaim abandoned mines in the Bennett Branch Sinnemahoning Creek. The primary water quality problems in the watershed are the result of uncontrolled and untreated discharges of acid mine drainage (AMD) from abandoned mine lands (AML) that have severely degraded the water quality in the lower 53.1 kilometers (33 miles) of the Bennett Branch and many of its tributaries. The primary objective of the Bennett Branch Restoration Project is to develop and implement a detailed mine drainage abatement and abandoned mine reclamation plan. The goals of the plan are to restore water quality in the main stem of the Bennett Branch, improve water quality in the AMD impacted tributaries, and maximize the reclamation of AML throughout the watershed. The restoration work is being pursued in conjunction with the PA Wilds Initiative which advocates economic dev

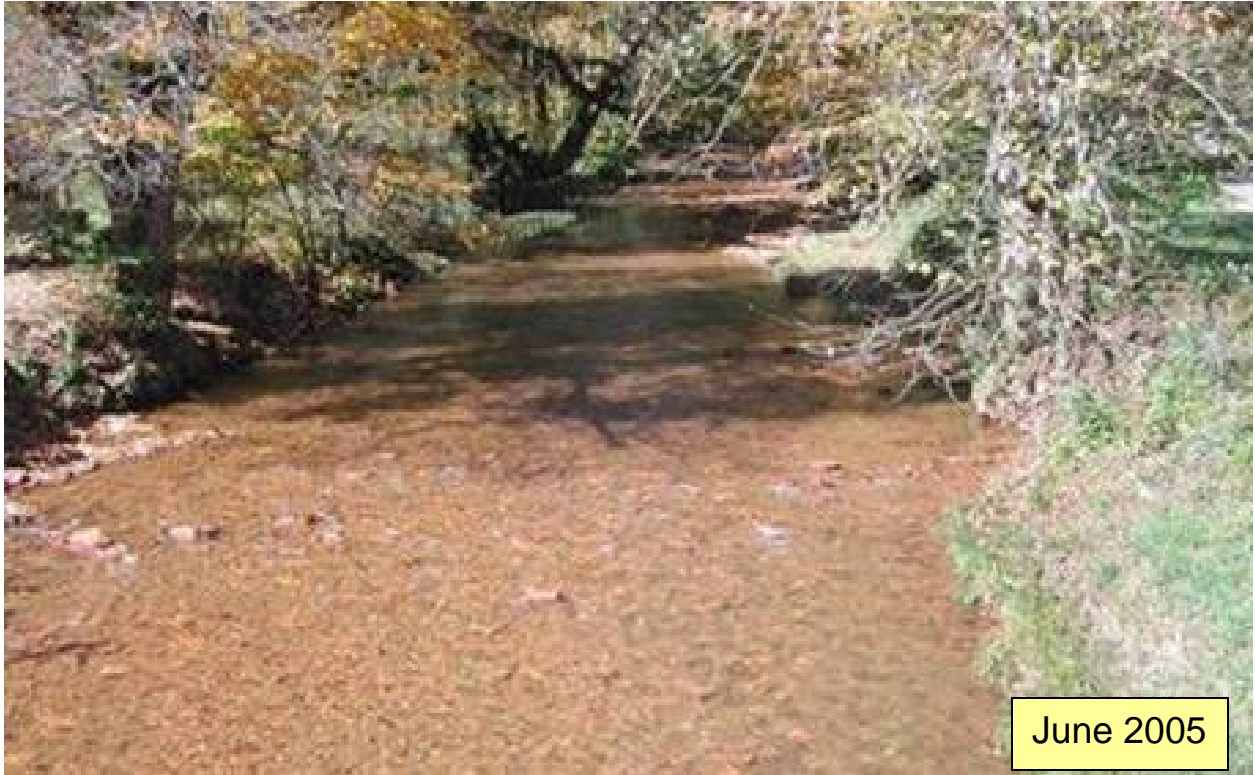
Figure 27. Dents Run just upstream of its confluence with the Bennett Branch prior to restoration.

mine land into rangeland for Pennsylvania’s growing elk herd; partnering with the active mining industry to reclaim several coal refuse piles and several hundred acres of AML at no cost to Pennsylvania’s AML Program; and completing development and design of the Hollywood Mine Drainage Treatment Plant that should eliminate an additional 40 percent of the acid load to Bennett Branch. State funding for capital construction of the plant was approved in June 2009. The project was originally advertised for bids on November 6, 2009 and the bid opening was January 28, 2010. Due to an inconsistency in the understanding by the bidders of the specifications for the pumps required for the project, a decision was made reject all bids and re-bid the project. The project was again advertised for bids on March 19, 2010 and the new bid opening is scheduled for April 13, 2010. Construction should begin by mid-summer of 2010. Table 6 summarizes the costs for the entire restoration of the Bennett Branch including the restoration work completed by the Army Corps of Engineers (ACOE) in the Dents Run Tributary and the value of the reclamation being completed by the active mining industry. To date, funding for over \$36 million of the nearly \$45 million has been committed. Figures 27 and 28 show Dents Run just upstream of its confluence with the Bennett Branch before and after restoration.

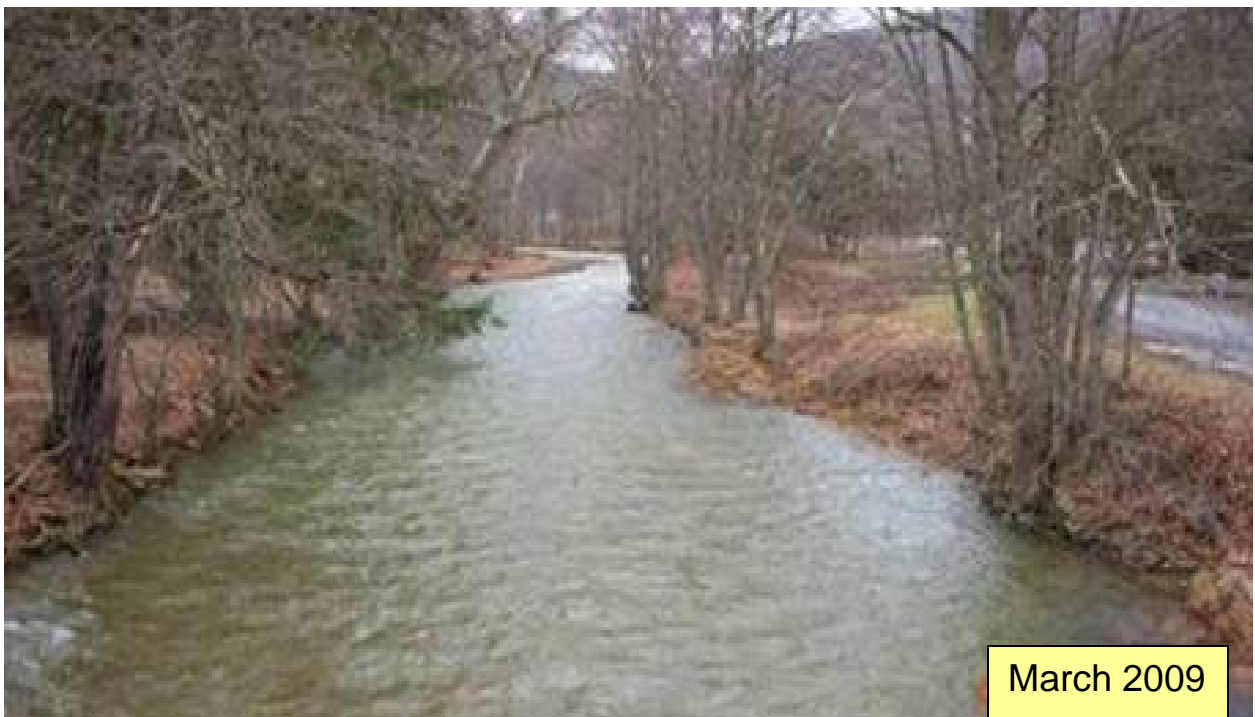
Figure 28. Dents Run just upstream of its confluence with the Bennett Branch following restoration.
