Vibration Monitoring Program for McConnell's Mill State Park

Vibra-Tech Engineers, Inc

April 30, 2001

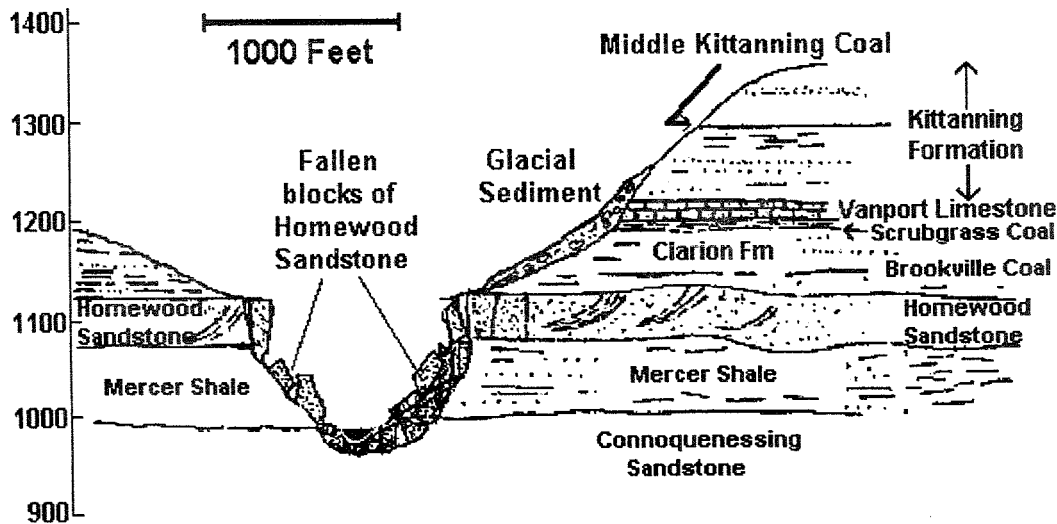
The gorge is deepest and narrowest near Cleland Rock on the divide and becomes progressively shallower and wider both to the north and to the south. Today, Slippery Rock Creek still has a steep gradient through the gorge (28 ft per mile compared to 8 feet per mile north of Kennedy Mill). The following graph illustrates a typical cross section of the gorge:

Figure 1-2-1 Gorge Cross Section

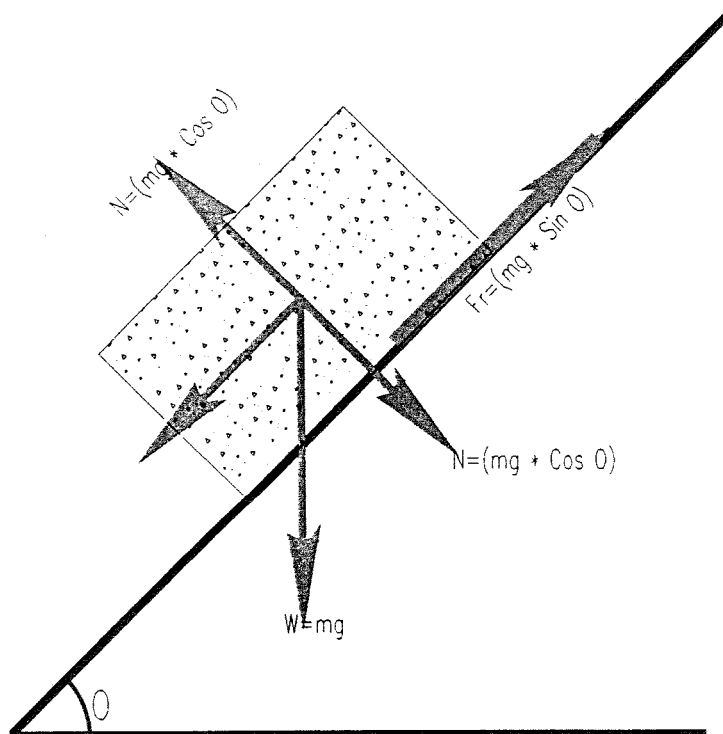
Based on our observation at the park, boulders are typically located on slopes of less than 45 degrees. On this basis, the force required to cause the boulder to slide was calculated assuming a 45-degree slope. Based on the results, a ground vibration level was recommended. The graphs and calculations on the following pages establish vibration criteria to prevent any sliding of rock.

Figure 2-1-1 Boulder Resting on Slope (Actual Photo & Model)

$\mu_s = 0.5$ Static Friction of Rock on Rock or Rock on Earth

$\phi = 45^\circ$ Angle of Incline Degrees

$N = m \cdot g \cdot \cos\left(\frac{\phi\pi}{180}\right)$ Normal Force

$F_s = \mu_s \cdot N$ Maximum Static Friction

$a = \sin\left(\frac{\phi\pi}{180}\right) - \mu_s \cdot \cos\left(\frac{\phi\pi}{180}\right)$ Mass starts to slide at this acceleration

$a = 0.354g$

$0.5 \cdot a = 0.177g$ Safety Factor of 2 (Recommended peak acceleration induced by blasting)

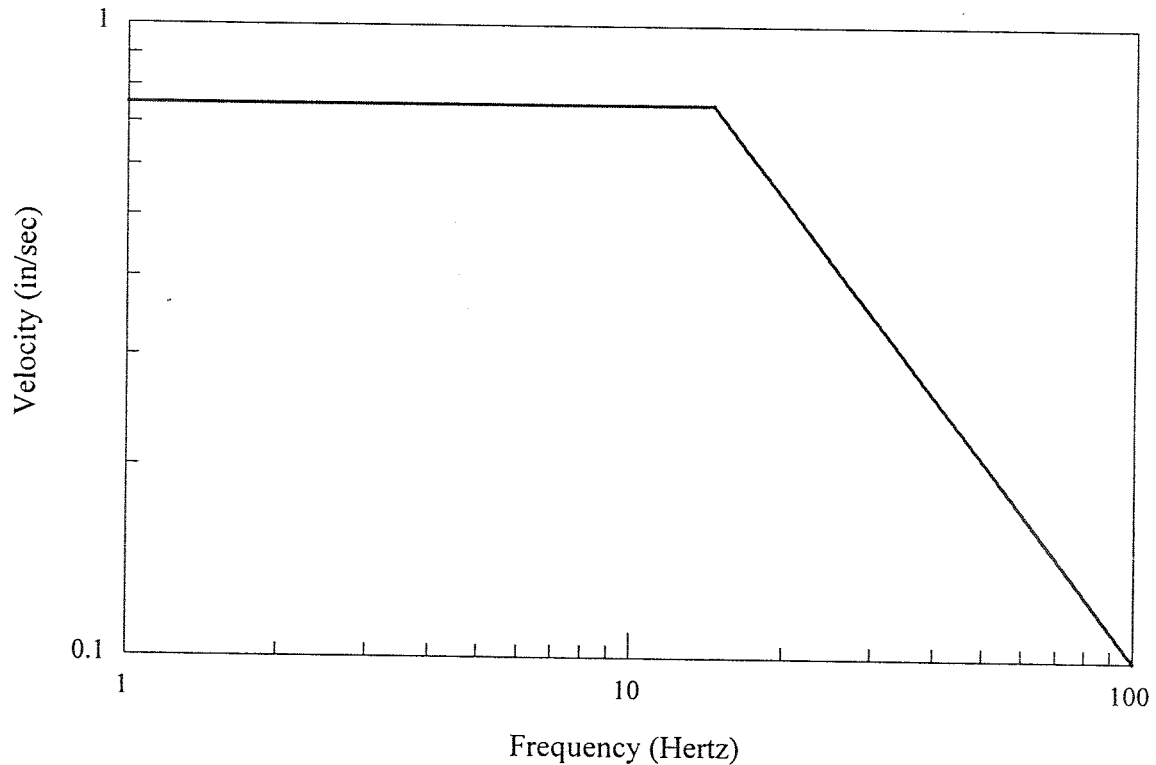
Figure 2-1-2 Allowable Peak Particle Velocity vs Frequency

In this calculation, a 50% factor of safety is included. Also, according to our observations at the park, all of the boulders we observed are resting on slopes that are less

Figure 2-1-2 shows the allowable peak particle velocity at different frequencies. It is also recommended that blasting patterns be designed to limit the induced peak particle velocity to no more than 0.75 in/sec. This value will result in a particle acceleration of less than 0.18 g, assuming that the dominant frequency is less than 15 hertz. It is also recommended that the ground vibration along Rim Road be monitored during each blast. It will be beneficial if the seismograph has the capability to directly measure particle acceleration rather than velocity.

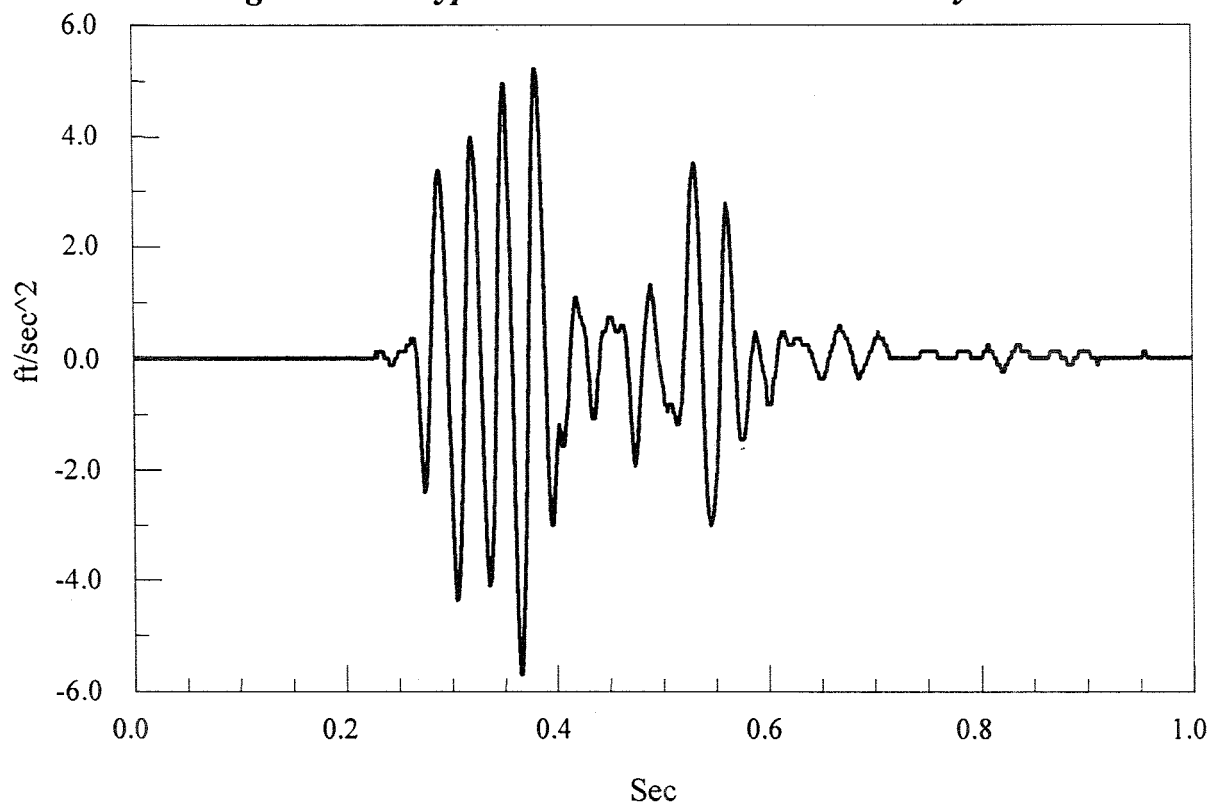
The stresses that developed within the rock surface were calculated. The graphs on the following pages illustrate the time history of the vibration and the stress levels within the rock. The stress values are given in pounds per square foot (psf). The review of the stress distribution on the finite element model indicates that the stress levels are far below the compressive and shear strength of the rock.

Figure 2-2-1 Typical Blast Vibration Time History

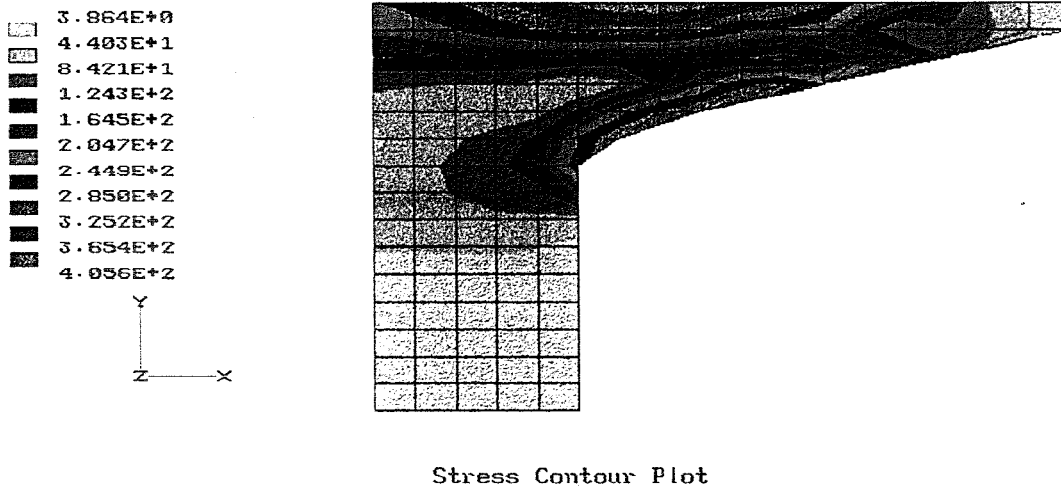
The Finite Element Analysis technique simulates structural response to certain loads (e.g. blasting) by using mathematical equations and knowledge of structural physical properties. In this study, we modeled one foot of a typical cross section of the cliff that included 139 nodes and 118 plate elements. The following material properties were used in the model:

Modulus of Elasticity = 77.24E6 (psf)
Weight Density = 143 (lbs/ft³)
Poisson's Ration = 0.25
Compressive Strength = 1.81E6 (psf)
Shear Modulus = 30.9E6 (psf)
Shear Strength = 173,800 (psf)

Figure 2-2-2 Stress Contour Distribution Caused by a Typical Blast.

Another potential form of damage to rock due to high levels of vibration is the collapse of overhanging cliffs. In this scenario, high vibration would excite the support of the cliff and cause excessive vibration of the overhang. The excessive shear stress would result in separation of the overhang from its support. In order to evaluate this potential, we used the finite element technique. In this analysis, we developed a computer model of a typical section of the overhanging cliff. A typical blast vibration with amplitude similar to the allowable level in the previous section (0.177g or 5.7 ft/sec²) was then applied to the support.
