## **SURFACE EROSION**

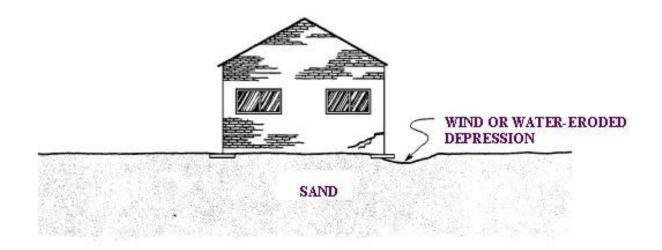
Cracking of Masonry Wall Due To Foundation Undermining by Surface Erosion
