HAMMER CREEK
LEBANON AND LANCASTER COUNTIES

WATER QUALITY STANDARDS REVIEW
STREAM REDESIGNATION EVALUATION

Segment: Source to Speedwell Forge Lake Dam
Stream Code: 07664
Drainage List O

WATER QUALITY MONITORING SECTION (TES)
DIVISION OF WATER QUALITY STANDARDS
BUREAU OF WATER STANDARDS AND FACILITY REGULATION
DEPARTMENT OF ENVIRONMENTAL PROTECTION

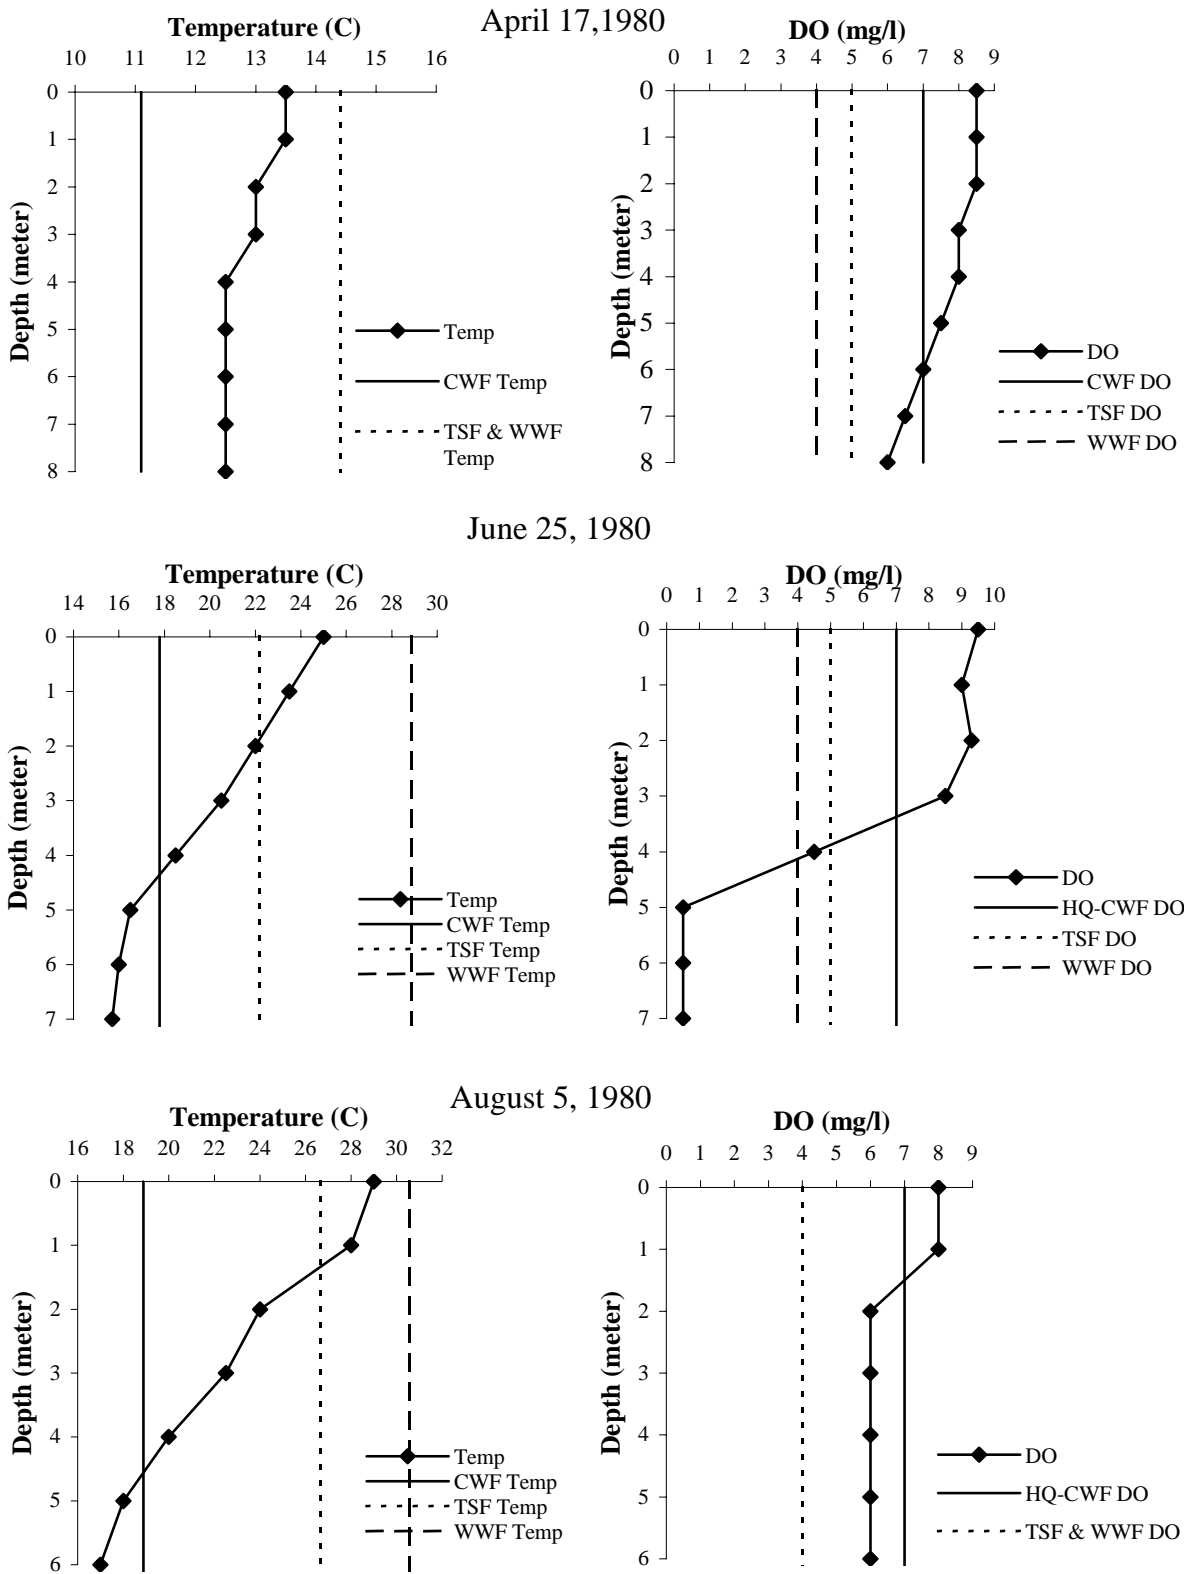
FIGURE 5.
SPEEDWELL FORGE LAKE - WATER CHEMISTRY¹
Temperature and Dissolved Oxygen Profiles
 Ulanoski and Shertzer 1981

¹Vertical lines depict parameter criteria. Depth measurements prevent the labeling of a thermocline.

Water quality data had also been collected from Speedwell Forge Lake by Ulanoski et al (1981), Ballaron et al (1996), and F.X. Brown Inc. (2003). Chemical samples were collected on three occasions from two locations within the lake in 1980 and 1995 (Tables 11-12). F.X. Brown, Inc. collected chemistry parameters on four occasions from two locations in 2000 (Table 13). Temperature/dissolved oxygen profiles were also recorded in 1980 and 2000 in conjunction with these chemical sampling events (Figures 5-7) and the Department collected profiles in 1997 (Figure 8). Water quality data collected from Speedwell Forge Lake indicates the lake has high nutrient concentrations. Temperature/dissolved oxygen profiles indicate that the lake stratifies during the summer separating into two distinct layers with dissolved oxygen levels in the hypolimnion often becoming anoxic (0.0mg/l).

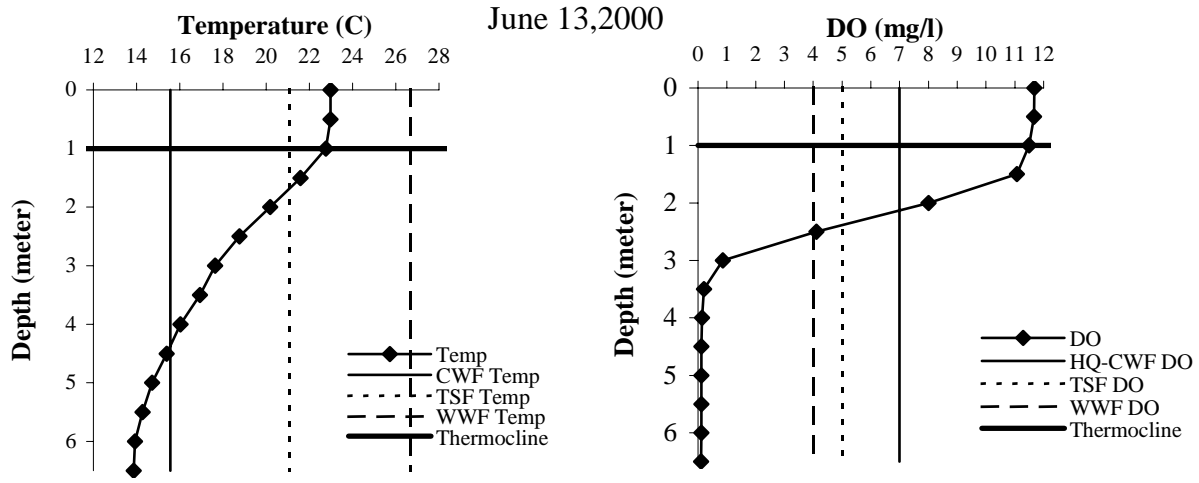
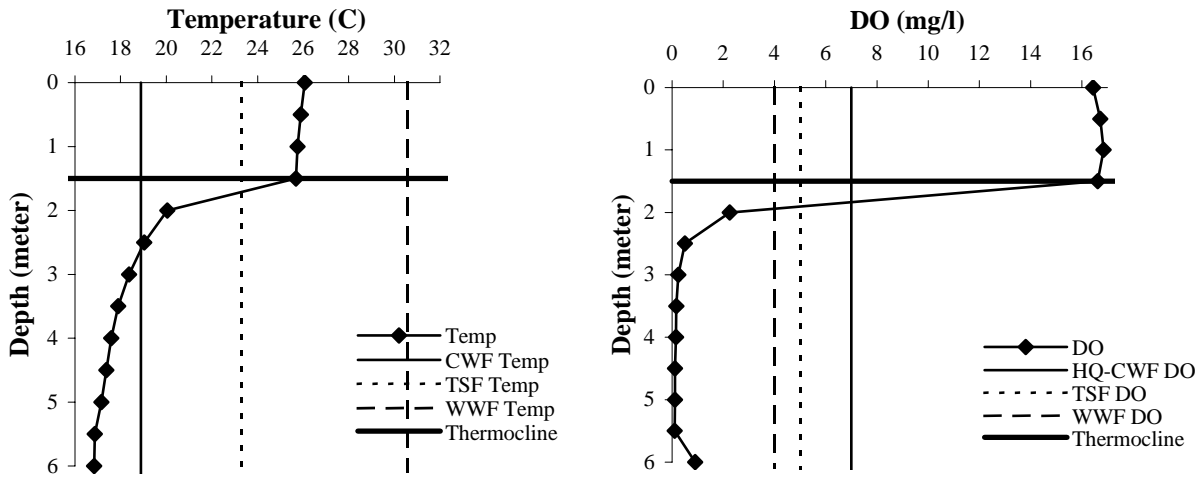
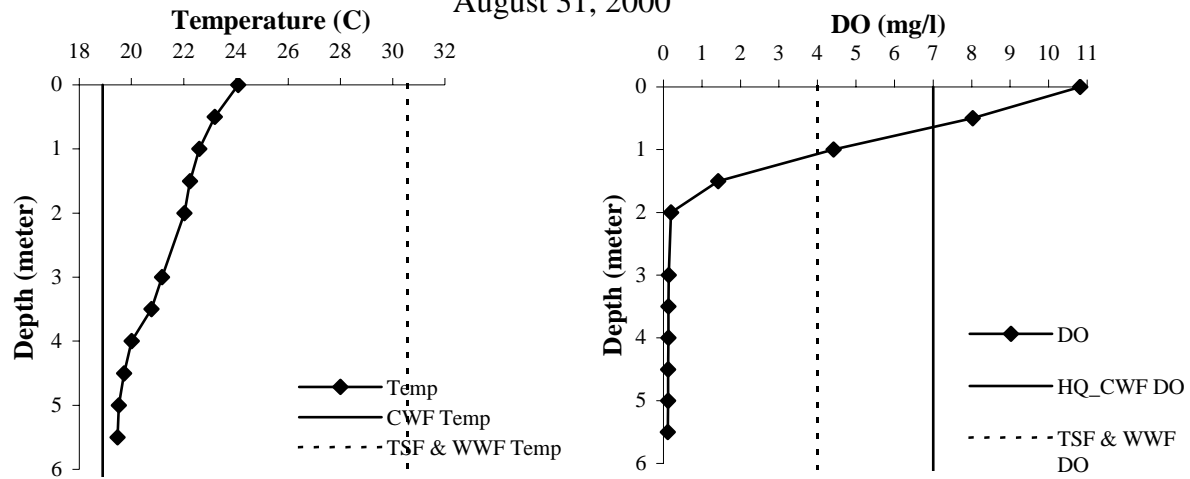
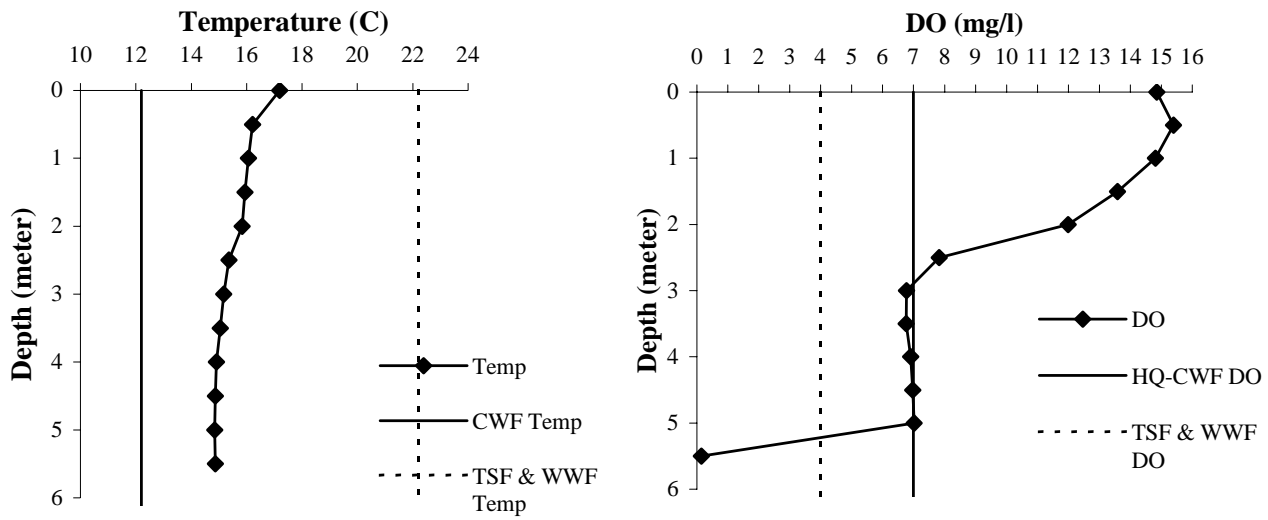
FIGURE 6.
SPEEDWELL FORGE LAKE - WATER CHEMISTRY
Temperature and Dissolved Oxygen Profiles
 Dam Location - F.X.. Brown, Inc.
 Vertical lines depict parameter criteria.

July 10, 2000

August 31, 2000

FIGURE 6. (cont.)
WATER CHEMISTRY - Temperature and Dissolved Oxygen Profiles
 October 2, 2000

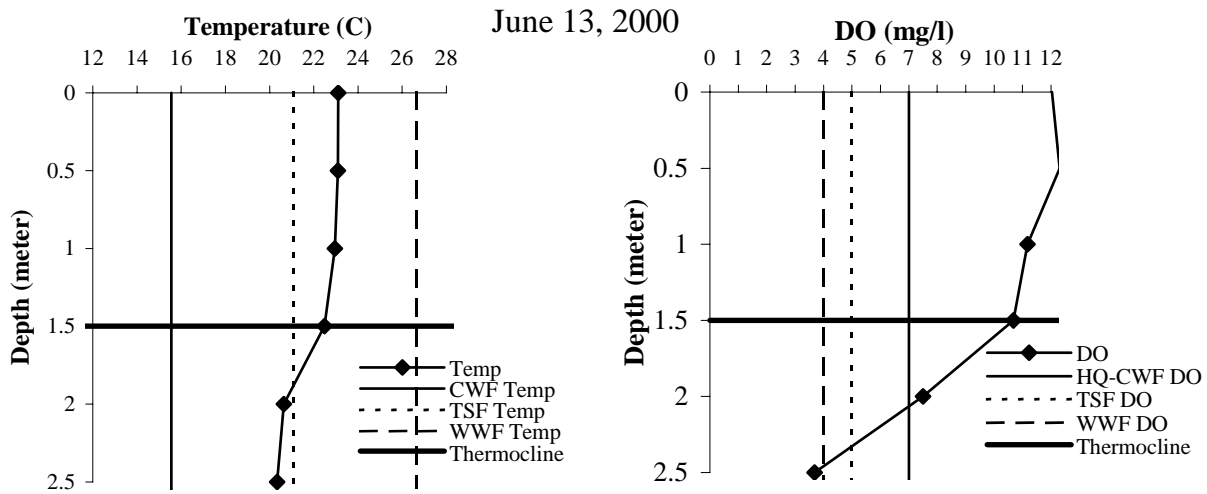
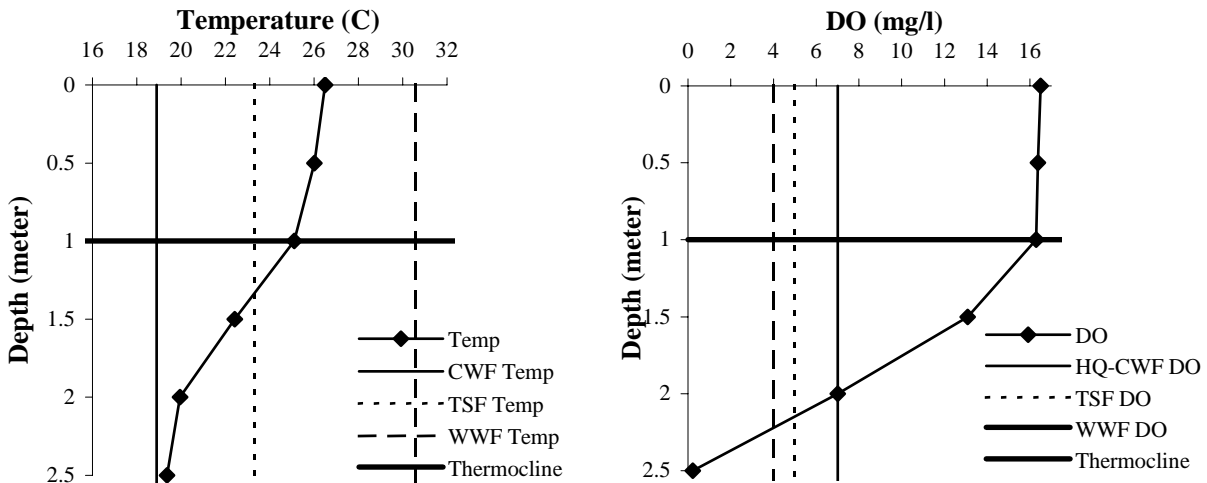
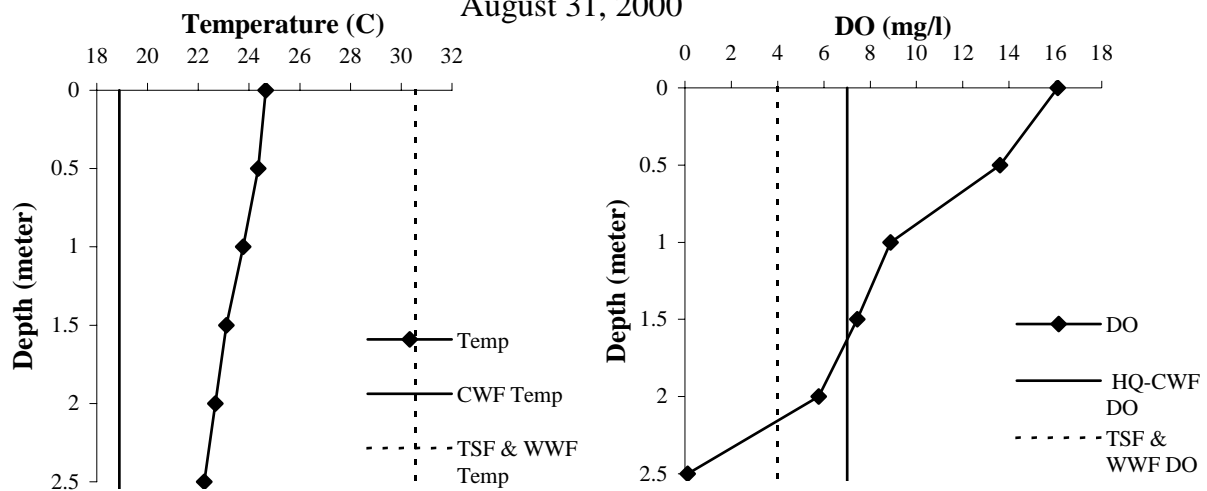
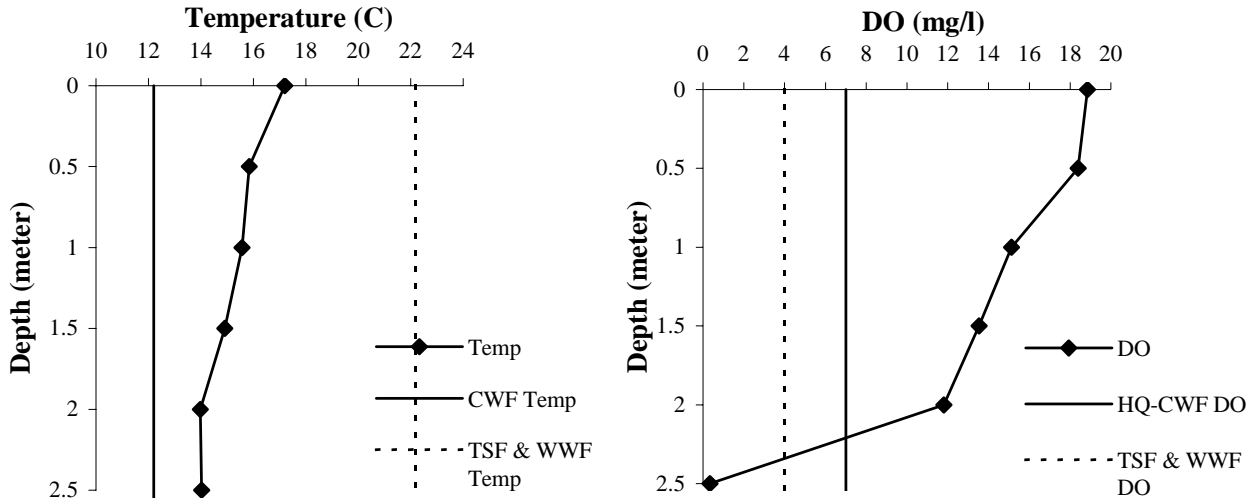
FIGURE 7.
SPEEDWELL FORGE LAKE - WATER CHEMISTRY
Temperature and Dissolved Oxygen Profiles

Uplake Location - FX Brown
 Vertical lines depict parameter criteria.

July 10, 2000

August 31, 2000

FIGURE 7. (cont.)
WATER CHEMISTRY - Temperature and Dissolved Oxygen Profiles
 October 2, 2000
