NARRATIVE REPORT FORM
Facility Name: Glenwood Drive and Walker Road:

Primary Facility ID: 881609 _____

Inspection Date: 12-22-25	Inspection Time: 9:18	Lat/Long:																																																																				
Program: ECB	<input type="checkbox"/> Storage Tanks	<input type="checkbox"/> HSCA	<input checked="" type="checkbox"/> LRP																																																																			
Owner Name: Energy Transfer		Inspection ID:	Site ID:																																																																			
Facility Location (911) Address: Glenwood Drive and Walker Road Washington Crossing, PA 18977		Municipality: Upper Makefield Twp.																																																																				
		County: Bucks																																																																				
Responsible Official Name: Brad Fish		Responsible Official Address: 100 Green Street Marcus Hook, PA 19061																																																																				
Title: Senior Environmental Specialist Emergency Response & Remediation																																																																						
Responsible Official Telephone: 610-859-6297 Email Address: b

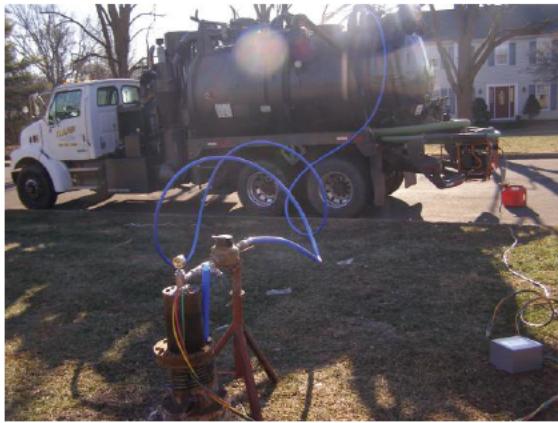
- Raab Drilling arrived on site, who were there to collect the purged water from the newly installed potable well at [REDACTED] so that a second water sample could be collected to be analyzed.
- Stantec personal were there to collect the samples.

Set-up to collect water sample under pumping conditions
 12-22-25 @ 9:59

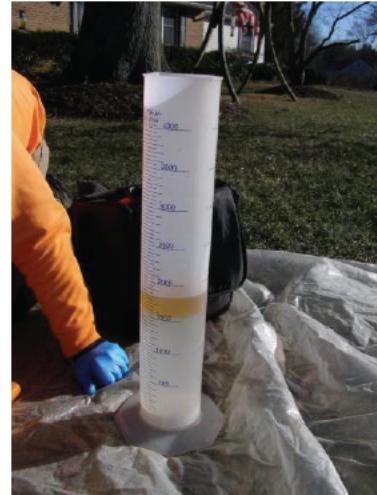
- There was a LNAPL thickness measured of 0.10' with the interface probe.
- The well was bailed and the water/LNAPL was poured into the graduated cylinder.
- After the well was bailed, the depth to water and LNAPL was gauged. There was 0.03' of LNAPL remaining in the well.
- GES estimated that there was approximately 310mL of LNAPL in the graduated cylinder.
- A LNAPL sample was collected at 10:30.
- The water/LNAPL was then poured into a dedicated metal bucket.

Water/LNAPL bailed from former potable well at [REDACTED]
 12-22-25 @10:24

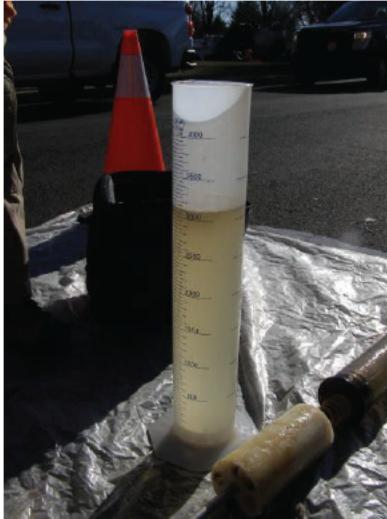
- The depth to water and LNAPL was measured with the skimmer in the well and after it was removed.
- After the skimmer was removed it was poured into the graduated cylinder, LNAPL was measured to be approximately 50mL.
- The contents were poured into a dedicated metal bucket, a LNAPL sample was collected at 10:47.
- The skimmer depth was readjusted to match the depth to water before it was reinstalled in the well.

Skimmer water/LNAPL from RW-2
 12-22-25 @ 10:42

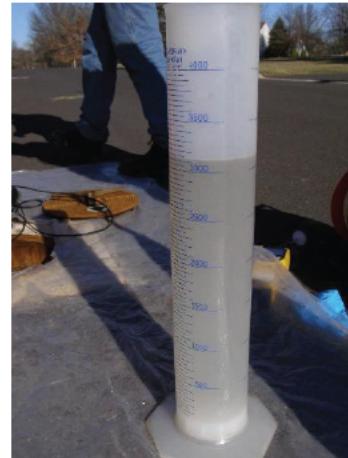
- The depth to water and LNAPL was measured with the skimmer in the well and after it was removed.
- After the skimmer was removed it was poured into the graduated cylinder, LNAPL was measured to be approximately 10mL.
- The contents were poured into a dedicated metal bucket, a LNAPL sample was collected at 11:05.
- The skimmer depth was readjusted to match the depth to water before it was reinstalled in the well.

Skimmer water/LNAPL from RW-3
 12-22-25 @ 11:04
